2010 Water Systems Report

June 30, 2011

Environmental Services Department
Alberni-Clayoquot Regional District
3008 Fifth Avenue
Port Alberni, BC

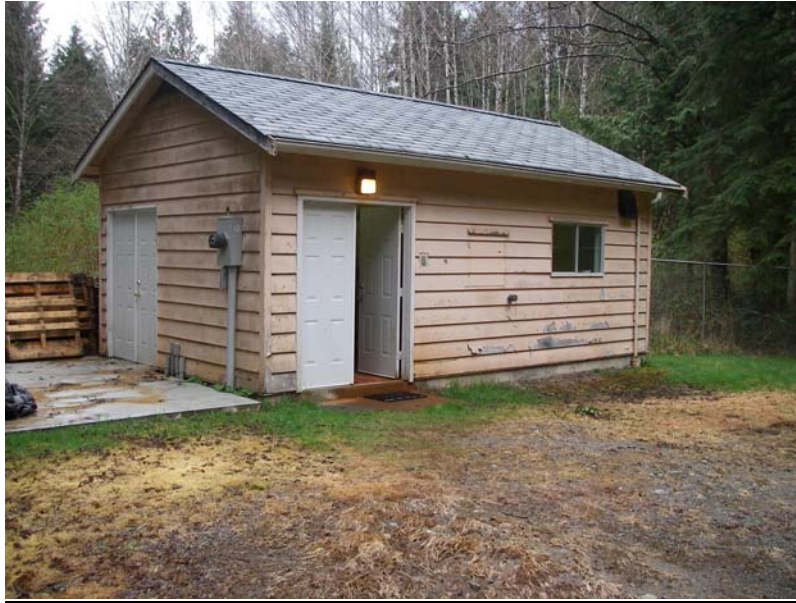
Photo 1. Tofino Airport Water System pump house

There are two (six inch diameter) deep wells with submersible pumps that supply water to the pump house. The #2 Well is the primary well due to the better water quality than the water quality of #1 Well. In the pump house a water softener (ion exchange with the use of salt) is used to remove iron, calcium, magnesium and manganese. The treated water is then disinfected with chlorine and stored in the (300,000 gallon) concrete reservoir. The reservoir filling is controlled via a float switch in the reservoir. Water pressure is maintained in the distribution system by centrifugal pumps operating automatically by a pressure switch with pressure tanks.

The system has two chlorination injection pumps to provide primary and secondary disinfection. The first pump chlorinates the water going into the reservoir to provide disinfection and to keep the reservoir clean. This initial chlorination provides a long contact time for the chlorine to oxidize any organics. The operating set point is to always have a free chlorine residual of the reservoir of 0.1 mg/l. The second pump increases the chlorine residual leaving the reservoir so that there is a residual at the end of the distribution system of 0.2 mg/l.

There is currently an increase in demand for water from the Tofino Airport Water System. The airport is seeing the beginnings of development on the airport property due to the ability to create and lease property for development. The Community of Esowista is undergoing a substantial increase in building lot development. The Pacific Rim National Park is also investigating possible water sources for nearby campgrounds. A new dependable water source may need to be found to accommodate the increase in demand. The Ion Exchange water treatment system may need to be replaced or be significantly increased with an increase of water demand. The next scheduled comprehensive testing of the water would be in 2011.

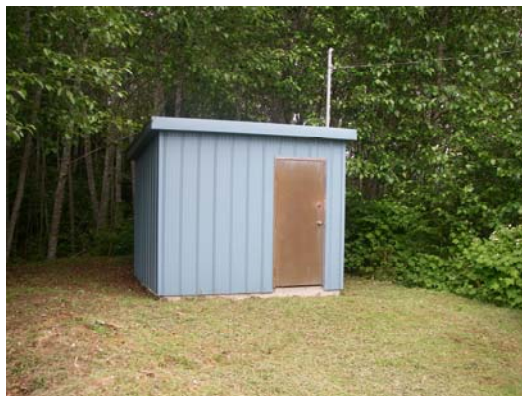
Photo 2. Alberni Valley Regional Airport pump house and well

The water well was dug approximately eighteen feet deep in the natural gravel. The well was then constructed with concrete casing rings and completed with a building enclosing it (Photo 2). The system is supplied with a shallow well and small pump located approximately 200m from the caretakers dwelling in a secure building. The distribution system follows the access road to the terminal building with a branch that goes to the caretaker's residence (see map in appendix iii).

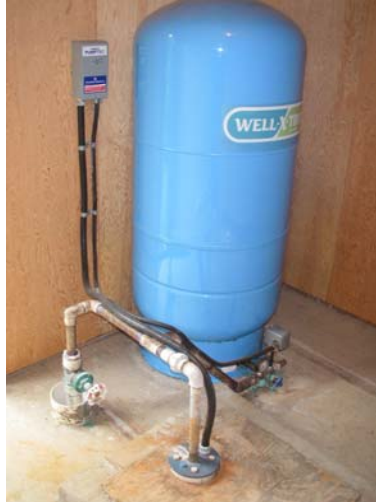
Photo 3. Alberni Valley Regional Airport pressure tank

The system operates with one "Novatek" submersible pump controlled by a pressure switch in conjunction with a 40 gallon pressure tank (Photo 3) - (Well-x-Trol by Amtrol, Model WX-350, max pressure 100 psi). The system is contained within a steel pumphouse building (10 by 8 feet & 9 feet high) and the distribution is comprised of approximately 350 meters of 1.5 inch poly ethylene pipe.

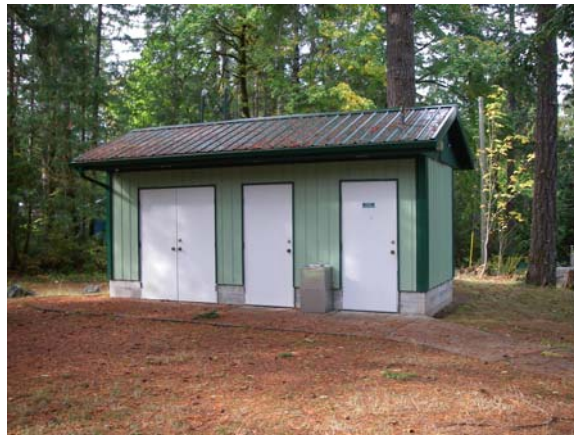
Photo 4. Cougar Smith Park water distribution and disinfection building

The new water well is located at the south end of the park near the end of the basketball court (see figure 8). The well was drilled 400 feet deep into bedrock with the majority of the water coming in at a gravel seem around the 40 foot level (see Figure 9). A water line runs up the side of the playground and then parallels the park road and into the Cougar Smith Park service building (Photo 4). Within the building are a pressure tank, an ultraviolet light disinfection system and a five micron particulate filter. From the service building the water goes to two public washrooms, an irrigation system, a drinking fountain and the caretaker’s residence.

The existing water treatment system will be upgraded to VIHA standards in order to obtain an Operating Permit. The upgrading will involve a redesign of the piping system. The redesign will include shut off valves, pressure gauges and a finer filtration down to one micron. Upon VIHA's recommendations a larger ultraviolet disinfection system may also be installed. A flow meter will also be installed to track water usage and trends in determining future needs.

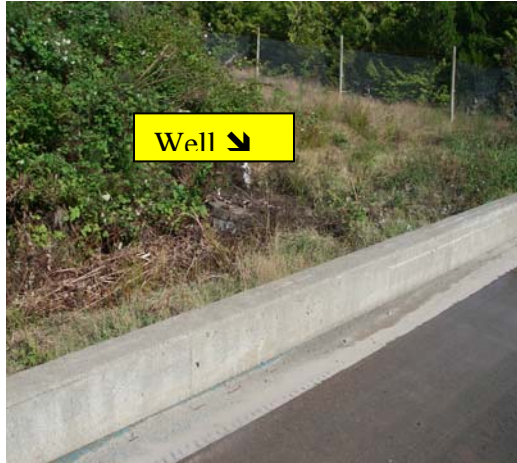
Photo 5. West Coast Landfill Small Water System shallow well

The water quality does not meet the Guidelines for Canadian Drinking Water Quality due to the presence of Fecal Coliforms and E. Coli. The water has a low pH of 6.34 and does not meet the Aesthetic Objectives for pH (Analytical results in Table 3).

Installing a simple water treatment system to provide potable water is not a practical solution due to the low pH of the well water. To raise the pH a treatment system would have to include a chemical addition of either sodium hydroxide (caustic soda) or other chemicals. Due to the proximity of the well to the landfill the quality control would be too exhaustive to maintain a potable water source.

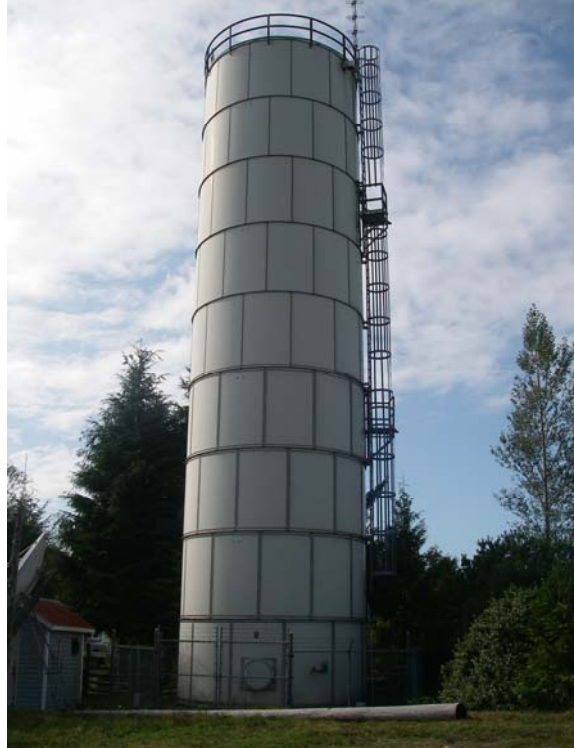
Photo 7. Millstream Community Water System reservoir

Millstream is a small residential community located approximately 3.5 km north of the District of Ucluelet. The area was originally developed by a logging contractor to provide accommodation for employees and their families. The existing water system was constructed between July and October 1969. The type of pipe used was asbestos cement (A.C.), which was the current technology at the time. The original wood reservoir was replaced with a metal reservoir in the early 1990's (Photo 7).

The reservoir will require a complete cleaning and mechanical inspection in the near future. A complete interior inspection or cleaning has not occurred since the reservoir was commissioned. In order to accomplish this, a separate supply method will have to be initiated while the reservoir is unavailable.

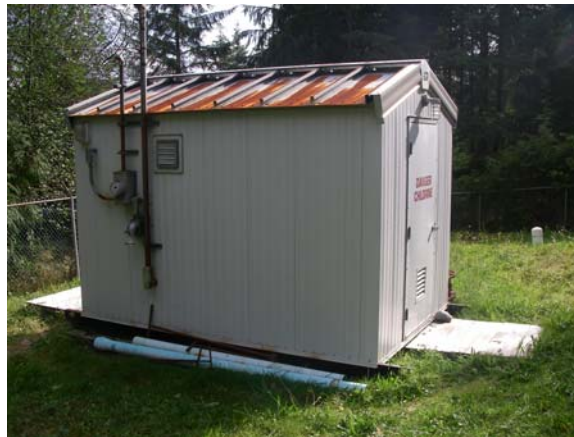
Photo 8. Millstream Community Water System pump house

The two centrifugal pumps are located in the pump house and are controlled by the water main pressure. Previously, the pumps were controlled by float switches located in the reservoir. The float switches used telephone lines to communicate with the control system located in the pump house. The local telephone company was upgrading the phone lines to fiber optics and gave us notice that our copper wire communication system would not be working. Due to the high costs of a radio communication system an innovative system of communication was installed. The pressure of the water main in the pump house is used to control the pumps starting. Once the pump starts, a timer is used to turn off the pumps when the reservoir is full. A pressure drop in the pump house is noticed when the water in the reservoir drops a know height. A built in delay eliminates frequent false starts from low pressure events due to water use along the water main.

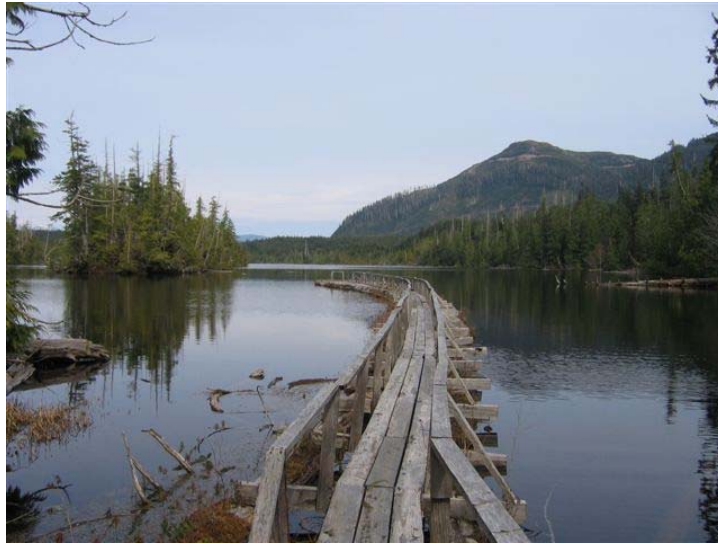
Photo 10. Bamfield Community Water System, Sugsaw Lake intake structure

The water supply system is comprised of a water source and intake structure at the south east end of Sugsaw Lake, approximately four kilometers northeast of Bamfield. The intake structure is a floating walkway with the water main and intake screens suspended underneath (Photo 10 & 11). The structure is anchored in many places to hold it in the correct position. The ACRD has a water licence from the Ministry of Environment for 91,250,000 gallons per year from Sugsaw Lake. The 2010 annual water use was 56,939 cubic meters.

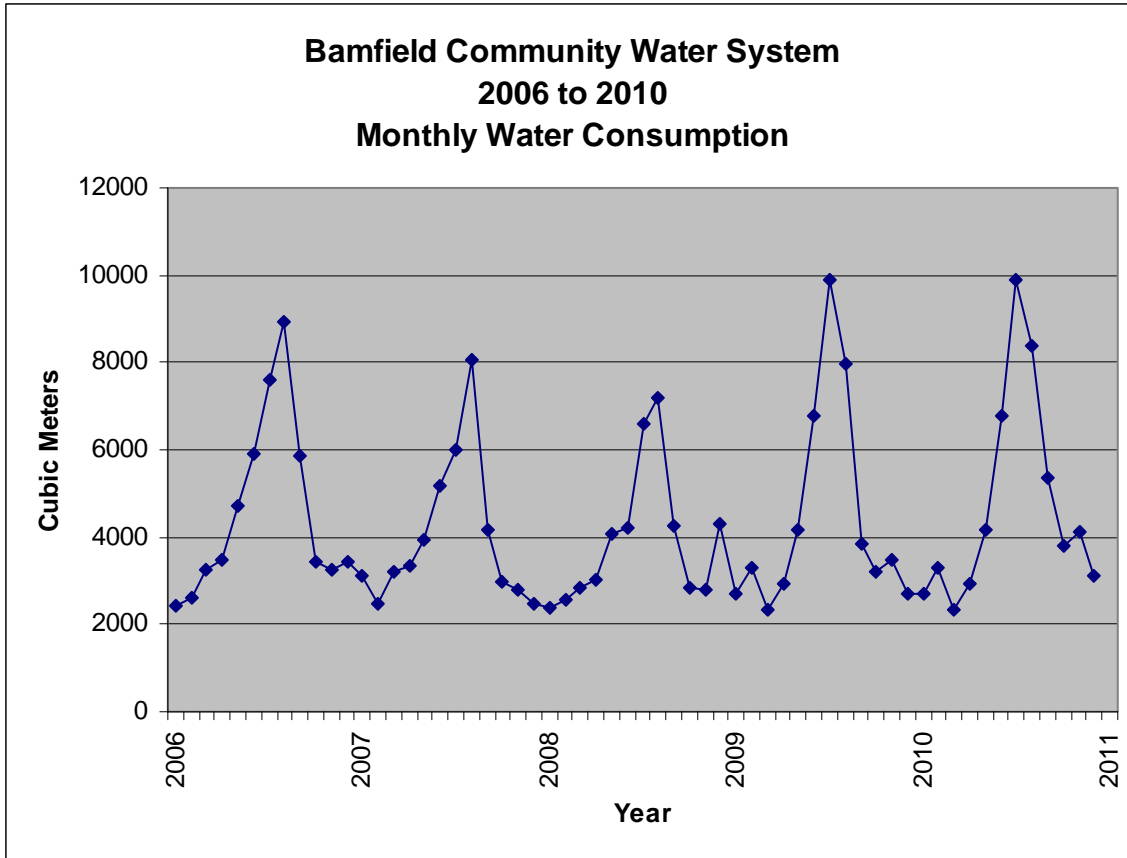
Figure 13. Bamfield Community Water System monthly water consumption

Water is tested daily for Free Chlorine and the residual is maintained at 0.2 mg/l. The last laboratory analysis of Bamfield’s raw water from Sugsaw Lake was taken in August 2007 (Table 5). All Aesthetic Criteria and Maximum Acceptable Concentrations were acceptable besides the Microbiological Analysis. The Microbiological Analysis showed a total coliform count of 8 Col./100 mL and E. coli of a count of 1 Col./100. These values are typical of a surface water source and demonstrate the need for disinfection. Monthly water consumption since 2006 does not show an increasing trend but does show regular significant water line leaks (Figure 13).

The water line from Sugsaw Lake to the pump house is located under Grappler Inlet. Having the water main under the ocean is problematic if repairs are required and for general maintenance. Another problem with this is that since the water main is gravity supplied there is a limited amount of water that can be pumped. An overland route concept has been reviewed that could pump water directly from Sugsaw Lake to the reservoirs. This would be able to supply more water to the community to facilitate growth of the community and supply adequate water for fire protection.
