ALBERNI-CLAYOQUOT REGIONAL DISTRICT Parks Linear Asset Assessment & Mapping Alberni Inlet Trail

PARKS LINEAR ASSET ASSESSMENT & MAPPING

ALBERNI INLET TRAIL, PORT ALBERNI, BC

Submittal Date: July 29, 2025

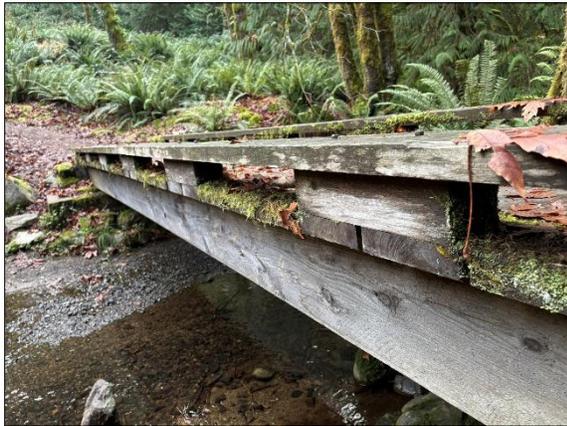
- Superstructure is slippery with moisture and biological accumulation (moss, etc.),
- One guard section is decayed and soft when probed,
- Abutments have vegetative growth around them.

Photograph 3: Bridge 1 Decking, note: soft at cut ends with significant growth

- Clean bridge surfaces of vegetation,
- Replace one section of vehicle guard,
- Clear abutments of vegetation.

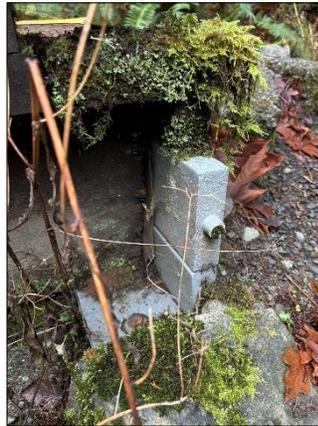
Photograph 4: Bridge 1 Abutment Wingwall, note: biological growth

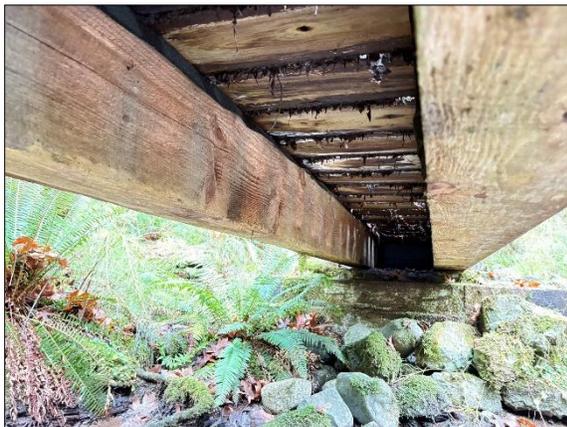
Photograph 5: Bridge 1 stringers and underside of decking, note: biological growth

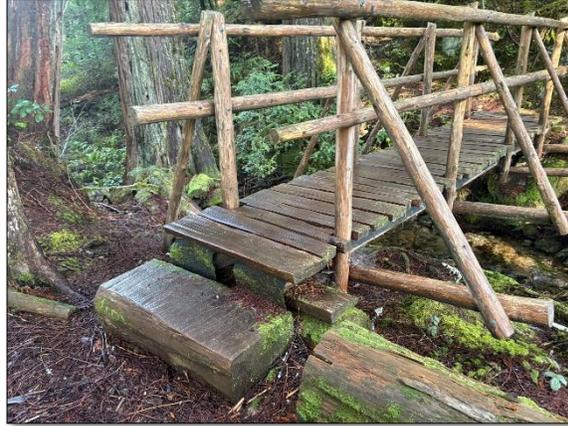
- Superstructure is slippery with moisture and biological accumulation (moss, etc.),
- Log stringers have moderate amount of biological growth (moss),
- Abutments have vegetative growth and are soft when probed.

Photograph 8: Bridge 2, note: biological growth on abutment and stringers

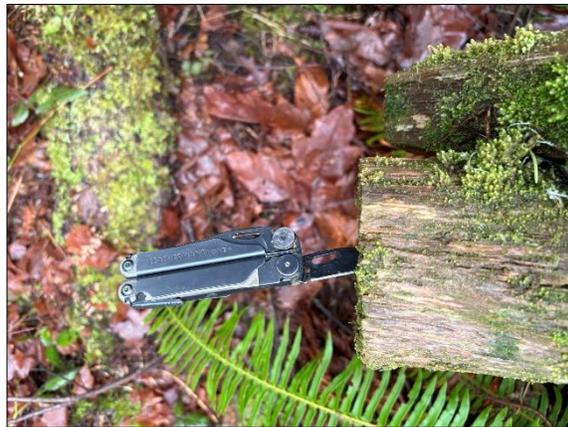
Photograph 10: Bridge 3 cross beam, note: decayed ends

- Install non-slip surface on the deck boards (e.g.: roofing shingles or profiled metal strips)
- Replace existing knee braces and cross beams,
- Replace existing abutments on both sides,
- Clean surfaces of vegetation,

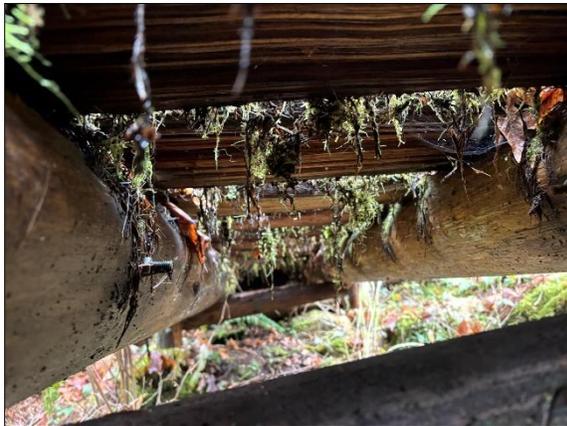
Photograph 11: Bridge 3 substructure, note: significant biological growth and moisture ingress

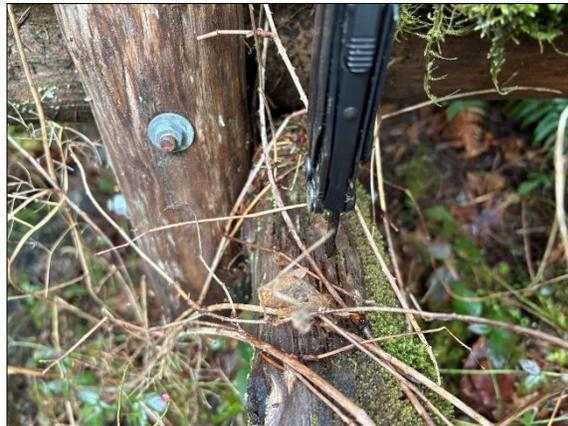
Photograph 12: Bridge 3 cross beam, note: decayed section

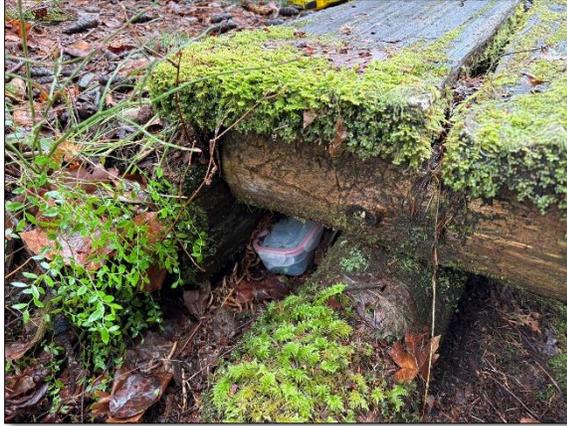
Photograph 13: Bridge 3 abutment, note: moisture and biological growth

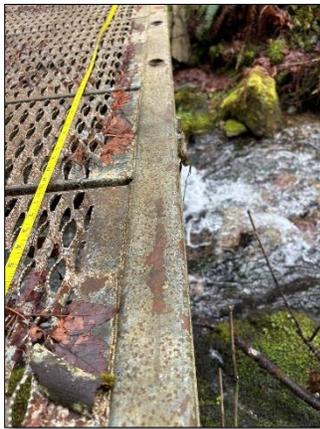
Photograph 15: Bridge 4, note: coating failure and surface corrosion

- Clean steel elements and re-coat,
- Replace three sections of serrated decking,
- Consider installation of abutments and guarding

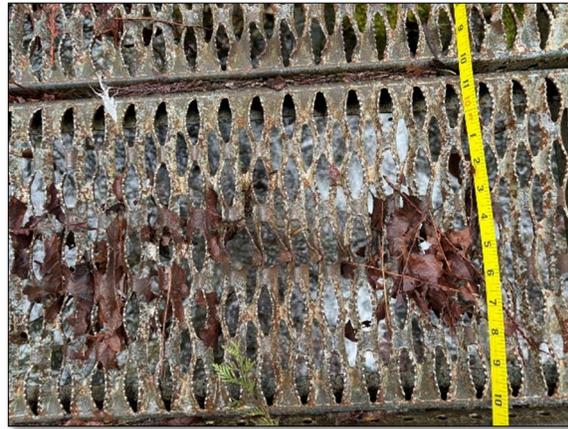
Photograph 16: Bridge 4, note: failed grating

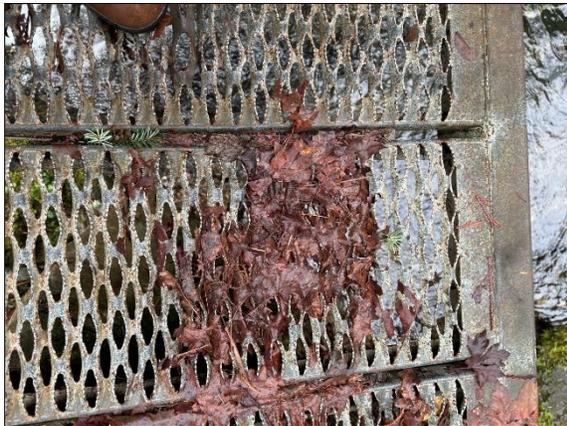
Photograph 17: Bridge 4, note: bent grating

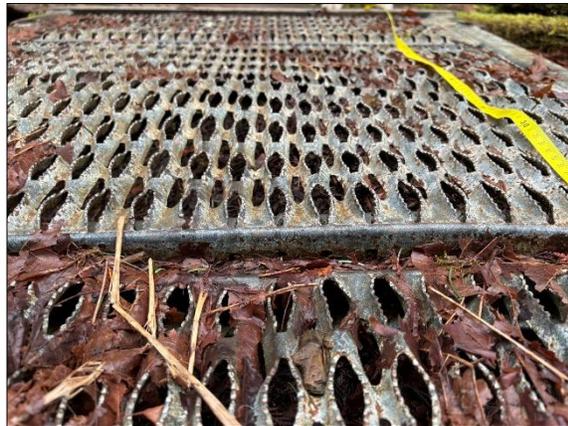
Photograph 18: Bridge 4, note: bent grating over rock outcropping

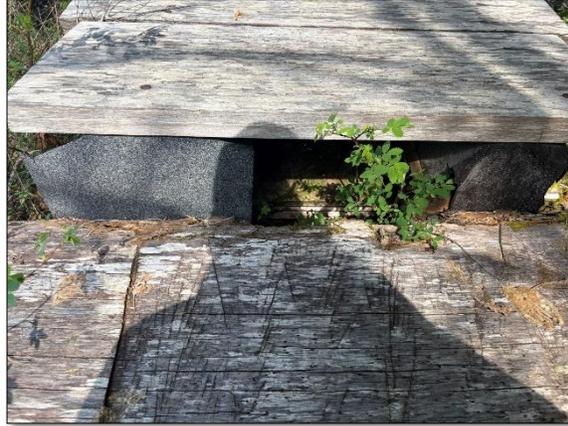
Photograph 20: Bridge 5, note: weather to timbers and roofing shingles between deck and stringers

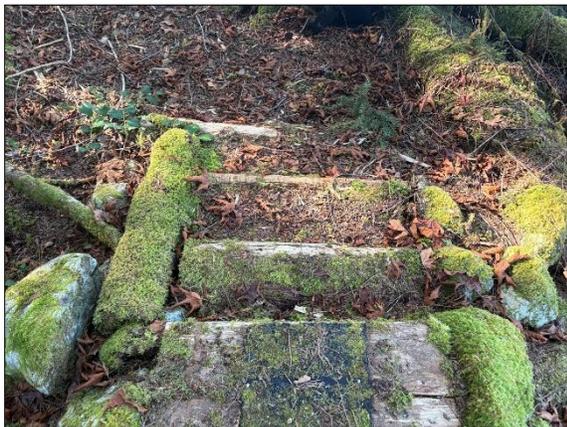
- Deck and stringers have significant biological growth (moss, etc.) and moisture ingress,
- Abutment stairs are deteriorating due to biological damage.

Photograph 23: Bridge 6, note: abutment stair significantly deteriorated.

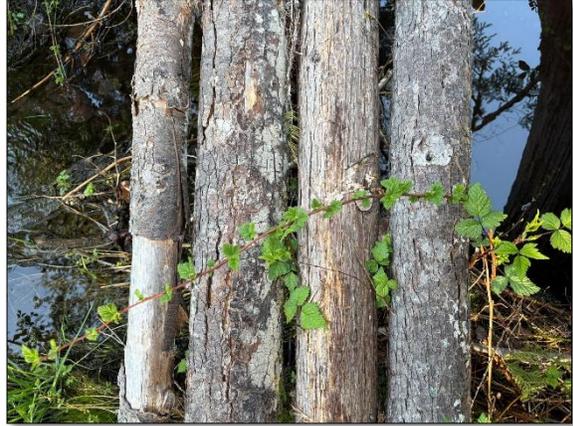
Photograph 26: Crossing 7, note: spacing between stringers with no connection

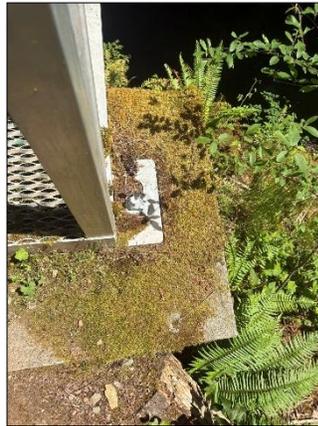
Photograph 28: Bridge 8, note: vegetative growth around bridge bearings

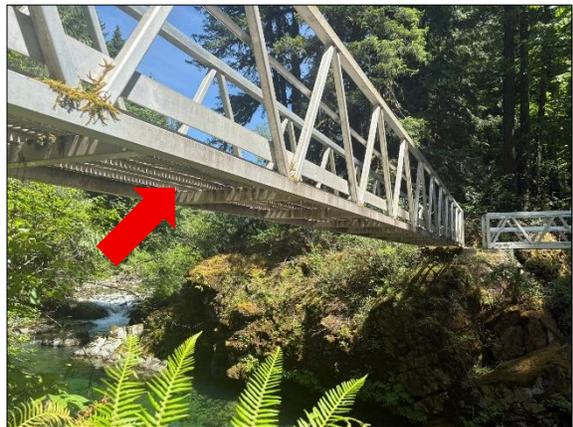
Photograph 30: Bridge 8, note: lack of plan bracing

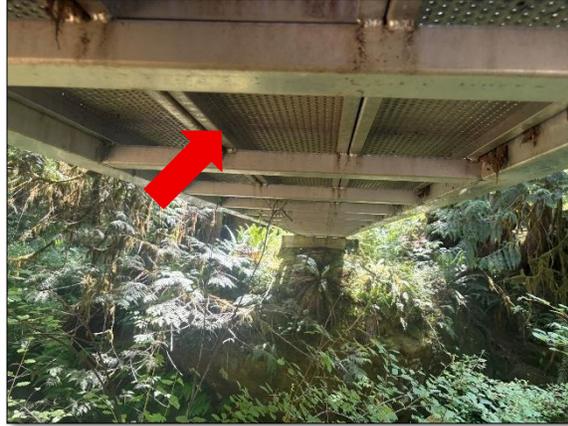
Photograph 32: Bridge 9, note: lack of plan bracing

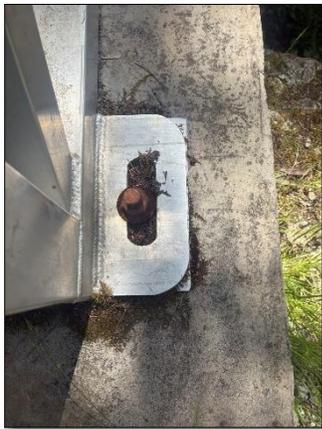
Photograph 33: Bridge 9, note: corroded anchor bolts

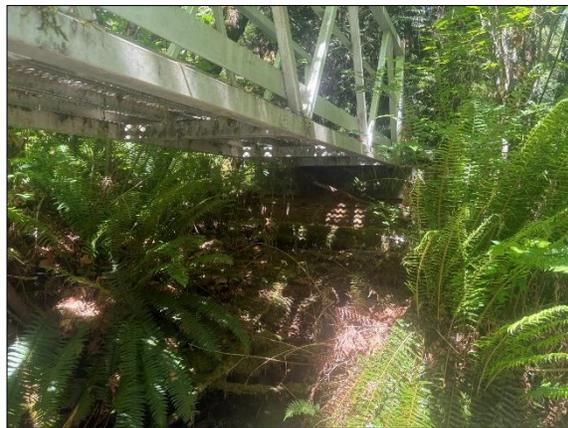
Photograph 36: Bridge 10, note: lack of plan bracing

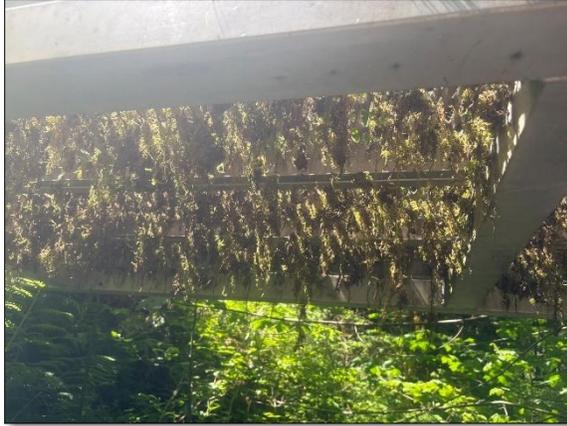
Photograph 37: Bridge 10, note: vegetative growth through deck

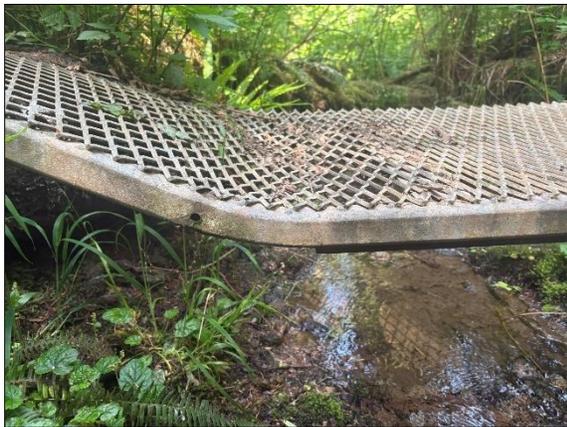
Photograph 39: Bridge 11, note: deflected and permanently deformed section

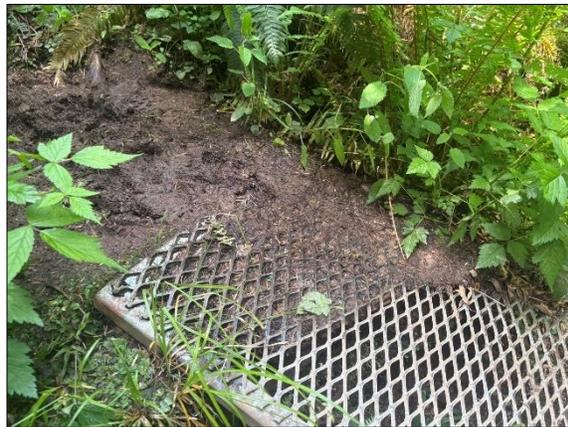
Photograph 40: Bridge 11, note: no abutment

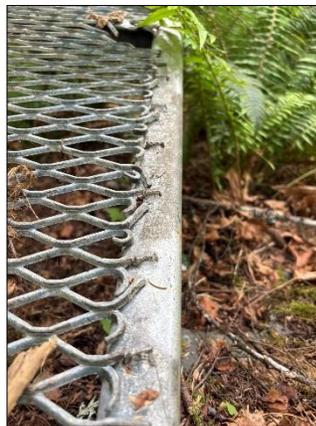
Photograph 42: Bridge 12, note: failed welds on grating

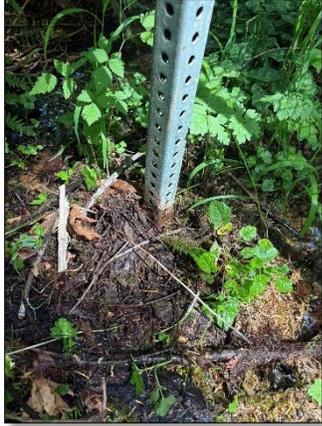
Photograph 43: Bridge 12, note: intermediate supports appear to have no foundation

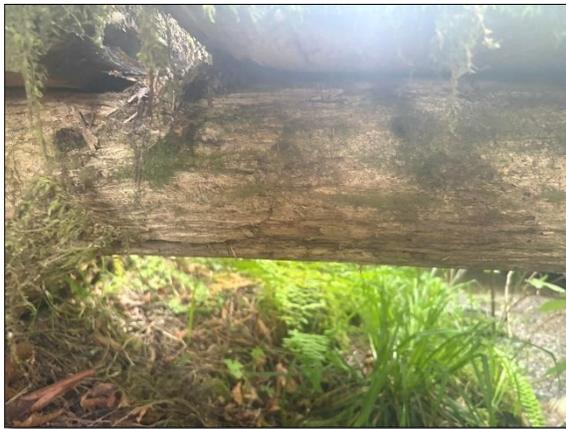
Photograph 45: Bridge 13, note: weathered and checked stringers

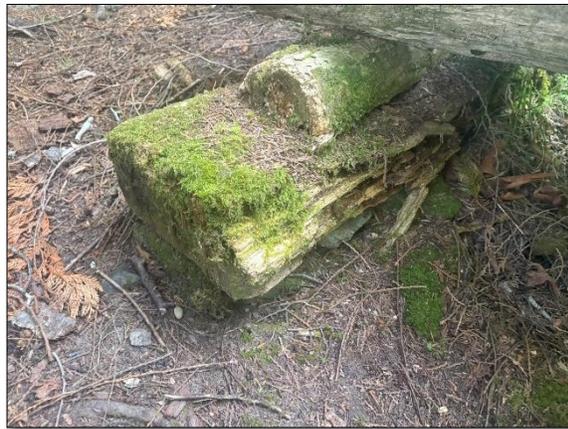
Photograph 46: Bridge 13, note: decayed abutment

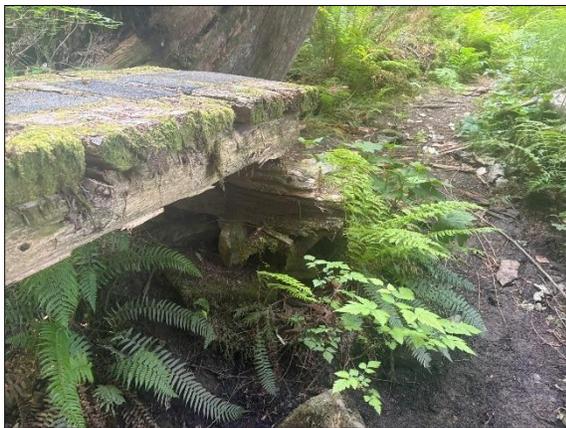
Photograph 47: Bridge 13, note: decayed abutment and decking

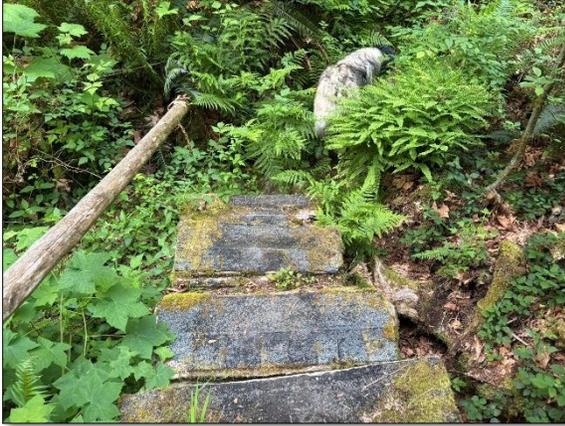
Photograph 49: Bridge 14 Access Stairs, note: decayed decking and overgrown access

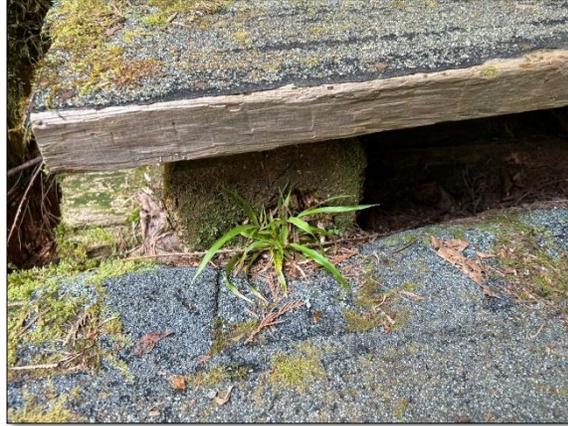
Photograph 50: Bridge 14 Stringer, note: decayed stringer through section

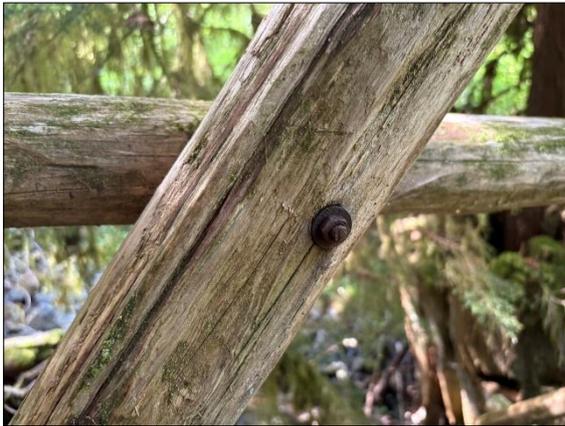
Photograph 51: Bridge 14, note: corroded and undersized hardware

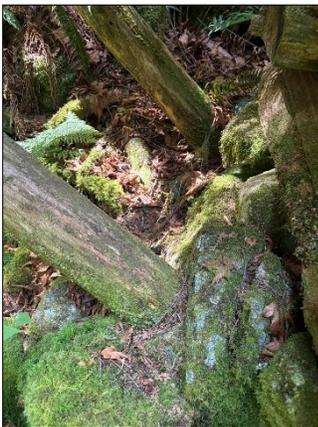
Photograph 53: Bridge 14, note: compression members not founded on a foundation

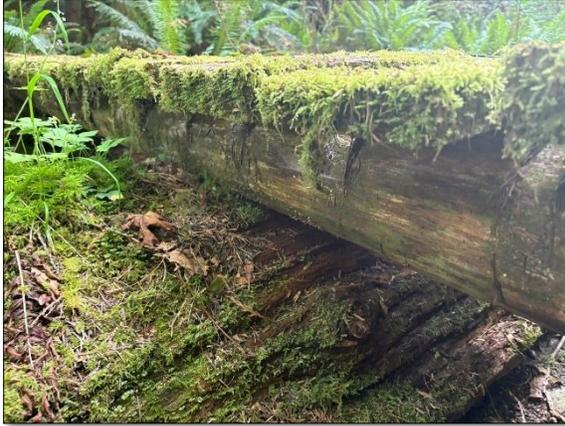
Photograph 55: Bridge 15, note: biological damage and growth on elements

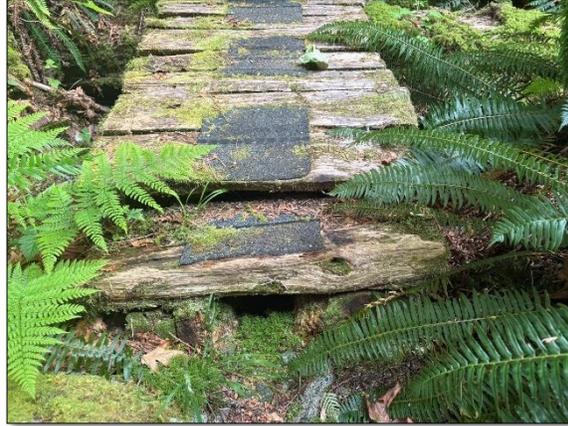
Photograph 56: Bridge 15, note: failed step at access

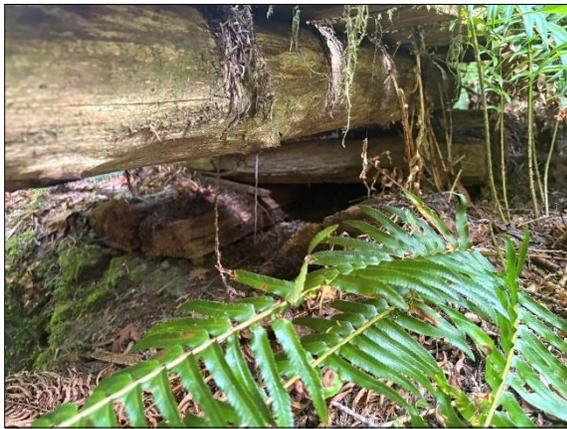
Photograph 57: Bridge 15, note: abutment is decayed and beginning to compress
