ALBERNI-CLAYOQUOT REGIONAL DISTRICT Parks Linear Asset Assessment & Mapping Dickson Park

PARKS LINEAR ASSET ASSESSMENT & MAPPING

DICKSON PARK, SPROAT LAKE, BC

Herold Project No.: 6516-001

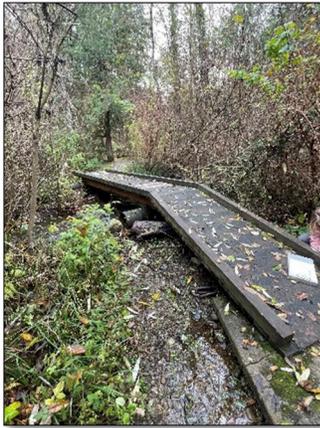
Photograph 1: Dickson Park Bridge, note: general arrangement looking west

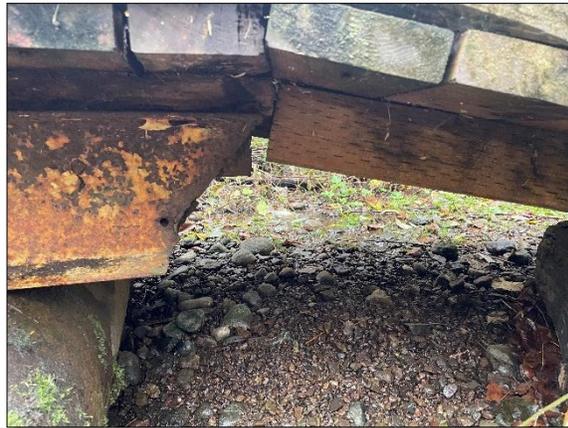
Photograph 2: Bridge and ramp, note: steel channel girders(bridge) and timber joists (ramp)

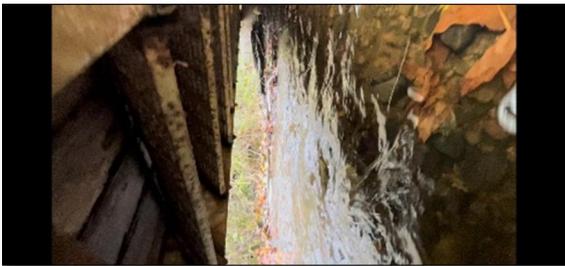
Photograph 3: Bridge substructure, note: joists supported on steel grating

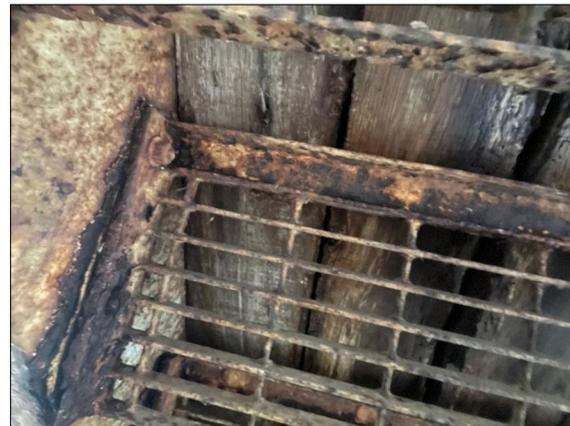
- Cut ends of guard timbers are soft and easily probed with a knife,
- Timber joists on bridge appear soft, but were not accessible for detailed assessment,
- Deck board nailing strip on top of channels is decayed and easily probed with a knife,
- Steel channels, grating and abutment pipe have moderate amounts of surface, corrosion with visible delamination/flaking and pitting of the steel material,
- Ramp slabs are undermined and cracking where ramp contacts concrete.

Photograph 4: Bridge substructure, note: deterioration of timber joists and surface corrosion on grating and channel

- Replace affected timber guards in kind,
- Remove decking to expose joists and assess degree of deterioration,
- Replace nailing strips on steel channels,
- Coat steel channels and abutment steel tubes with marine grade paint
- Re-instate bearing under approach slabs and parge and patch cracks with marine grade non-shrink grout.

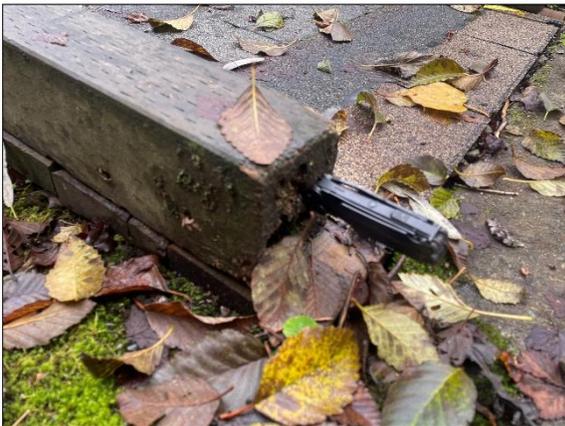
Photograph 5: Timber guarding, note: decayed cut ends

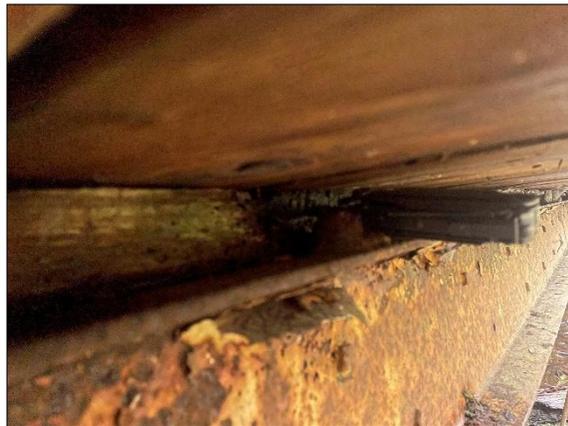
Photograph 6: Nailing strip on steel channel, note: decayed through section

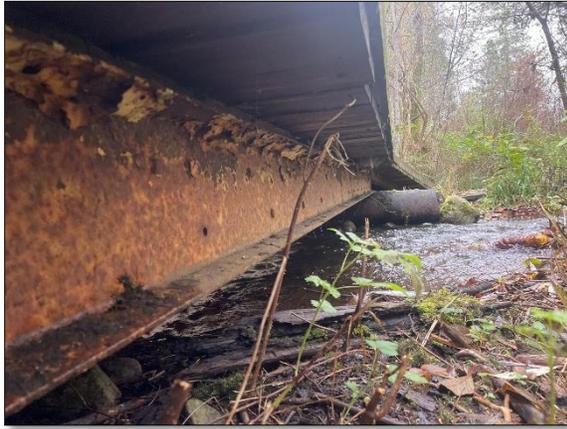
Photograph 7: Bridge stringer, note: surface corrosion

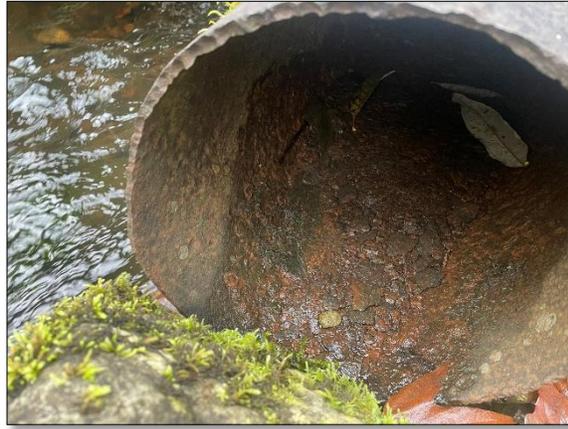
Photograph 8: Bridge abutment, note: corrosion and delamination of steel

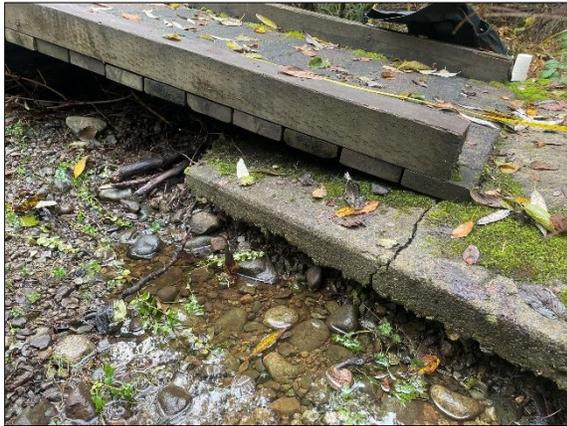
Photograph 9: approach Slab, note: cracking

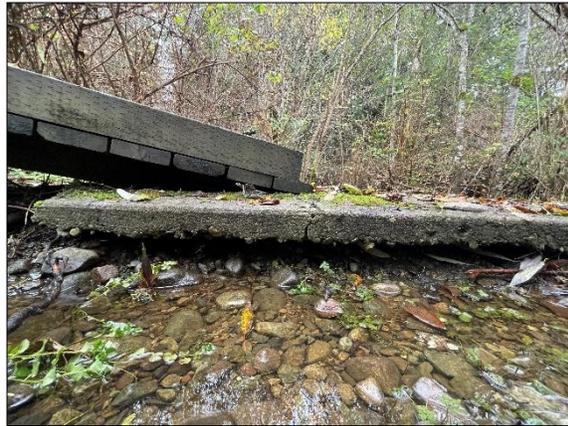
Photograph 10: Approach Slab, note: undermining

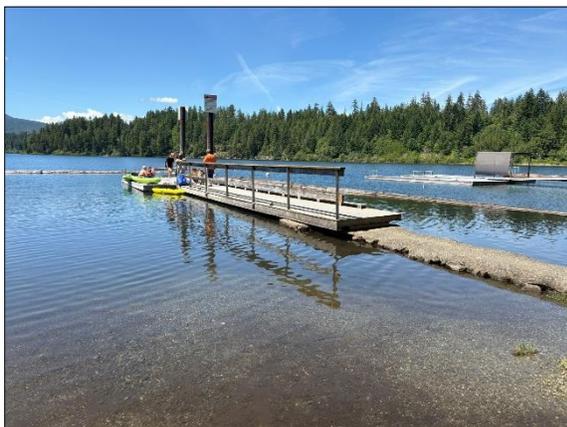
Photograph 11: Dickson Marine Infrastructure, note: general arrangement looking northwest

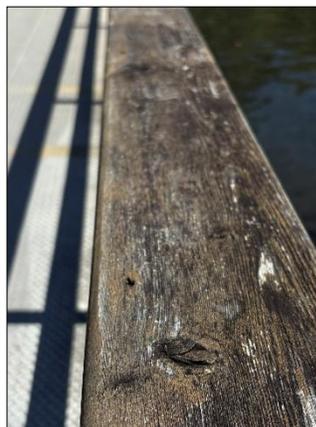
Photograph 12: Gangway handrail, note: coating failures

- Re-coat handrail system,
- Re-coat steel pipe pilings,
- Consider installation of standard guarding in the form of bull rails.

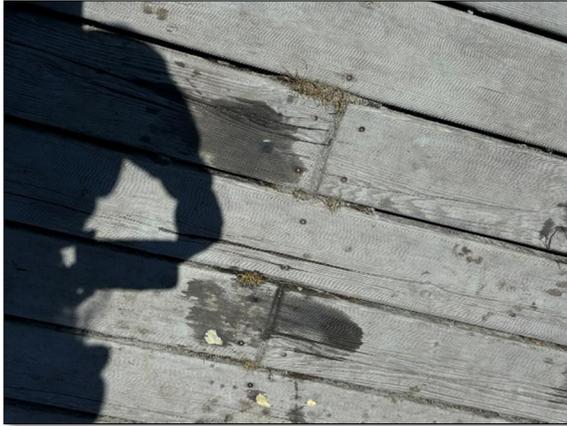
Photograph 13: Float Decking, note: weathered

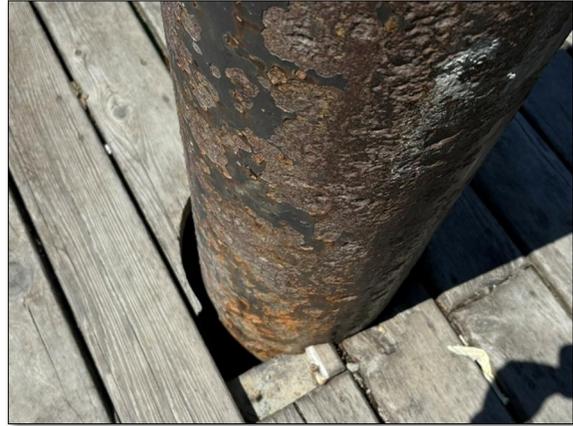
Photograph 14: Float Mooring Piles, note: coating failures and surface corrosion

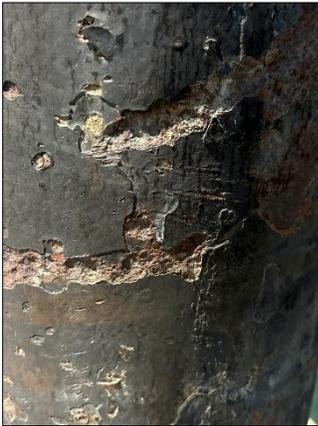
Photograph 15: Float Mooring Pile, note: scaling and pitting of bare steel

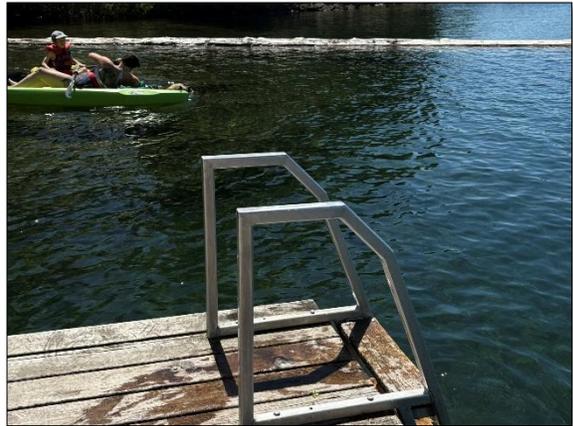
Photograph 16: Float Safety Ladder, note: general arrangement
