ALBERNI-CLAYOQUOT REGIONAL DISTRICT Parks Linear Asset Assessment & Mapping Evergreen Park

PARKS LINEAR ASSET ASSESSMENT & MAPPING

EVERGREEN PARK, PORT ALBERNI, BC

Herold Project No.: 6516-001

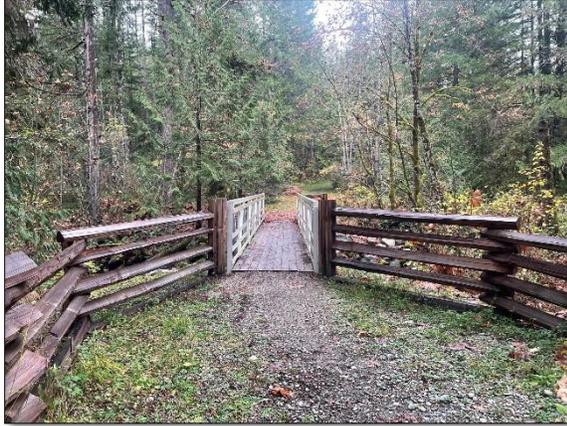
Photograph 1: Evergreen Park Bridge, note: general arrangement looking north

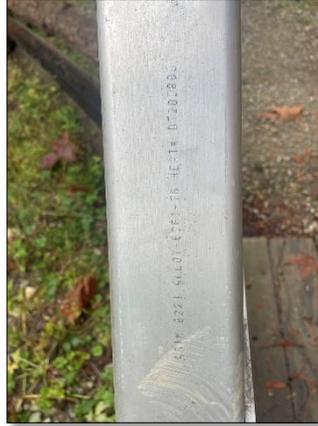
Photograph 2: Aluminum Elements, note: structural aluminum grade 6061-T6

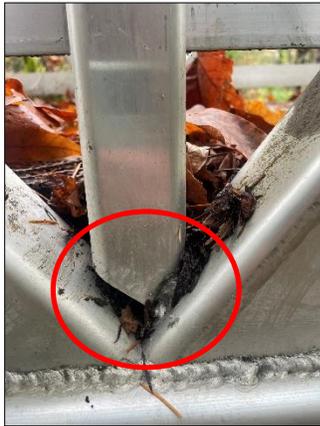
Photograph 3: Vertical Truss Element, note: incomplete weld at bottom connection

ITEM	LOCATION	DAMAGE	CONDITION	COMMENTS	RECOMMENDATION	RISK	REMEDIAL YEAR
General							
Welded Connections	At base of intermediate verticals	-	Fair to Poor	Vertical elements are not fully welded at base. This can affect the load path of the trusses	Provide continuous welded connection at base of intermediate verticals.	16	2025/2026
Bridge Deck	General	-	Good to Fair	Debris was noted along the bottom chord of trusses and deck boards.	Clean off debris.	2	varies

- 2024 – WELDED CONNECTIONS AT THE BASE OF THE INTERMEDIATE VERTICALS ARE NOT CONTINUOUS. THIS MAY AFFECT THE LOAD PATH OF THE TRUSS STRUCTURE.
- DEBRIS WAS NOTED ON THE BOTTOM CHORD OF THE TRUSS AND DECK BOARDS.

ITEM	LOCATION	RECOMMENDATION	COST (\$)
Mobilization/Demobilization			\$2,000.00
Welded Connections	At base of intermediate verticals	Provide continuous welded connection at base of intermediate verticals	\$1,500.00
Bridge Deck	General	Clean off debris	\$300.00

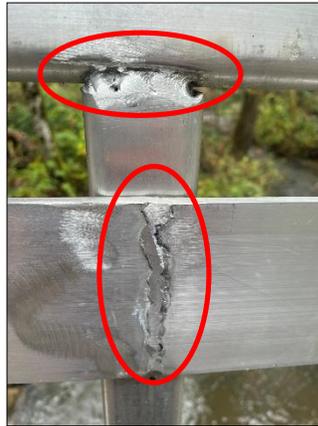
Photograph 4: Aluminum plate rails and vertical top connection, note: imperfections in welds

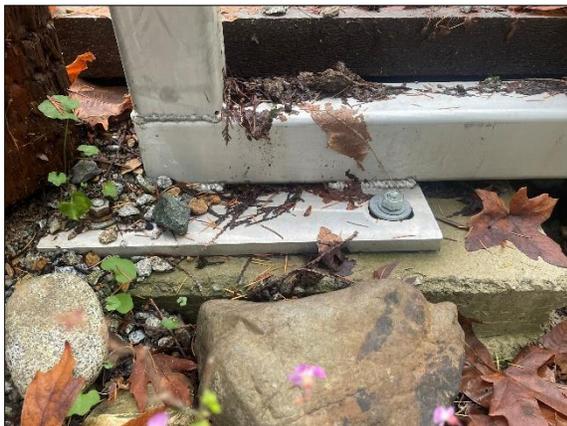
Photograph 5: Bridge abutment, note: general arrangement

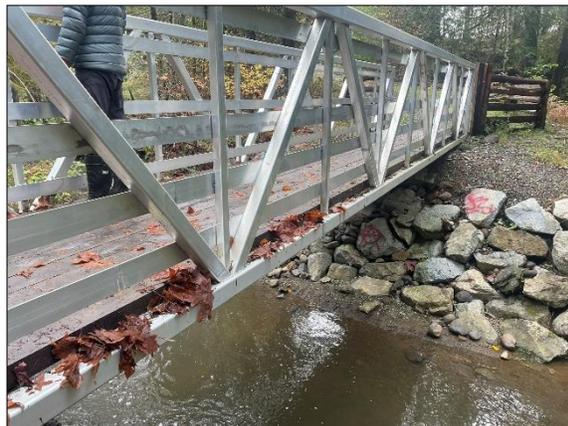
Photograph 6: Bridge bottom chord, note: accumulation of debris

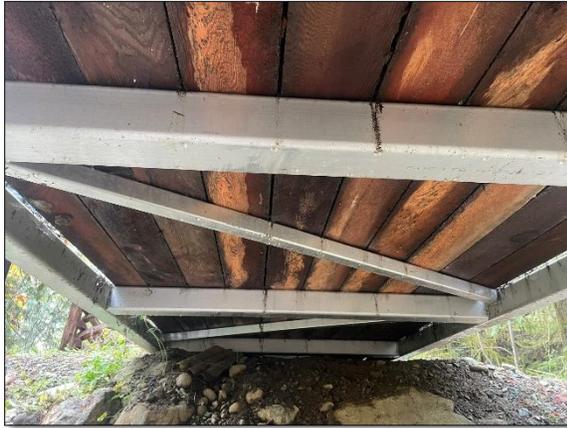
Photograph 7: Bridge decking, note: expected moisture

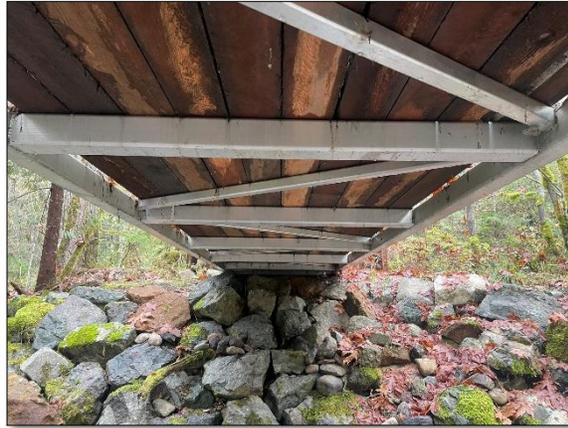
Plan bracing was observed between the truss bays. This bracing provides resistance to lateral loads such as wind or seismic demands to the structure.

Photograph 8: Bridge plan bracing, note: presence of lateral support
