ALBERNI-CLAYOQUOT REGIONAL DISTRICT Parks Linear Asset Assessment & Mapping Grappler St. Wharf

PARKS LINEAR ASSET ASSESSMENT & MAPPING

GRAPPLER ST. WHARF, BAMFIELD, BC

Herold Project No.: 6516-001

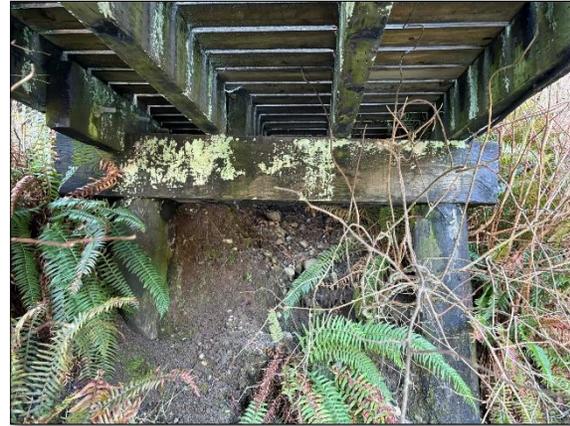
- Approach stringers and pile caps have biological growth along surfaces, wood section is competent when probed.
- Pile caps generally have bolts penetrating their section, with notable checking on the underside of the elements. This compromises the treatment layer. Pile caps are competent when probed.
- One cross brace cut end is decayed with visible deterioration of the cross section.

Photograph 4: Approach stringers and pile cap, note: biological growth on surfaces of elements

- Cleaning of the stringers and pile caps to remove vegetative growth,
- Ongoing monitoring of the pile cap sections damage by thru-bolts,
- Replace one cross brace.

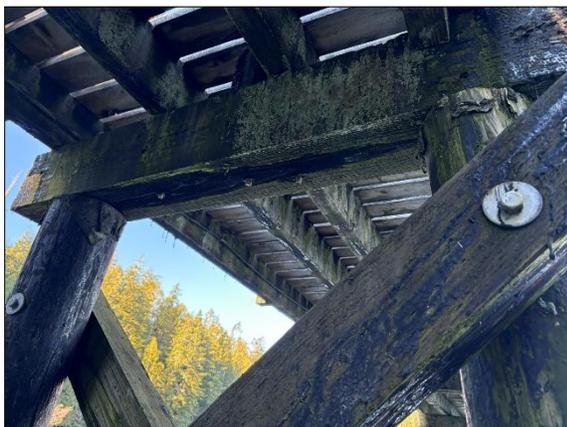
Photograph 5: Pile Cap at Bent 2, note: check in underside where stringer hardware penetrates section. Loss of treatment layer

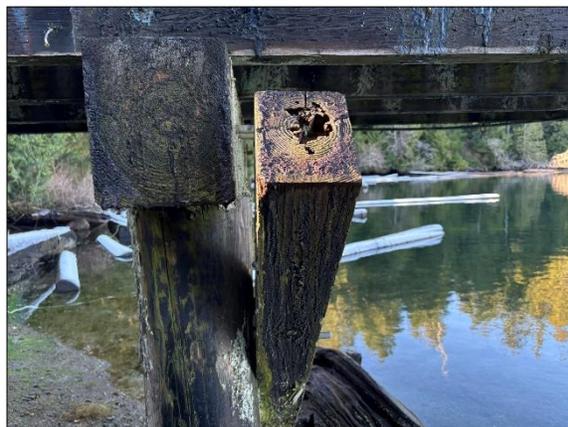
Photograph 6: Cross Brace at Bent 2, note: decay at cut end

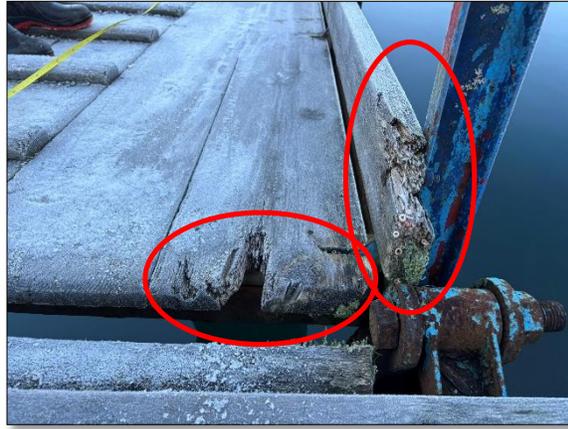
- One deck board is decayed and missing a portion of the cross section at the connection point.
- Kick plate is decayed at cut end.
- Kick plate is missing on the west side of gangway
- Drop hinges and steel truss elements have notable coating failures and surface corrosion.

Photograph 8: Gangway deck board and kick plate, note: mechanical damage

- Replace one deck board,
- Replace one kick plate and install a second kick plate,
- Clean drop hinges and steel elements of all delaminated, corroded steel and have the elements reviewed by an engineer registered to practice in British Columbia to ensure the remaining section is sufficient.
- Recoat cleaned steel elements or replace steel truss elements where appropriate,
- Install a transition plate at seaward transition to Float A,
- Clean corrosion off angle guides and evaluate remaining thickness. Replace or re-

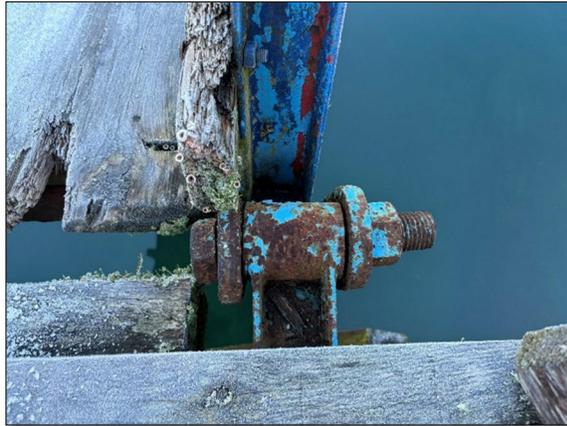
Photograph 7: Gangway drop hinges, note: coating failures and surface rust

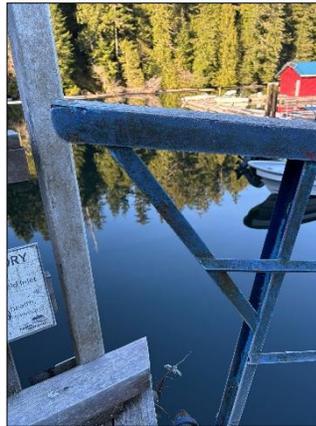
Photograph 8: Gangway top chord, note: coating failures and surface rust

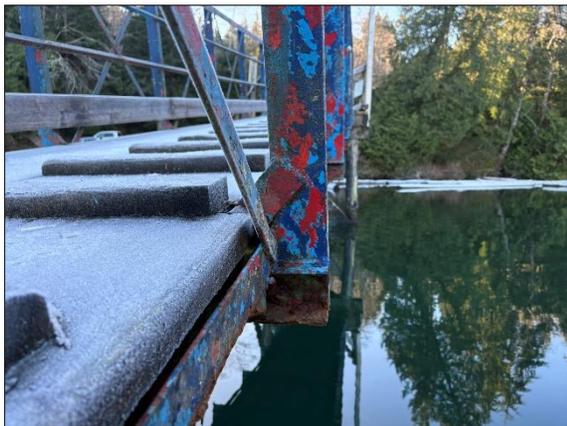
Photograph 9: Gangway steel elements, note: coating failures and surface rust

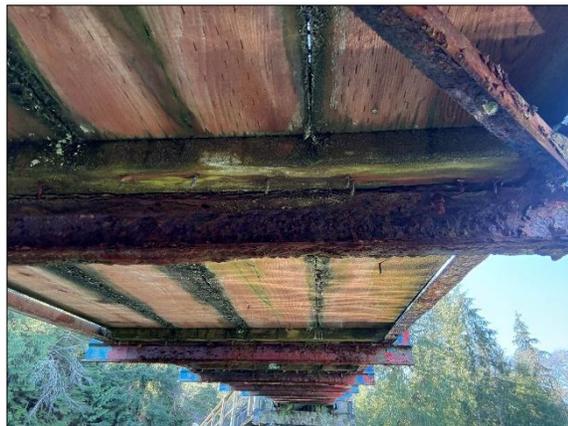
- Cross beams of steel truss are beginning to delaminate with corrosion penetrating the surface of the members.
- The seaward transition plate is missing, which is a possible tripping hazard.
- Angle guides on landing pad are visibly corroded with delamination of the steel.

Photograph 10: Gangway cross beams, note: failed coating and significant corrosive damage.

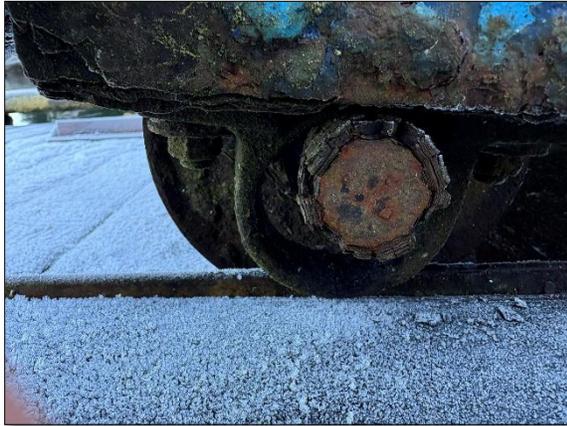
Photograph 11: Gangway roller, note: roller pin significantly corroded and delaminating

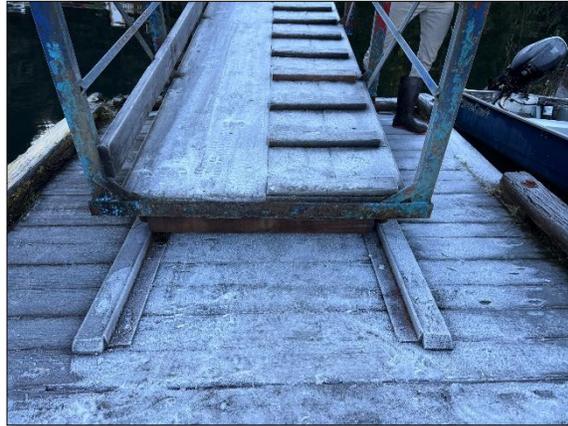
Photograph 12: Gangway transition, note: no transition plate to float

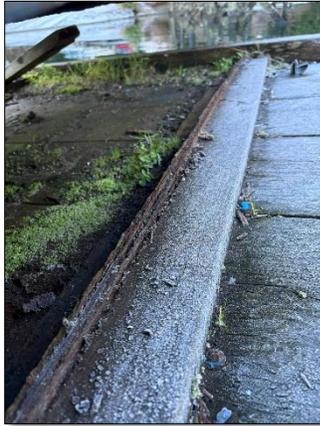
Photograph 13: Gangway angle guides, note: scaling and corrosion to steel guides

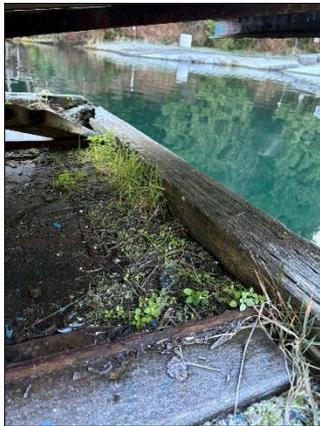
Photograph 15: Float A deck boards under gangway, note: biological decay

- Replace five deck boards in kind,
- Install two missing bull rails,
- Replace two decayed bull rails in kind,
- Replace rub board in kind,
- Replace float-to-float connections with engineered chain and mounting bracket connections,
- Ongoing monitoring of floatation via freeboard measurement.

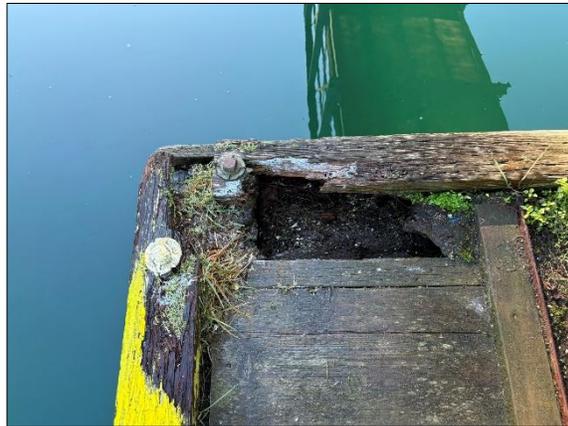
Photograph 16: Float A deck boards under gangway, note: biological decay and cross section failure

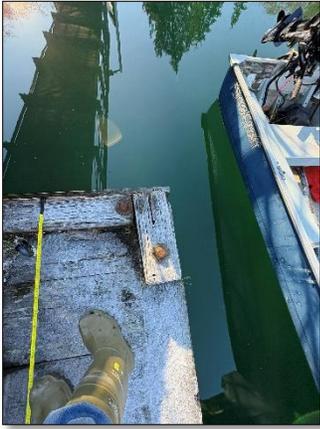
Photograph 17: Float A at 0m, note: bull rail missing

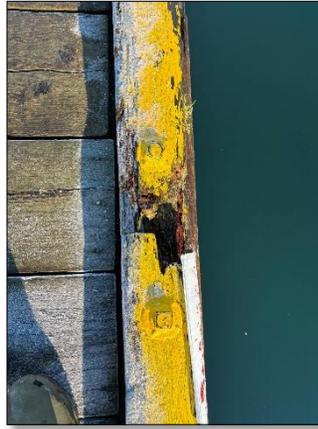
Photograph 18: Float A bull rail at 7.0m east side, note: decayed bull rail at connections

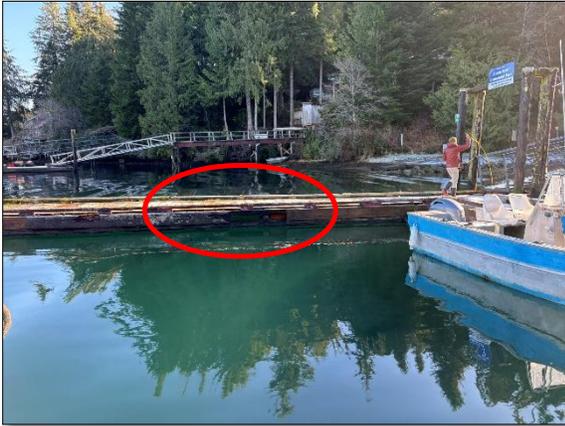
Photograph 19: Float A Rub board at 11m, note: failed section

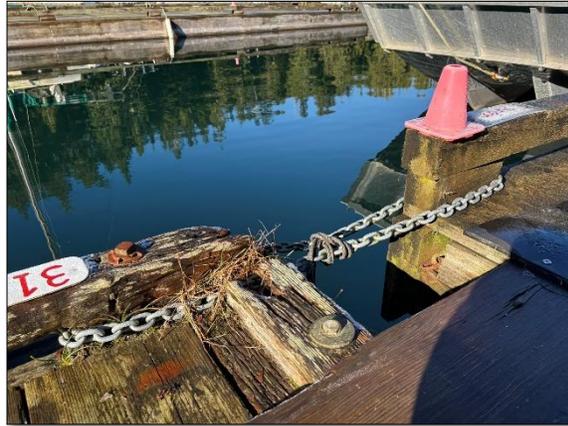
Photograph 20: Float A connection west, note: secured to bull rail

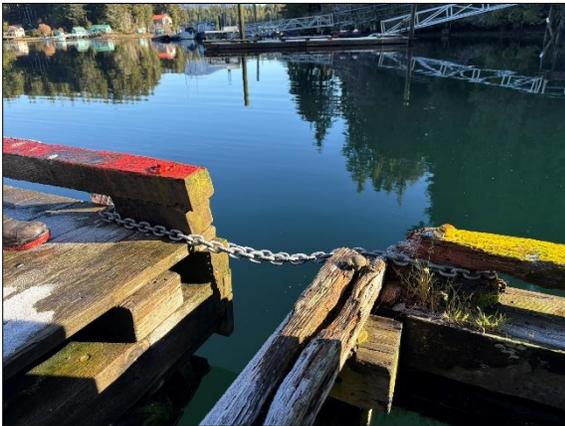
Photograph 21: Float A connection east, note: secured to bull rail

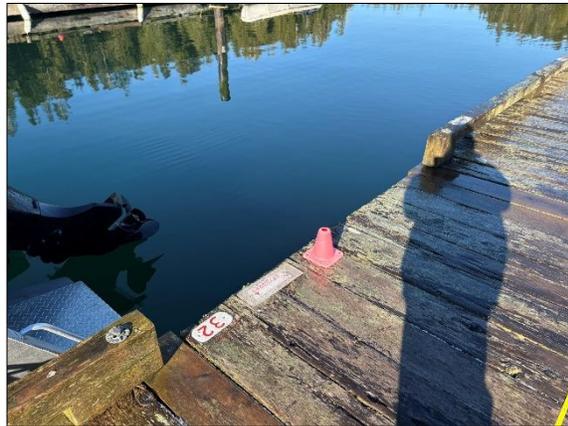
Photograph 22: Float A bull rail at 28m on west side, note: missing

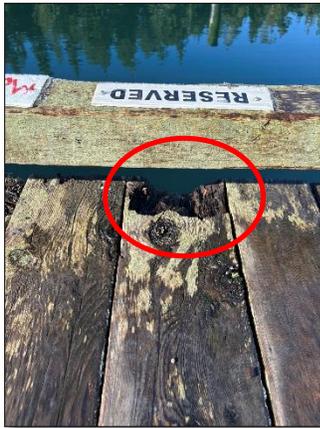
Photograph 23: Float A deck board at 35.3m,
note: failed section through
connection to float

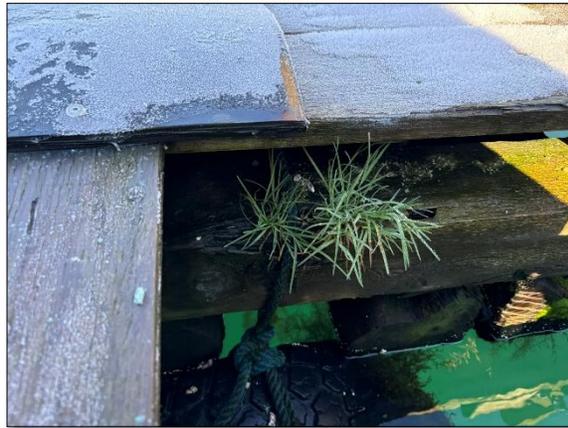
Photograph 24: Float A substructure, note:
decayed substructure elements
with visible biological growth

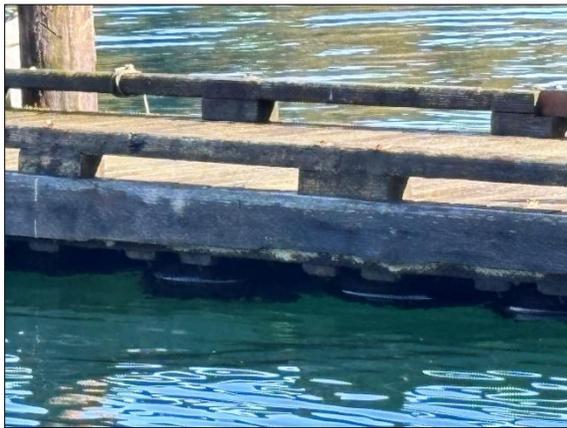
Photograph 25: Float A, note: mixed floatation
including rubber tires

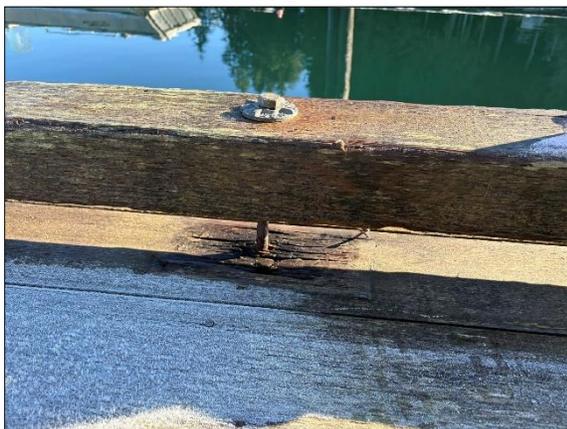
Photograph 27: Float B bull rail, note: missing riser
at 12.2m.

- Re-secure deck boards to substructure,
- Replace one bull rail in kind,
- Install one riser to match existing,
- Replace one riser in kind,
- Ongoing monitoring of damage to mooring pile creosote layer.

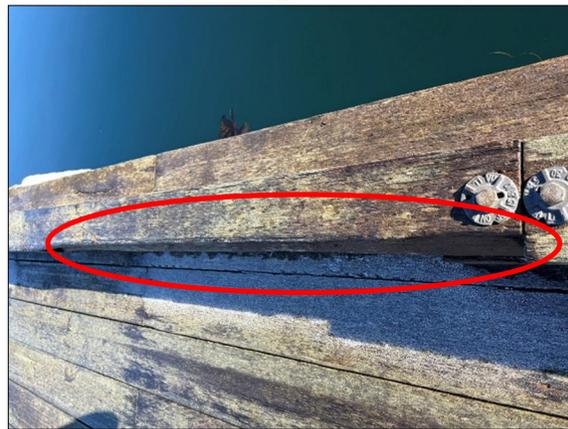
Photograph 28: Float B bull rail note: check in
element at 14.8m

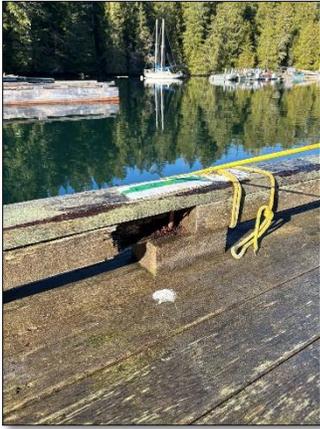
Photograph 29: Float B bull rail at 23.1m, note: decayed through section

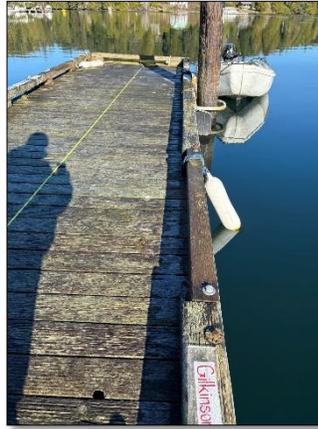
Photograph 30: Float B bull rail, note: new section of bull rail is smaller than other sections

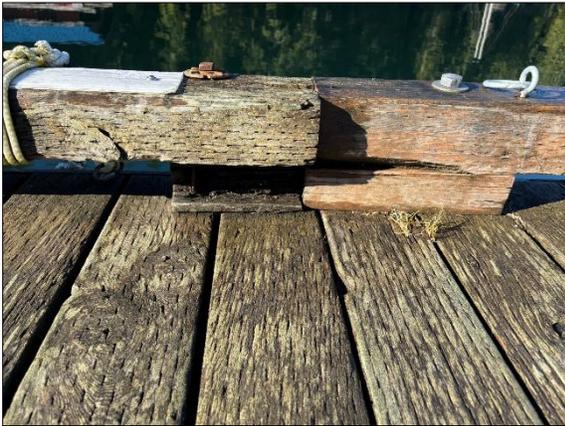
Photograph 31: Float B bull rail at 32.9m, note: decayed riser

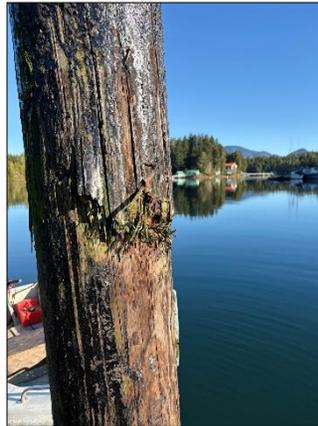
Photograph 32: Float mooring pile, note: mechanical damage through creosote layer

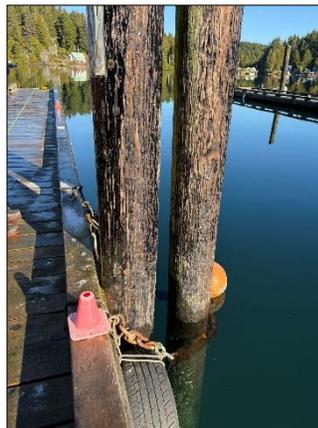
Photograph 34: Float C mooring piles, note: abrasion damage to creosote layer

- Install bull rail to match existing,
- Ongoing monitoring of damage to mooring pile creosote layer.

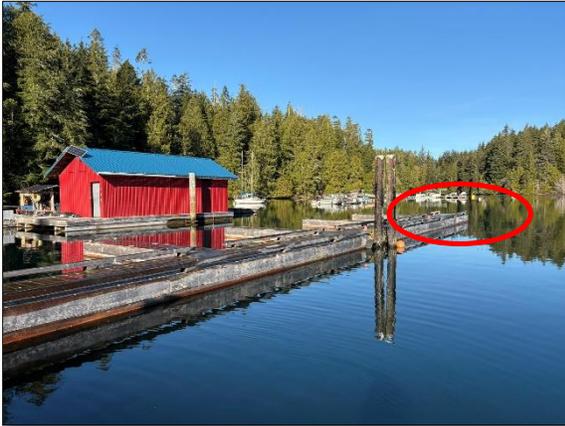
- The bull rail is missing at the end of the float.
- Moderate mechanical damage due to abrasion on the mooring piles.

Photograph 35: Float C, note: no guarding at north end of float

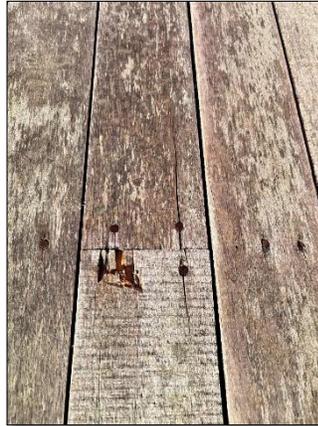
Photograph 38: Float H decking, note: check through hardware

- Secure loose hardware on deck,
- Ongoing monitoring of deck boards, replace as elements fail through connection points,
- Ongoing monitoring of the mooring hoop, consider cleaning and re-coating during remediation of the gangway steel.

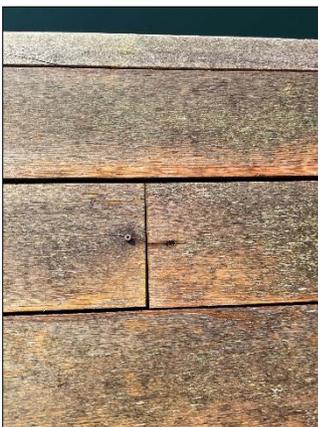
Photograph 39: Float H decking, note: loose hardware

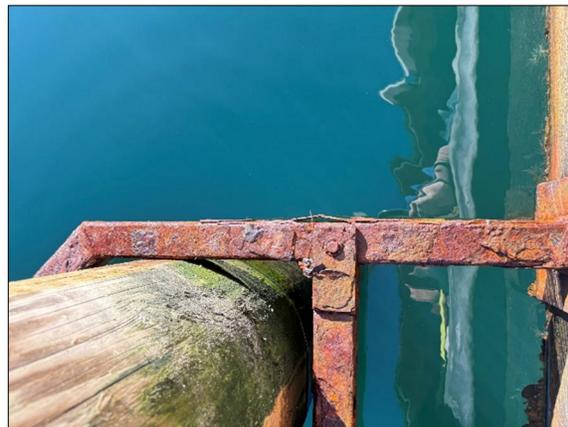
Photograph 40: Float H mooring pile, note: coating failures and corrosion to bracket

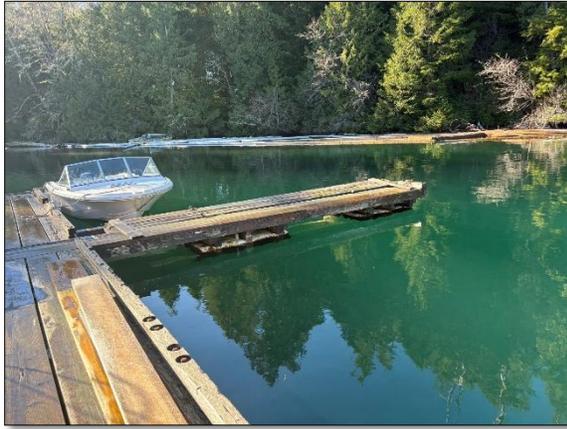
Photograph 41: Slip F-1, note: exposed Styrofoam flotation and listing superstructure

The floats and slips are at the end of their service life. Most of the structural elements require replacement, and most of the floats need all new floatation. It is likely more cost effective to replace the floats in kind or with a floating configuration that is better suited to the service requirements of the fire department.

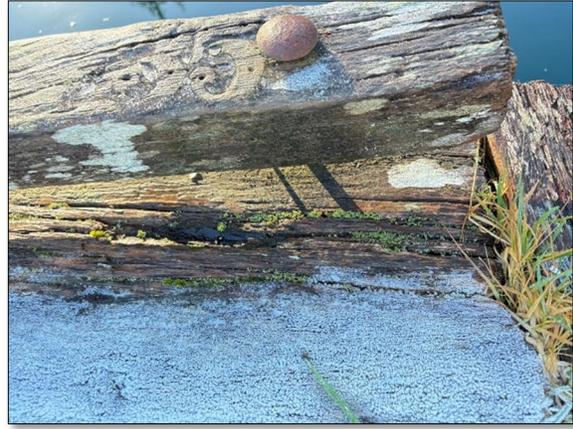
Photograph 42: Fire Department Float, note: decayed float elements

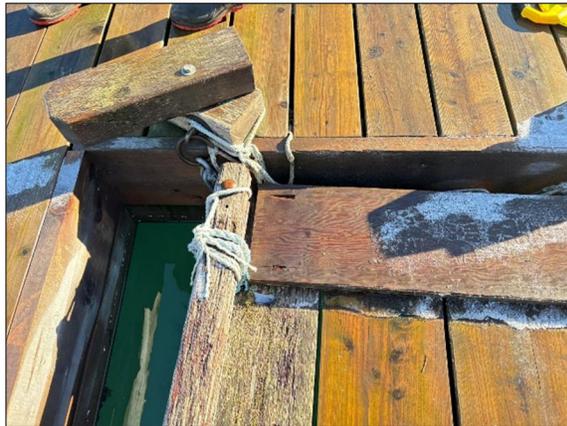
Photograph 43: Float E, note: insufficient connection to adjacent structures

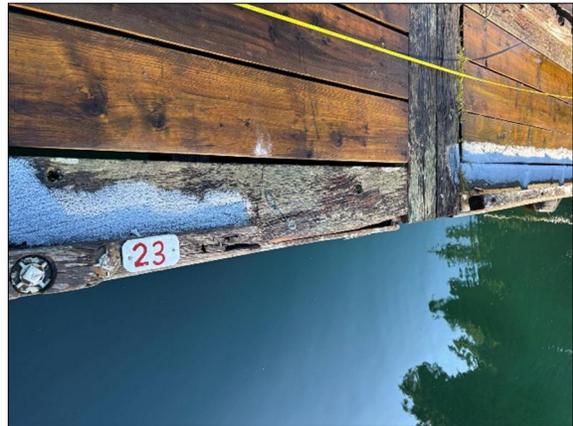
Photograph 44: Fire Department Floats, note: decayed bull rails and decking

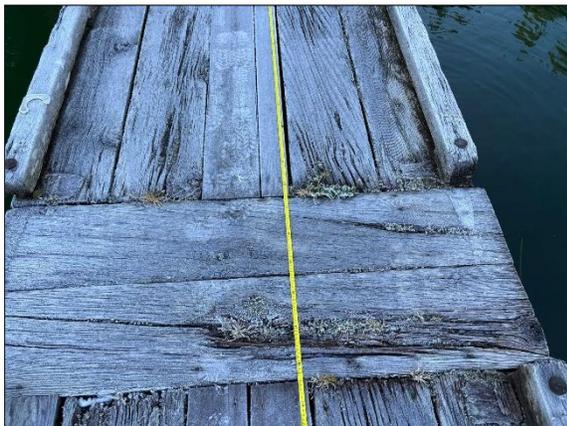
Photograph 45: Fire Department Floats, note: decay and weathering to deck and other structural members

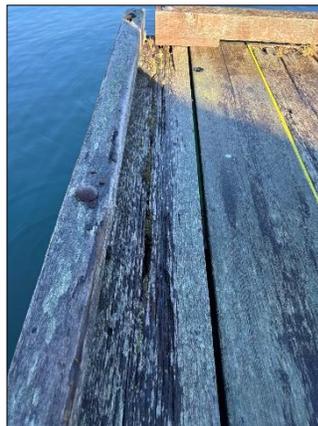
Photograph 46: Fire Department Floats, note: decayed bull rails and decking
