# ALBERNI-CLAYOQUOT REGIONAL DISTRICT Parks Linear Asset Assessment & Mapping Log Train Trail

# PARKS LINEAR ASSET ASSESSMENT & MAPPING

## LOG TRAIN TRAIL, PORT ALBERNI, BC

Herold Project No.: 6516-001

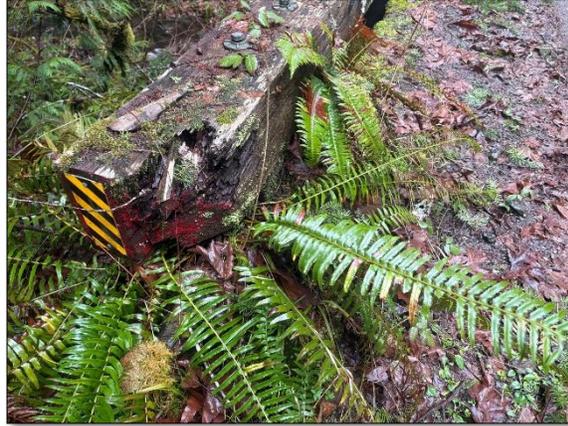
- Guard sections are decayed and soft when probed,
- Joint filler has dislodged from between two of the concrete planks,
- Superstructure has significant debris accumulated.

Photograph 2: Bridge 1, note: damaged vehicle guard

- Replace vehicle guard in kind,
- Re-instate joint filler between planks,
- Clean bridge surfaces of vegetation,

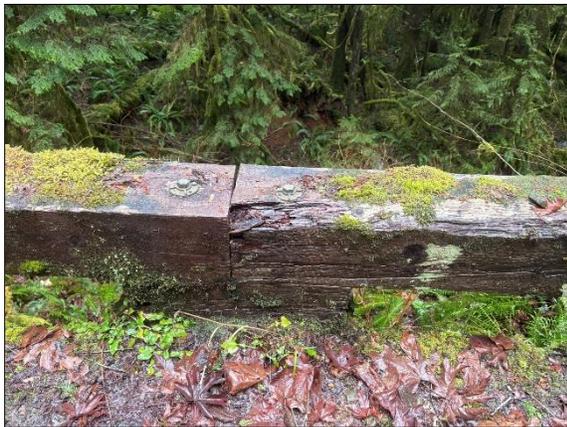
Photograph 3: Bridge 1, note: vehicle guard checked and decayed at connection

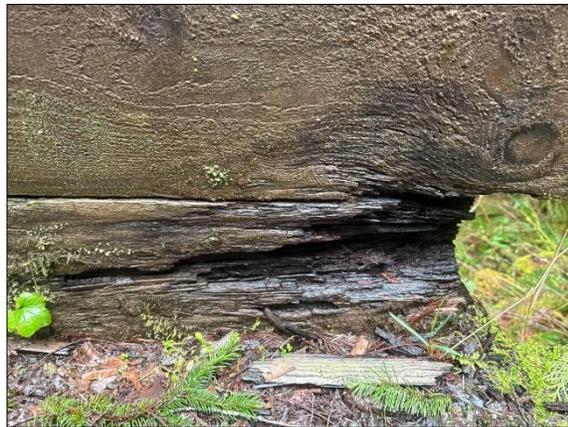
Photograph 4: Bridge 1, note: decayed vehicle guard riser

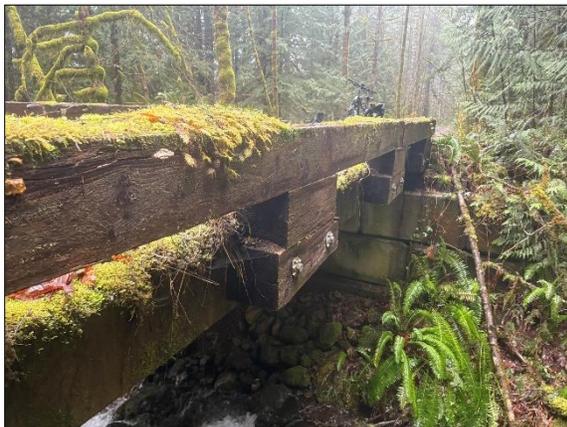
Photograph 5: Bridge 1 Vehicle Guard and Deck Panels, note: vegetative growth and moisture

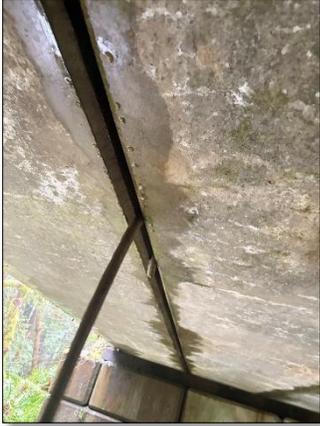
Photograph 7: Bridge 1, note: failed joint filler

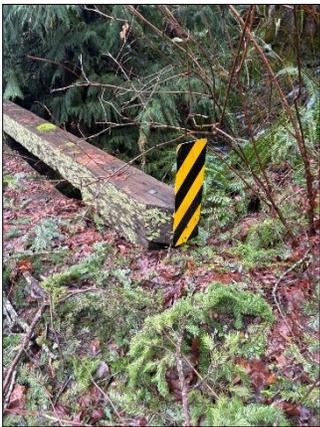
Photograph 9: Bridge 2, note: vehicle guard decay and accumulation of debris on structure

- Clean surfaces of vegetation,
- Replace vehicle guard within the next three years,
- Replace deck boards within the next one to three years,
- Monitor coating deterioration and re-instate as part of a larger upgrade.

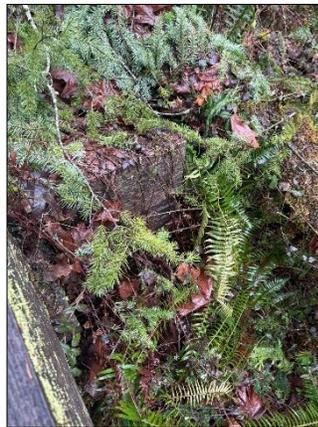
Photograph 10: Bridge 2, debris and biological growth on bridge abutment wing wall

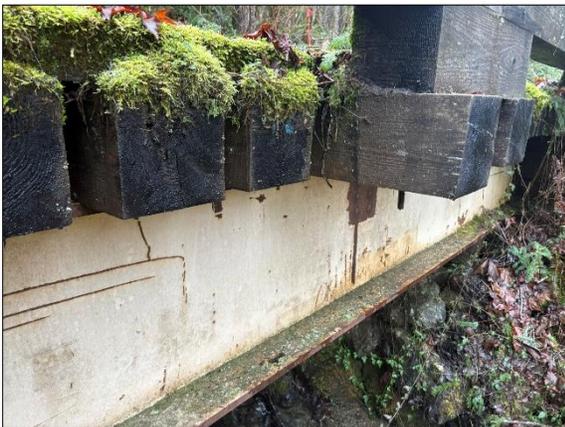
Photograph 11: Bridge 2, note: biological growth on cross beams

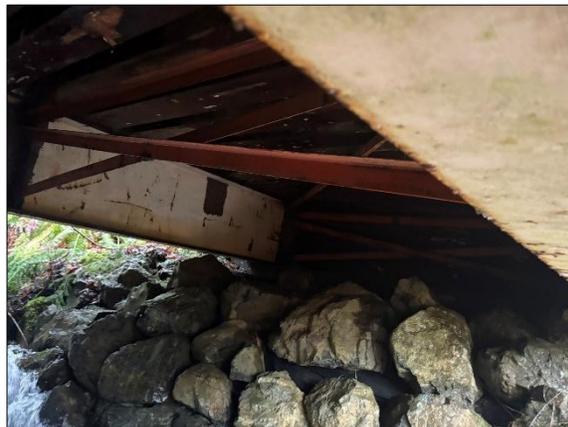
Photograph 12: Bridge 2, note: substructure plan bracing and girders, note: minor coating failures

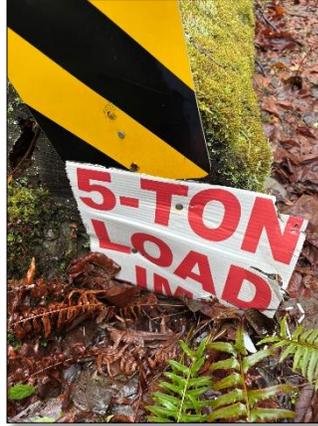
Photograph 14: Bridge 3, note: load rating signage

- Remove load limit signage that is not applicable given the overall bridge condition,
- Clean superstructure and substructure,
- Replace both vehicle guards,
- Remove overlay and replace stringers and roofing material,
- Ensure new roofing material is cut to the bridge footprint.

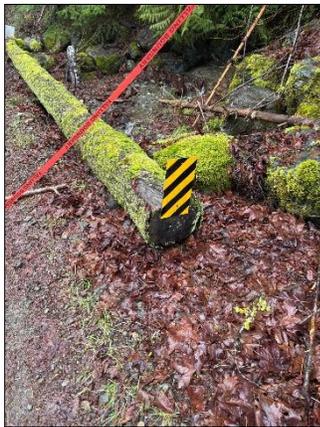
Photograph 15: Bridge 3 vehicle guard, note: biological growth and moisture

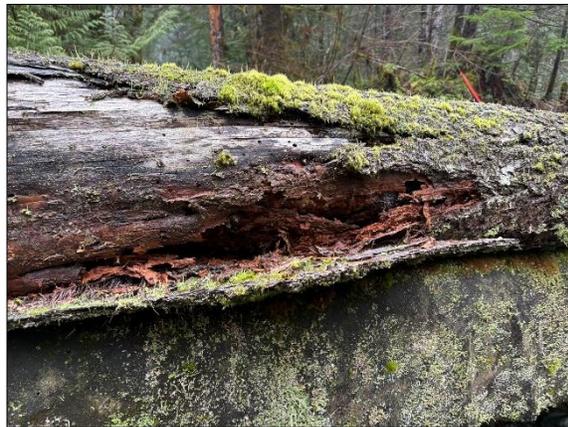
Photograph 16: Bridge 3 vehicle guard, note: decayed cross section

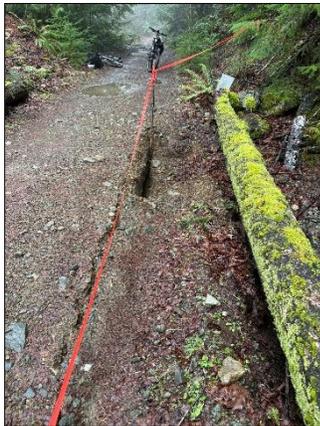
The bridge is in very poor condition with primary structural members requiring replacement. One of the timber stringers has failed in shear and the deck (overlay) has failed in this location. The remaining bridge elements are soft when probed with evidence of moisture ingress and biological damage (decay).

Photograph 17: Bridge 3, note: failed stringer and overlay

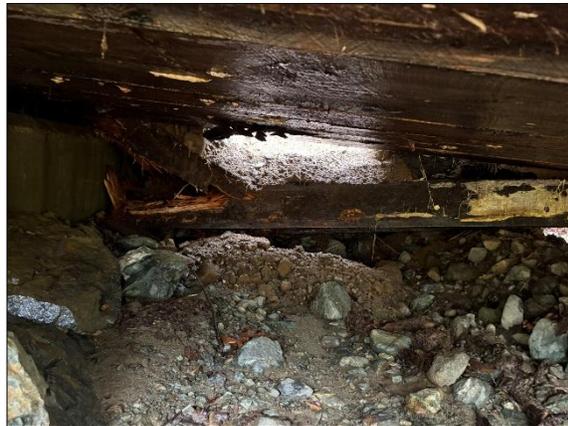
Photograph 18: Bridge 3, note: failed stringer at support (abutment)

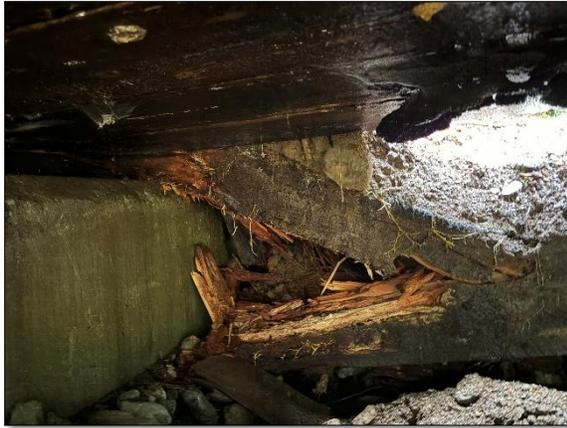
Photograph 19: Bridge 3, note: failed stringer with decay to the cross section.

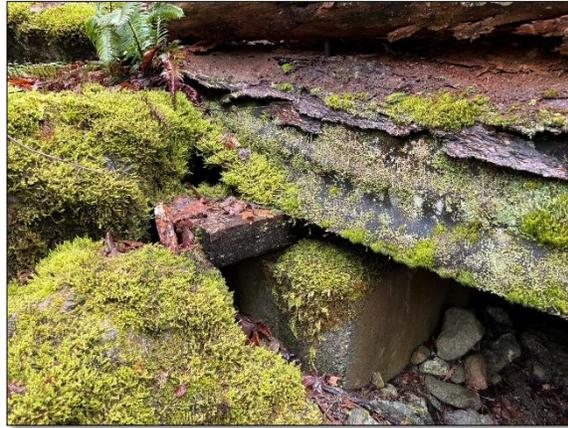
Photograph 20: Bridge 3, note: roofing material extending past supports. Significant moisture present

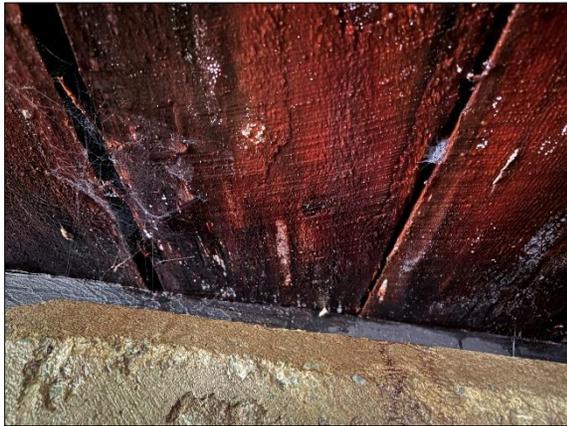
Photograph 21: Bridge 3, note: remaining stringers visible decay

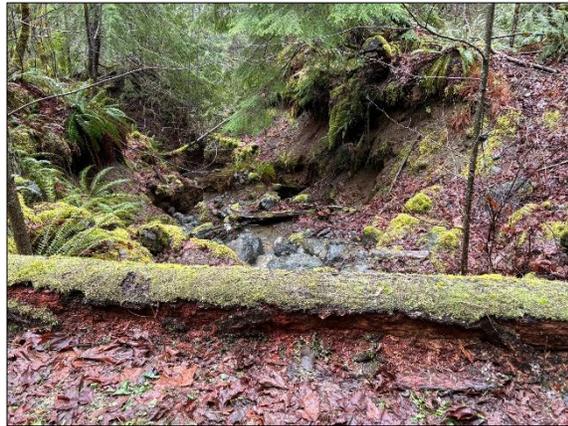
Photograph 22: Bridge 3, note: decayed vehicle guard and excess moisture

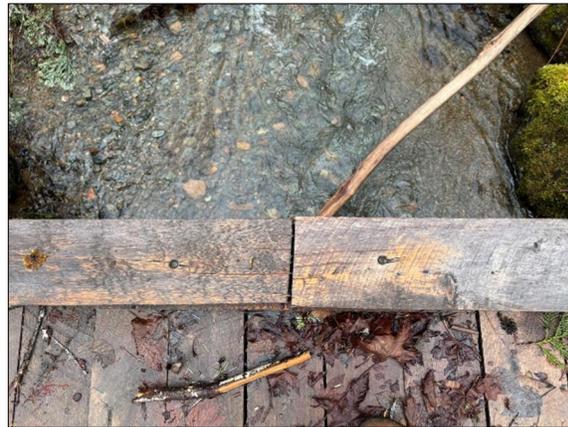
Photograph 24: Bridge 4 vehicle guard, note: cracks through connections

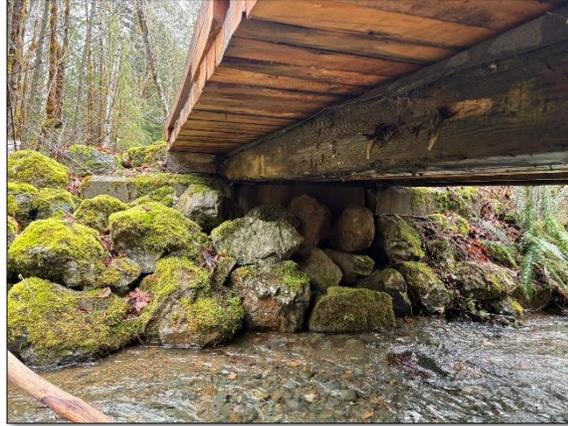
Photograph 26: Bridge 4 exterior stringer, note: checking along length

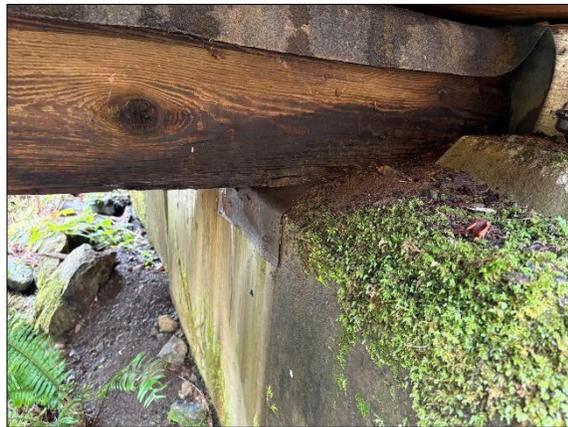
Photograph 28: Bridge 4 abutment, note: moisture at exterior stringer with visible decay to bearing points

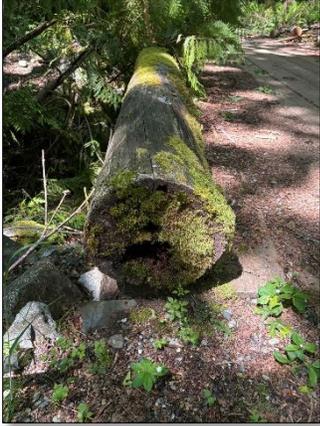
Photograph 31: Bridge 5 vehicle guard, note: decayed section

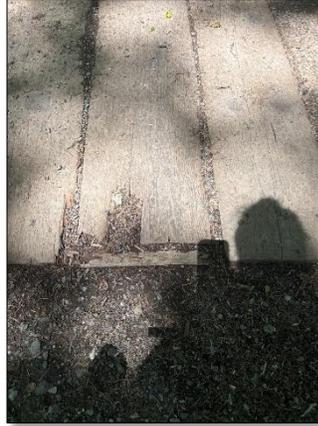
Photograph 32: Bridge 5 deck boards, note: decayed and checked ends at approach

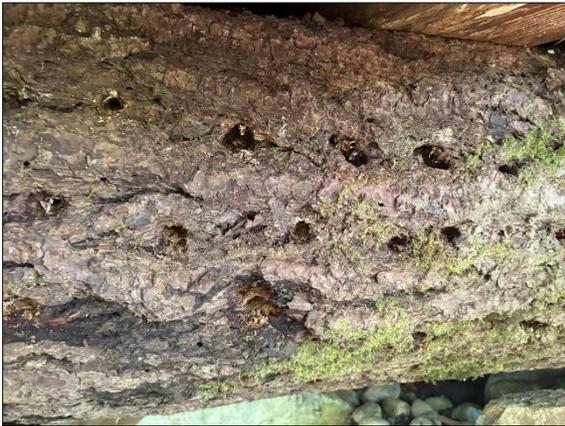
Photograph 33: Bridge 5 stringer, note: penetrations in bark

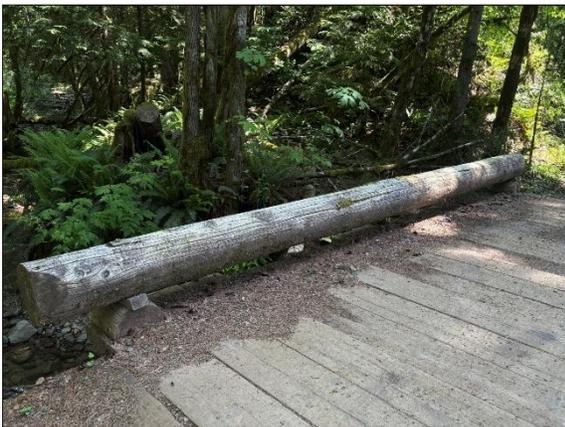
Photograph 35: Bridge 6 vehicle guard, note: insufficient number of risers

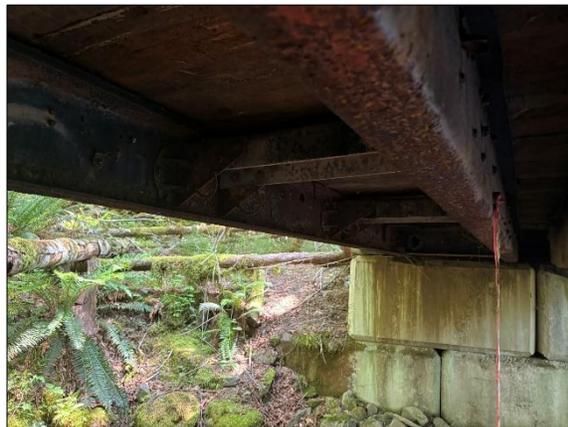
Photograph 36: Bridge 6 substructure, note: vehicle frame being used as stringers

Based on the overall construction, the bridge is recommended to be retrofitted with conventional substructure elements (stringers) to replace the existing car frame. Stringers are to be designed and specified by a structural engineer registered to practice in British Columbia. The following minor repairs are also recommended:

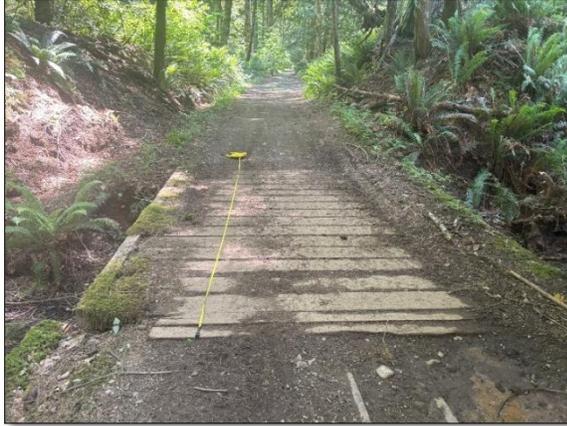
Photograph 37: Bridge 7, note: debris accumulation, guard is completely buried

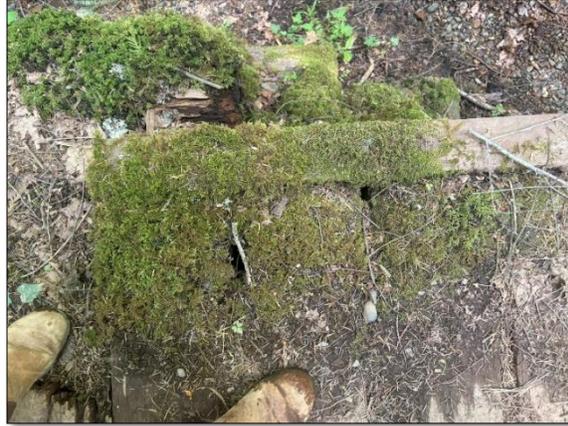
Photograph 38: Bridge 7, note: movement in decking with >25mm voids

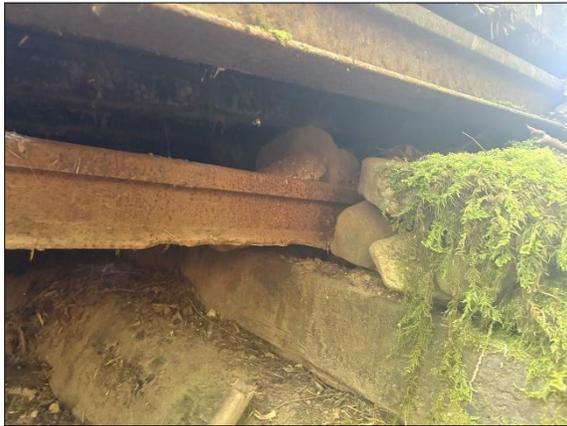
Photograph 39: Bridge 7, note: failed steel stringer

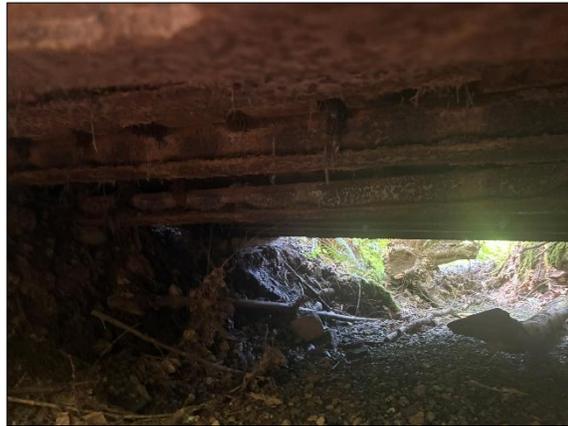
Photograph 40: Bridge 7, note: remaining stringers with visible corrosion and movement

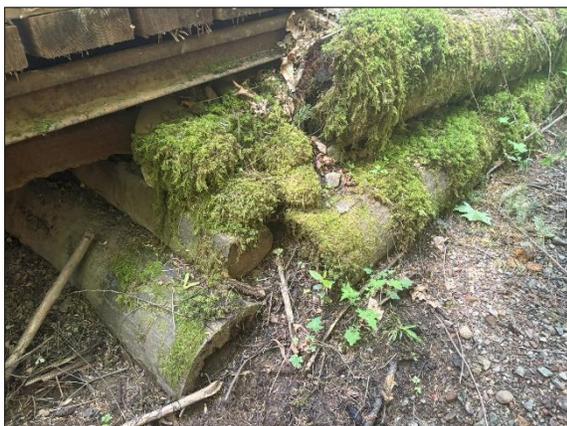
Photograph 41: Bridge 7 abutment, note: decayed sections

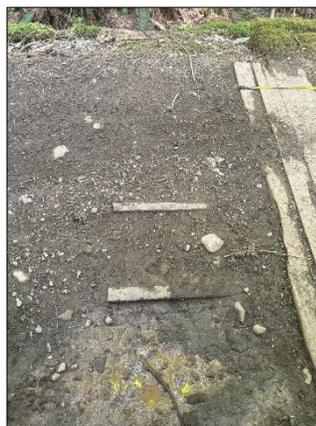
Photograph 42: Bridge 7 approach, note: stringer ends exposed

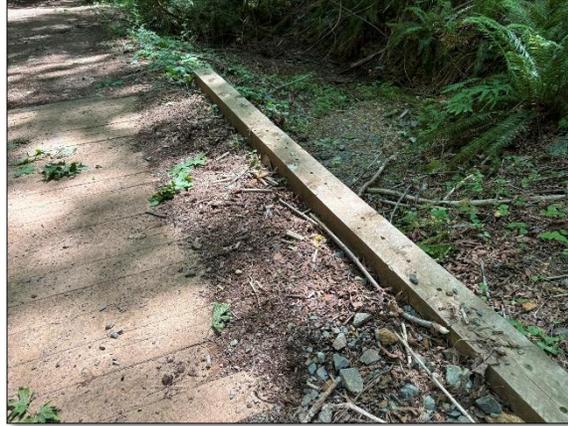
Photograph 44: Bridge 8, note: debris accumulation

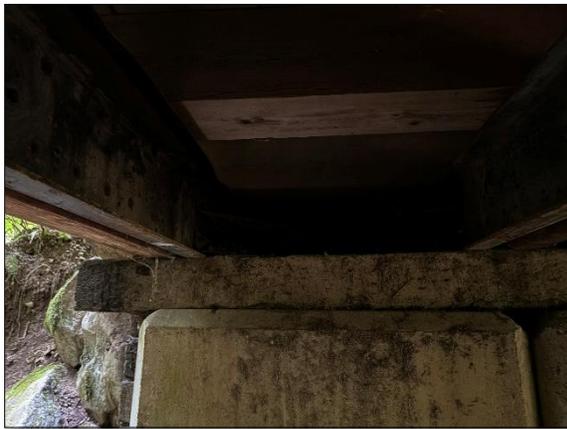
Photograph 45: Bridge 8 abutment and stringers, note: car frame used as bridge stringers

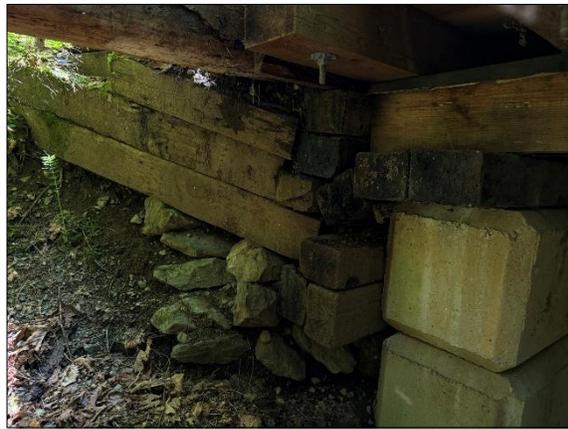
Photograph 46: Bridge 8 abutment, note: old abutment in place and decaying

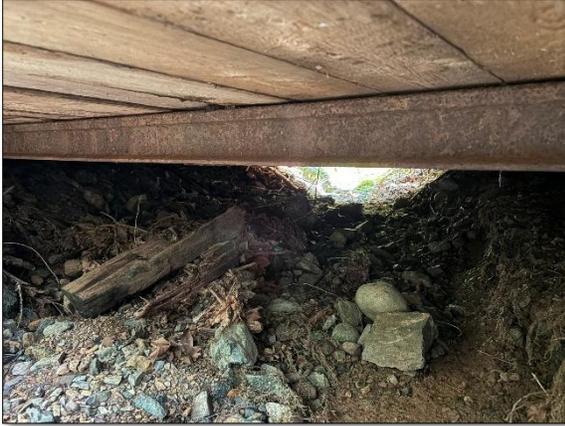
Photograph 49: Bridge 9 stringer, note: surface corrosion

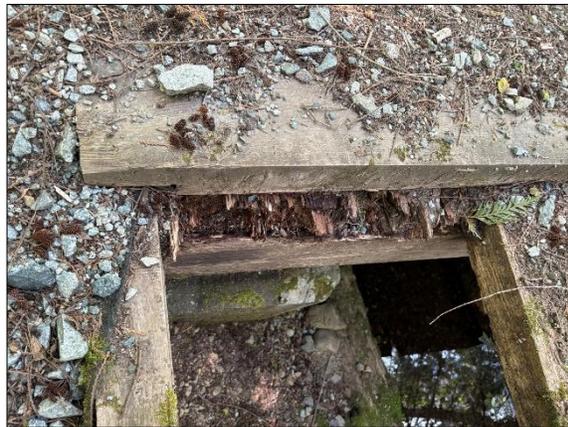
Photograph 52: Bridge 10 deck board, note: failed

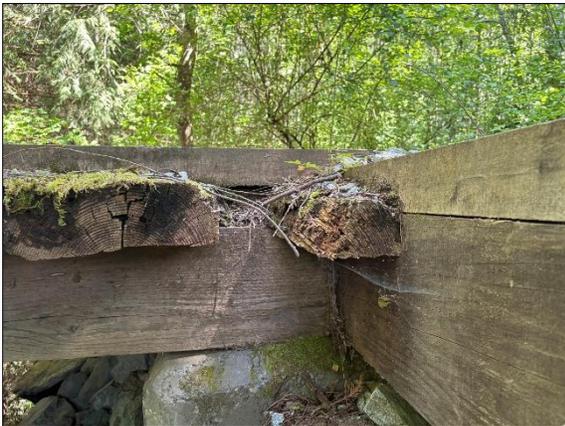
Photograph 53: Bridge 10 deck board cut ends, note: decayed and failed

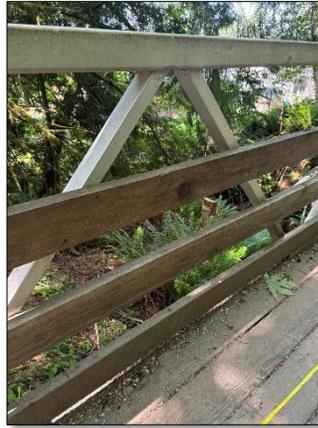
Photograph 56: Bridge 11 handrails, note: climbable
