# ALBERNI-CLAYOQUOT REGIONAL DISTRICT Parks Linear Asset Assessment & Mapping Maplehurst Park

## MAPLEHURST PARK, PORT ALBERNI, BC

Herold Project No.: 6516-001

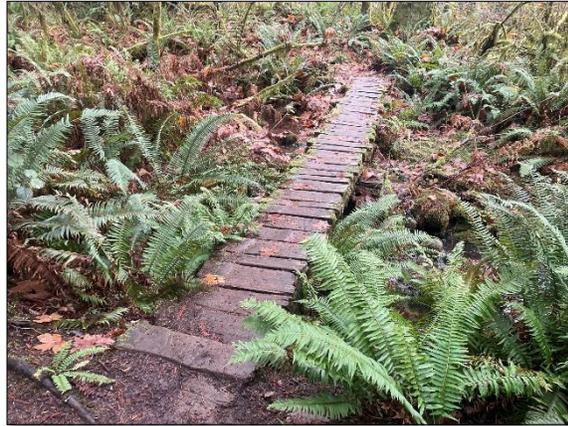
The bridge is in overall poor condition. It is narrow and spans a small stream channel. The bridge elevation is near the water level. Generally, the elements rest on organic matter and have visible signs of moisture ingress. Timber elements are weathered with evidence of biological decay. The bridge does not have any guarding and has an uneven surface. The structure is clearly intended for use by able-bodied hikers/recreators. The following items were noted on-site:

- Two deck boards are loose,
- Decking cut ends are soft and easily penetrated with a probe,
- Decking is slippery with moisture and biological accumulation (moss, etc.),
- Stringers are soft and easily penetrated with a probe in localized areas,
- Intermediate supports and abutments founded on organics with no foundation system

Photograph 2: Bridge 1, general arrangement

Based on the condition of the log stringers, replacement of the structure is recommended within one year. If structure is replaced in kind, consideration should be given to widening the deck and ensuring a level and anti-slip surface for users. If the structure is replaced in kind, consideration should also be given to signage at the trailhead indicating the level of difficulty and accessibility restrictions.

- Re-secure two loose deck boards
- Power-wash or clean surfaces of vegetation
- Install non-slip surface on the deck boards (e.g.: roofing shingles or profiled metal strips)

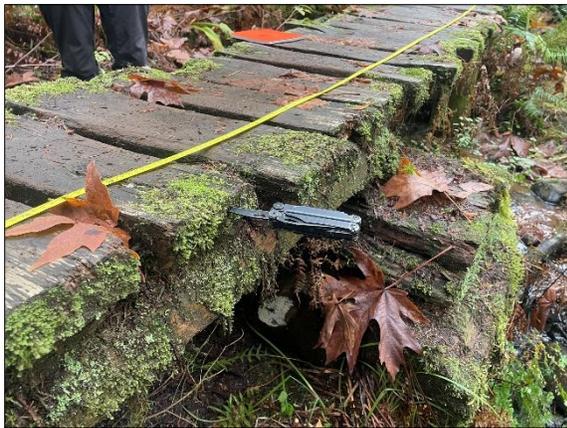
Photograph 3: Bridge 1 Decking, note: soft at cut ends

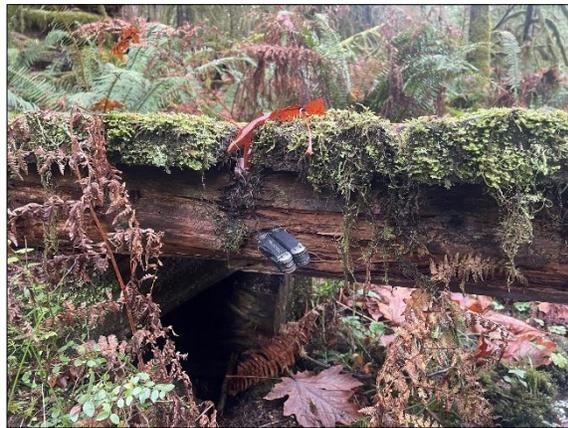
Photograph 4: Bridge 1 Stringer, note: decayed section

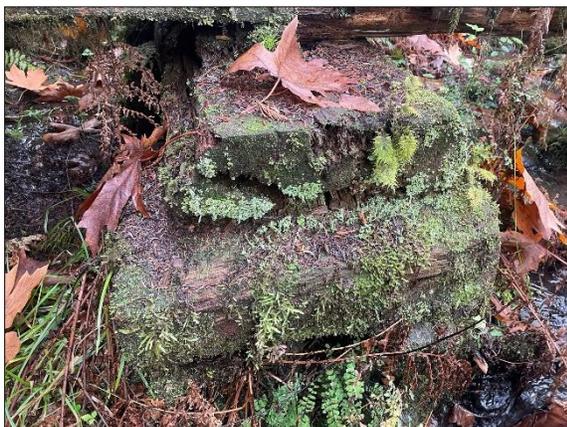
Photograph 5: Bridge 1 intermediate support, note: biological damage and decay

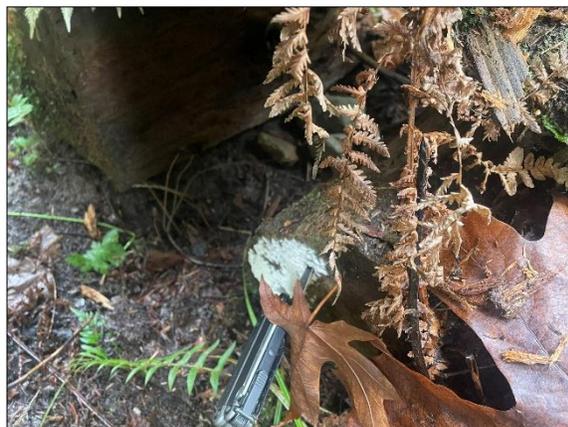
Photograph 6: Bridge 1 log abutment, note: biological damage and decayed section

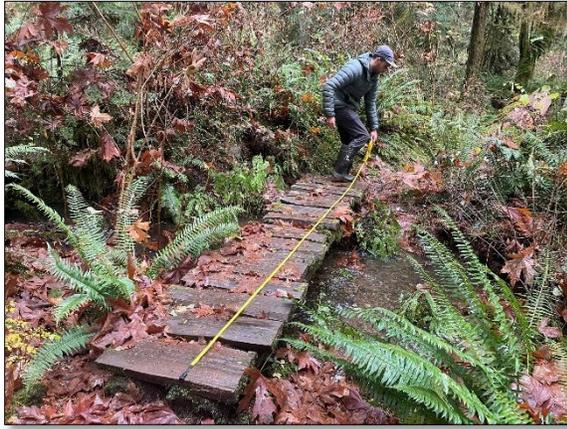
The bridge is in overall very poor condition. It is narrow and spans a small stream channel. The bridge elevation is near the water level. Timber elements are generally weathered with biological damage and visible decay/vegetative growth. The bridge does not have any guarding and has an uneven surface. The following items were noted on-site:

- One deck board is missing,
- Decking cut ends are soft and easily penetrated with a probe,
- Decking is slippery with moisture and biological accumulation (moss, etc.),
- The abutment is soft with visible decay of the cross section and biological damage.

Photograph 7: Bridge 2, general arrangement

Based on the overall condition the bridge is recommended to be replaced within the next one to three years. If structure is replaced in kind, consideration should be given to widening the deck and ensuring a level and anti-slip surface for users. If structure is replaced in kind, consideration should also be given to signage at the trailhead indicating the level of difficulty and accessibility restriction.

- Replace one deck board,
- Power-wash or clean surfaces of vegetation,
- Install non-slip surface on the deck boards (e.g.: roofing shingles or profiled metal strips)

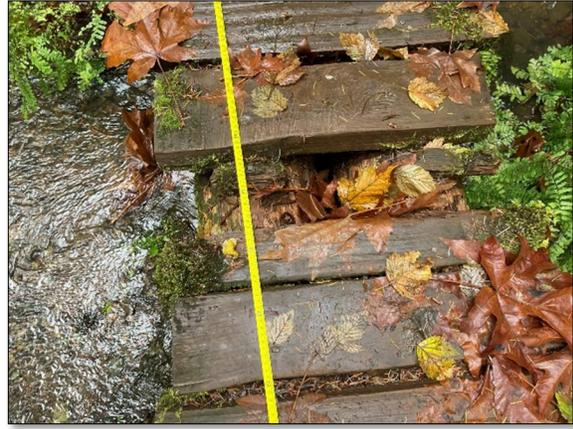
Photograph 8: Bridge 2, note: missing deck board

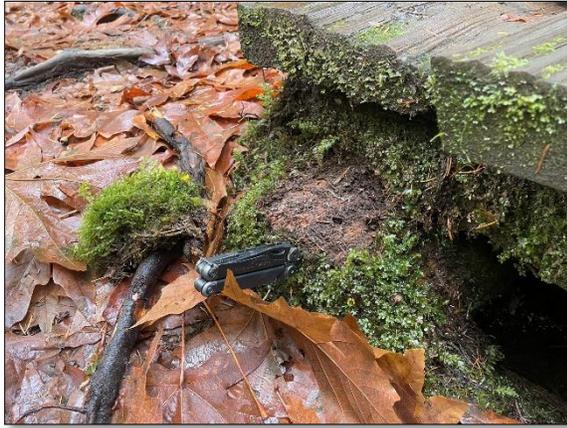
Photograph 9: Bridge 2 abutment, note: decayed section

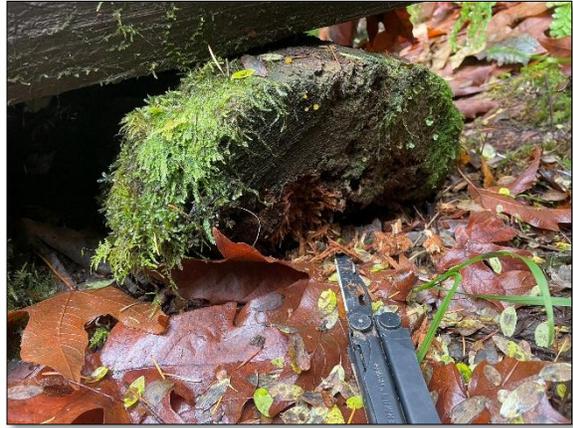
Photograph 10: Bridge 2 abutment, note: decayed section

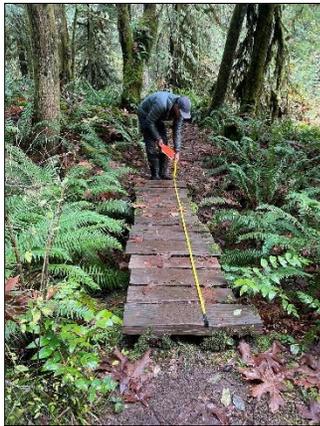
The bridge is in overall very poor condition. It is narrow and spans a small stream channel. The bridge elevation is near the water level. Timber elements are generally weathered with biological damage and visible decay/vegetative growth. The bridge does not have any guarding and has an uneven surface. The following items were noted on-site:

- Decking cut ends are soft and easily penetrated with a probe,
- Decking is slippery with moisture and biological accumulation (moss, etc.),
- Stringers are soft and easily penetrated with a probe in localized areas,
- Abutments are deteriorating due to biological damage; at one end the abutment is nearly gone, and the stringers are resting in organics/soil.
- The abutments are soft with visible decay of the cross section and biological damage,

Photograph 11: Bridge 3, general arrangement

Based on the overall condition the bridge is recommended to be replaced within the next year. If structure is replaced in kind, consideration should be given to widening the deck and ensuring a level and anti-slip surface for users. If structure is replaced in kind, consideration should also be given to signage at the trailhead indicating the level of difficulty and accessibility restriction.

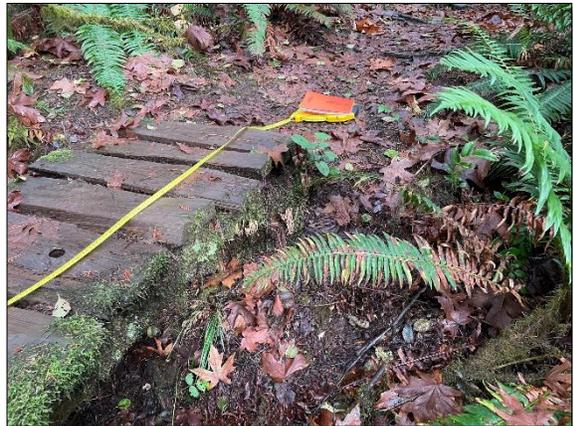
Photograph 12: Bridge 3 abutment, note: deteriorated cross section such that stringers nearly rest on organics below

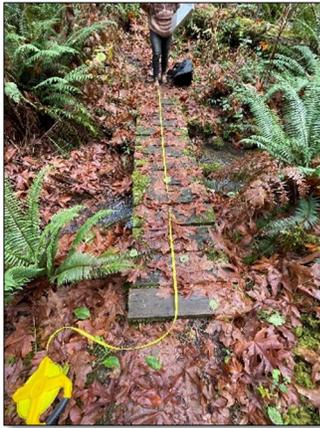
The bridge is in overall very poor condition. It is narrow and spans a small stream channel. The bridge elevation is near the water level. Timber elements are generally weathered with biological damage and visible decay/vegetative growth. The bridge does not have any guarding and has an uneven surface. The following items were noted on-site:

- One deck board is loose.
- Decking cut ends are soft and easily penetrated with a probe,
- Stringers are soft and easily penetrated with a probe in localized areas,
- Abutments are deteriorating due to biological damage; at one end the abutment is nearly gone, and the stringers are resting in organics/soil.
- There is evidence of settlement at the abutment. One side of the bridge has only 75mm of clearance to the ground below,

Photograph 13: Bridge 4, general arrangement

Based on the overall condition and construction, the bridge is recommended to be replaced within the next year. If structure is replaced in kind, consideration should be given to widening the deck and ensuring a level surface for users. If structure is replaced in kind, consideration

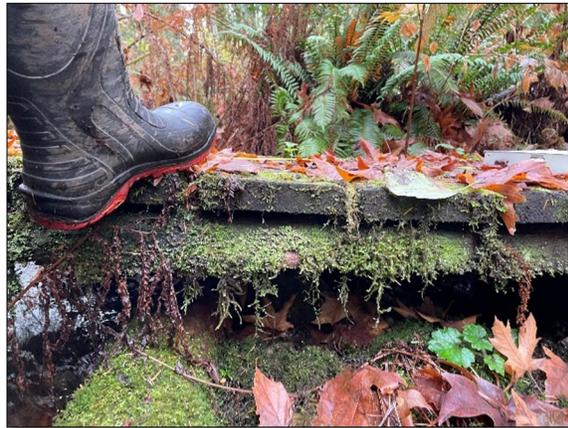
Photograph 14: Bridge 4 abutment and stringers,  
note: biological damage to  
sections

<b>Bridge 4</b>							
Deck Boards	at 0m	Mechanical/ Biological	Very Poor	One deck board is loose.	Re-secure deck boards to the substructure	15	2025
Abutment	General	Mechanical/ Biological	Poor to Very Poor	Abutment has visibly settled resulting in listing of the structure	Replace abutment within the next year	25	2025/2026
