Track and Bridge Condition Assessment

ACRD Rail Corridor

Port Alberni Subdivision

Alberni-Clayoquot Regional District

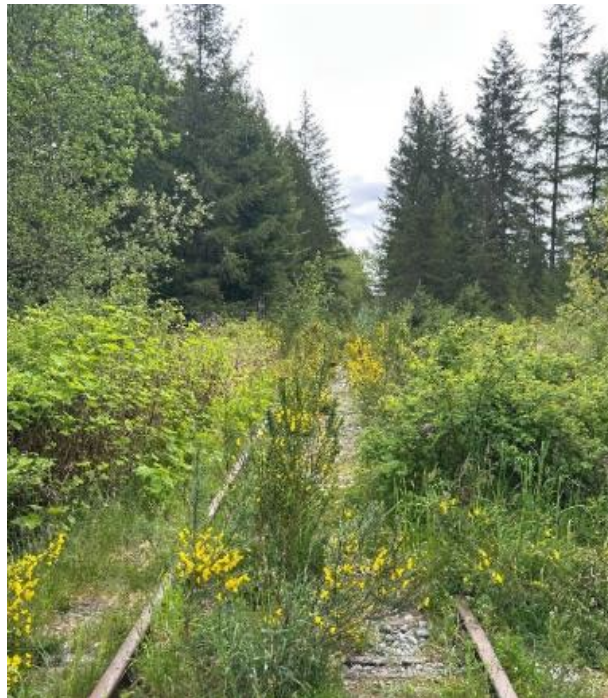
Figure 2-2: Segment 1 - Typical Track Roadbed

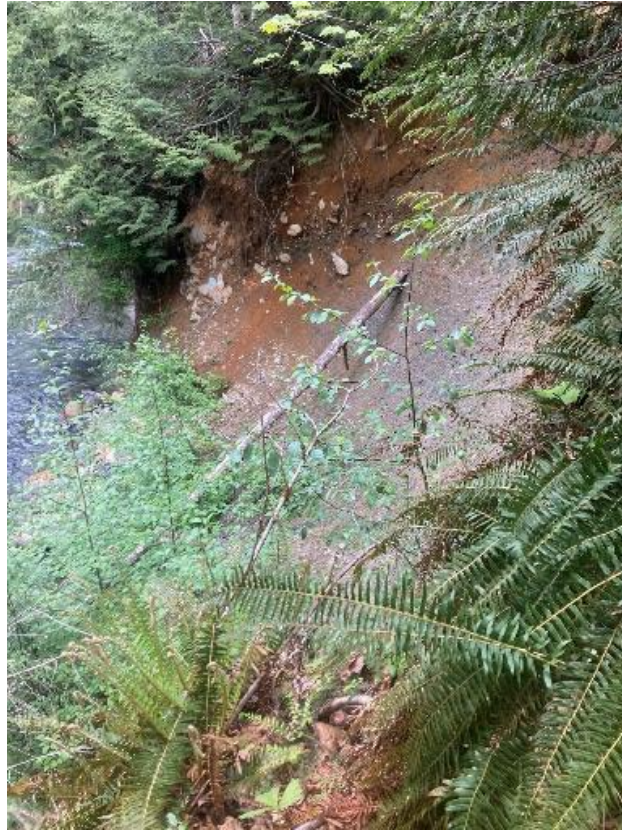
Figure 2-3: Eroding River Bank Near Mile 12

Recommendations	Description	Cost
River Bank Assessment and Repair	It is recommended to complete a drone flight at Mile 12 to view the river bank erosion which may affect the stability of the track roadbed. Costs included are for estimation of the river bank repair.	\$168,000
Locate and Clean Out Culverts if Required	As mentioned above, most culverts in this segment were not found. Locating and clearing the culverts is recommended to maintain proper drainage conditions.	N/A
Assessing the track condition along between Mile Post 0.0 - 12.0	Once the vegetation has been cleared along the entire segment, it is recommended to hi-rail or walk the track between Mile posts 0.0 - 12.0 to assess the track condition.	N/A
Track Patrols	It is recommended that regular patrols be done on the track segment once the required upgrades are completed for 10-ton hi-rail access. This will ensure the track is in operating condition ahead of any emergency access needs.	N/A

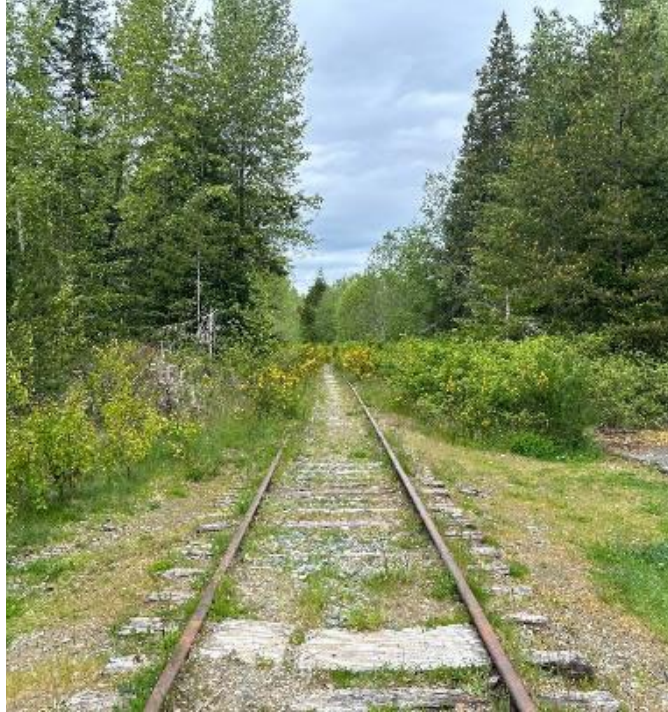
Figure 2-4: Segment 1 - Typical Track Structure

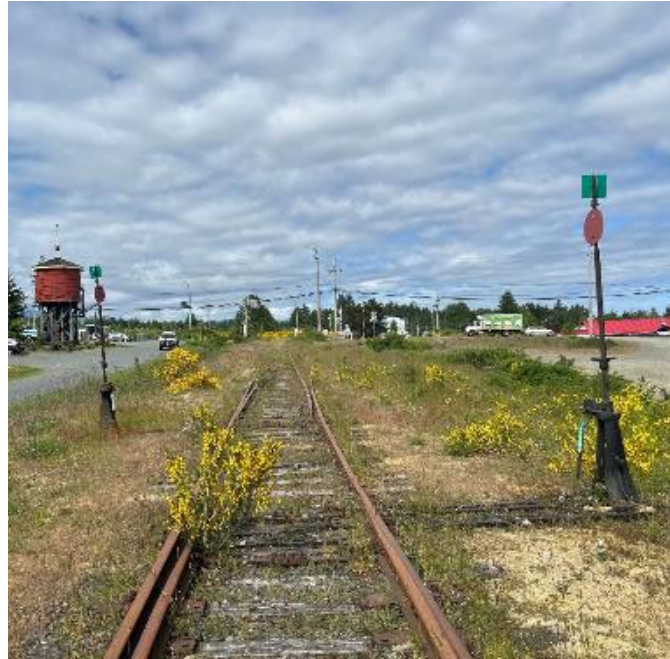
Overall, the turnout looks to be in fair condition with no major defects found in the visual inspection. This switching component of the turnout was unable to be determined if it could be moved from a normal to diverging route as the switch stands were locked.

Figure 2-5: Segment 1 – Turnout Mile 0.03

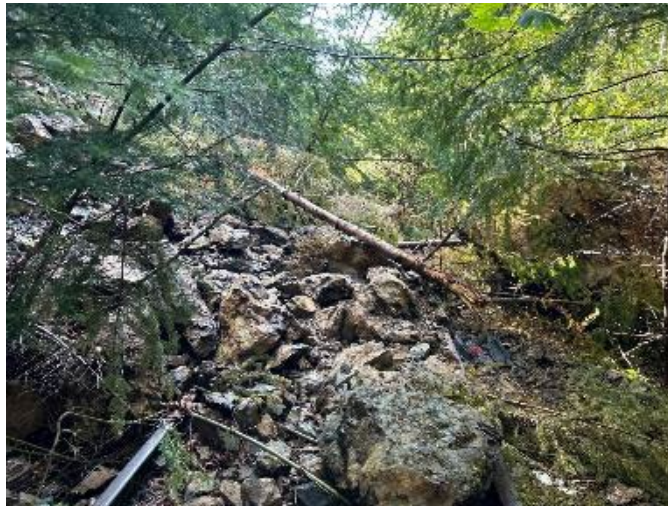
Various rockslides/rockfall locations were observed at Mile 13.4, 13.73, 13.8, 14.8, 15.6, 15.7, 15.8, 15.85, 15.9, 16.0, 16.1, 16.8, 19.6, as well as a mud slide at Mile 15.2.

Figure 2-6: Segment 2 – Rockslide Mile 13.4

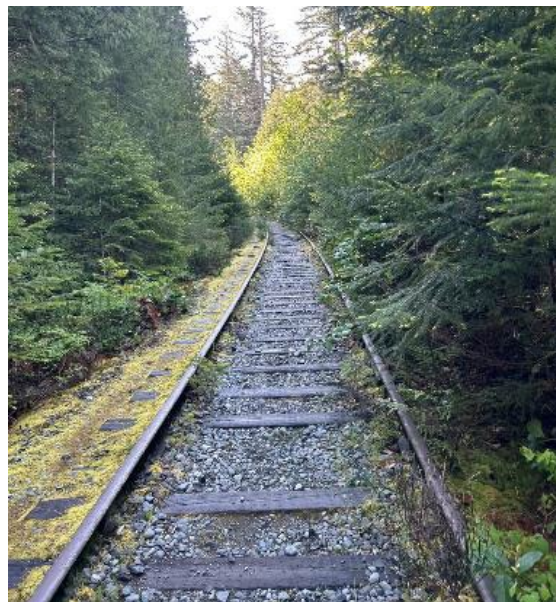
Figure 2-8: Segment 2 - Typical Track Structure

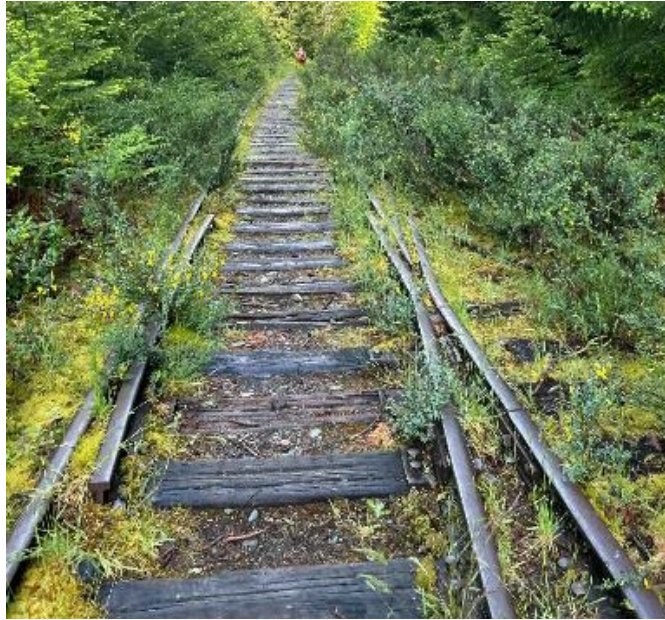
Figure 2-9: Segment 2 – Turnout Mile 12.5

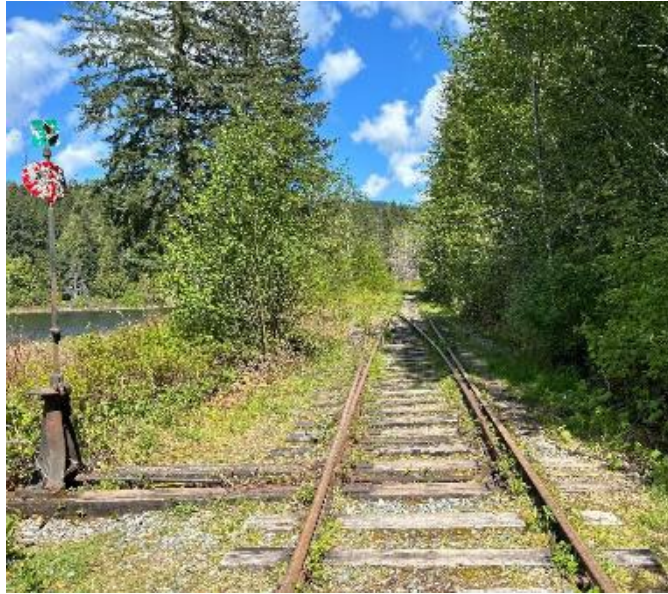
Figure 2-11: Segment 2 – Turnout Mile 21.95

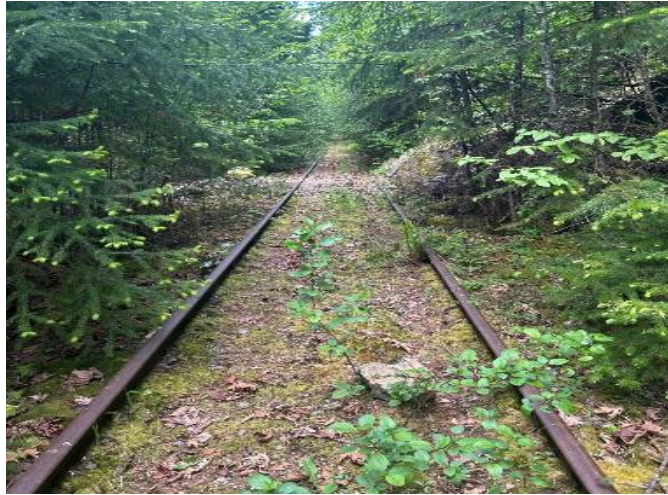
Figure 2-12: Segment 3 - Typical Track Roadbed

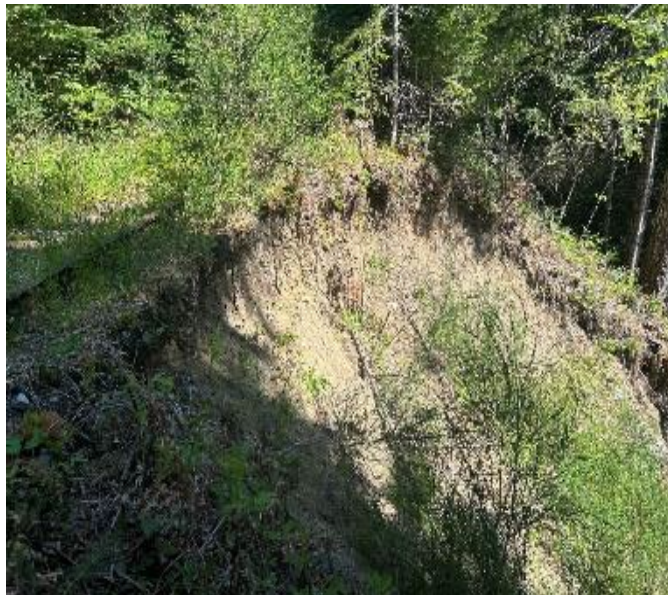
Figure 2-13: Segment 3 – Track Embankment Washout Mile 24.4

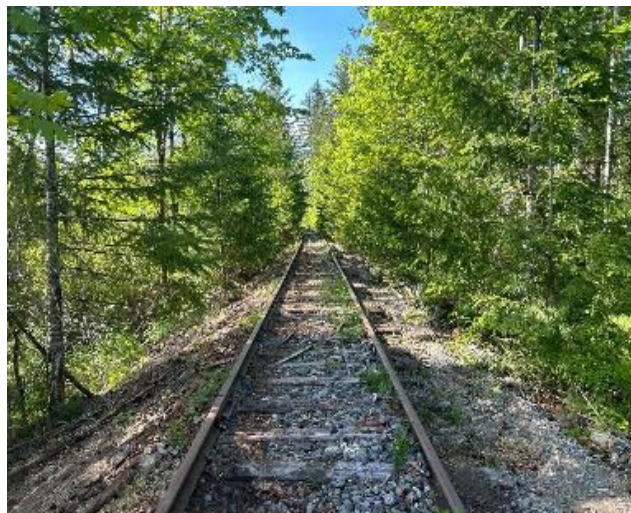
Figure 2-14: Segment 3 - Typical Rail/Tie/Ballast Structure

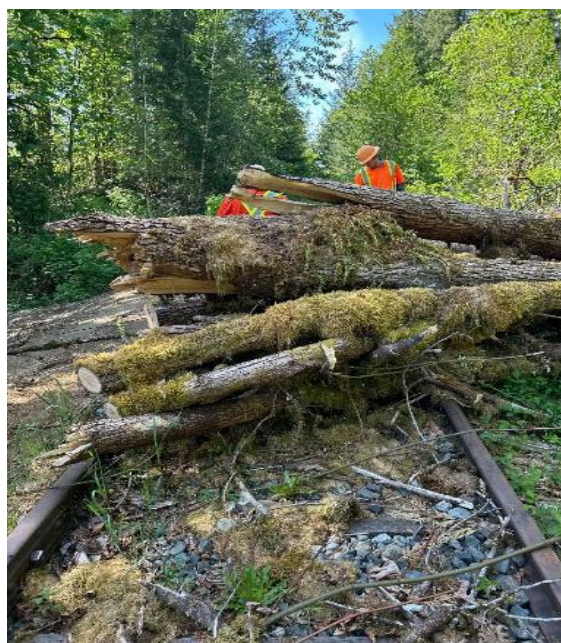
Figure 2-15: Segment 3 – Tree Fall Mile 31.7

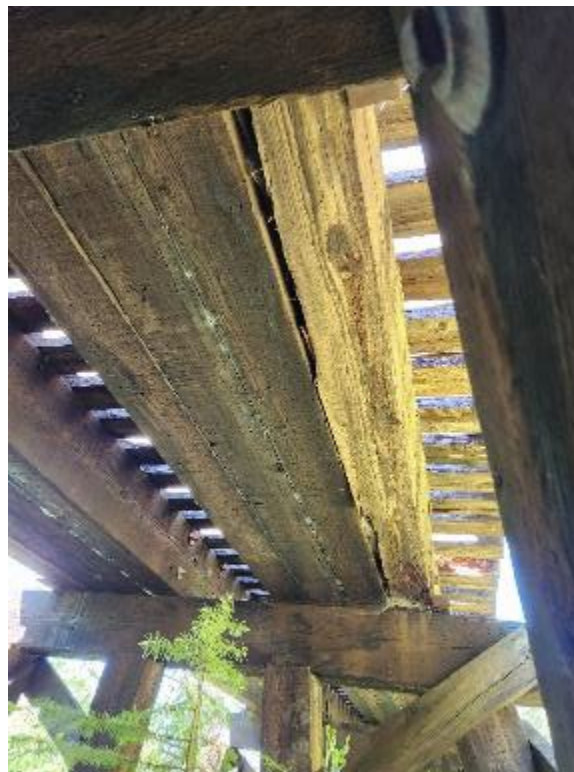
Figure 3-20: Bridge at Mile 14.6 – Stringer Chord Splitting

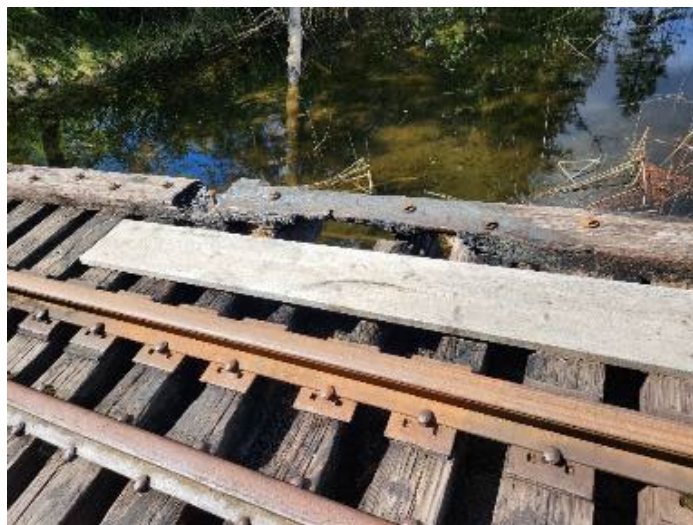
Figure 3-43: Bridge at Mile 22.1 – Fire Damage

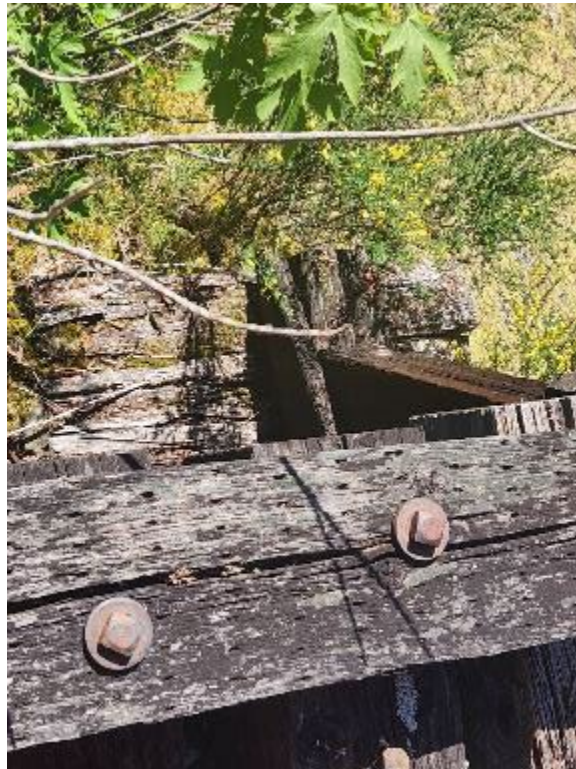
Figure 3-48: Bridge at Mile 25.0 – Mud Sill Decay

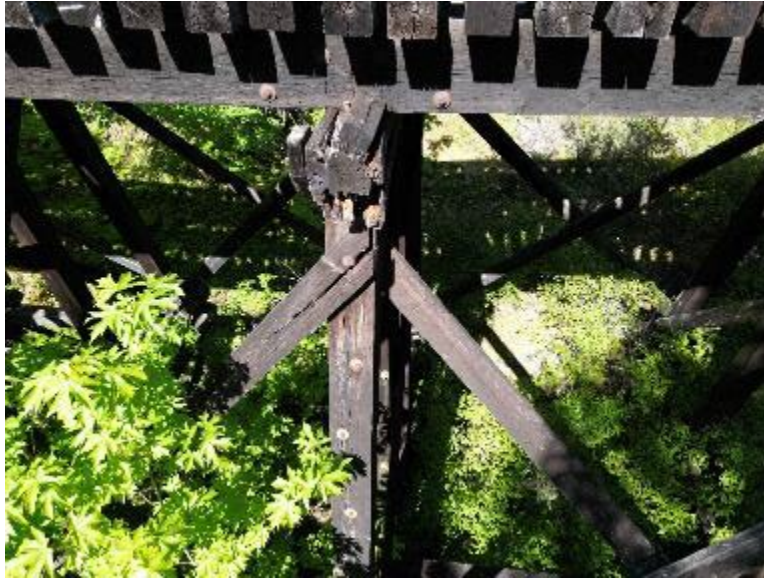
Figure 3-49: Bridge at Mile 25.0 – Failed Cap and Brace

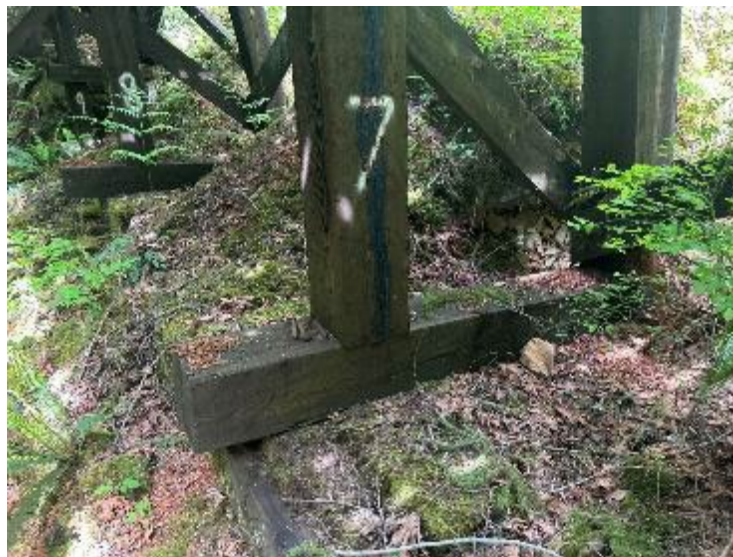
Figure 3-55: Bridge at Mile 29.9 – Decayed Mud Sills – Post 3, Bent 7

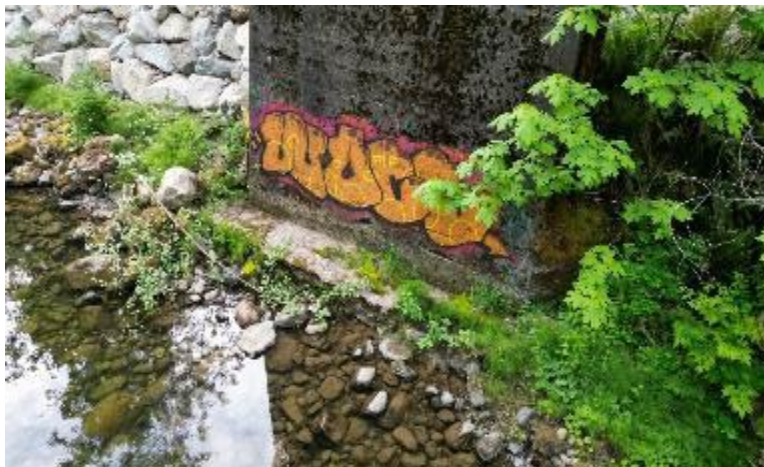
Figure 3-63: Bridge at Mile 37.1 – Pier 2 Foundation Minor Scour
