REQUEST FOR PROPOSAL
Vegetation Management Contract Area 3 (40.7 hectares)
Alberni Valley Regional Airport (CBS8)
Alberni Clayoquot Regional District

Harvest Plan Map
Block AP1 & 28

Fish Habitat Assessment and Environmental Plan - April 2015

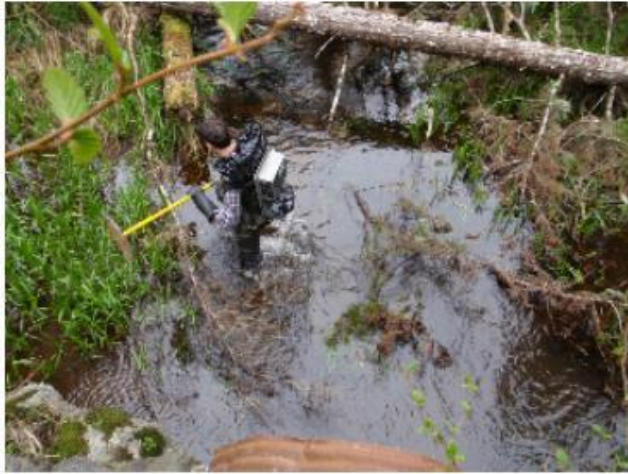
1.) Debbie Creek mainstem below airport.

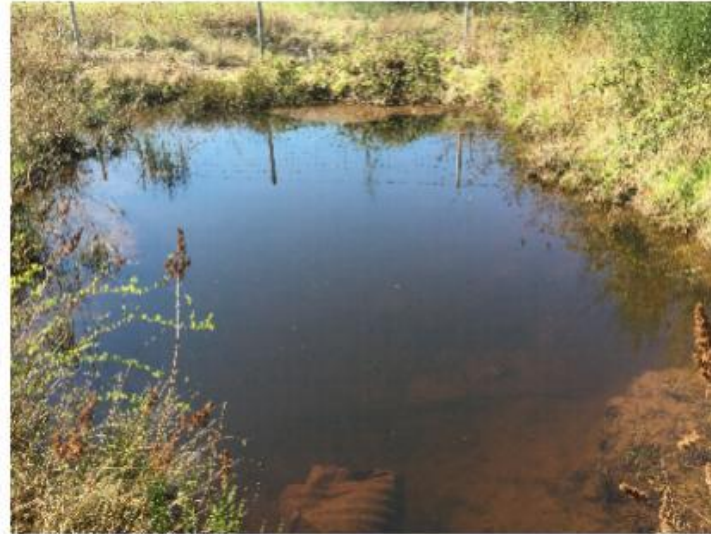
3.) Ditch 4 submerged culvert under service road.

The beavers may plug culverts and drainages. They are backing up the waterways and possibly flooding the airport runway. This was evident at Ditch 4 where water from the adjacent Beaver dam was spilling across the service road and into the ditch that leads down to settling Pond 2 through a culvert under the road. If the Beavers plug this culvert, the runway may flood. This culvert is already undersized and placed improperly, such that it should be replaced with a larger pipe or bridge. A beaver baffle may be required to prevent the uncontrolled plugging of the culvert. There are several designs of metal grilles that could be applied.

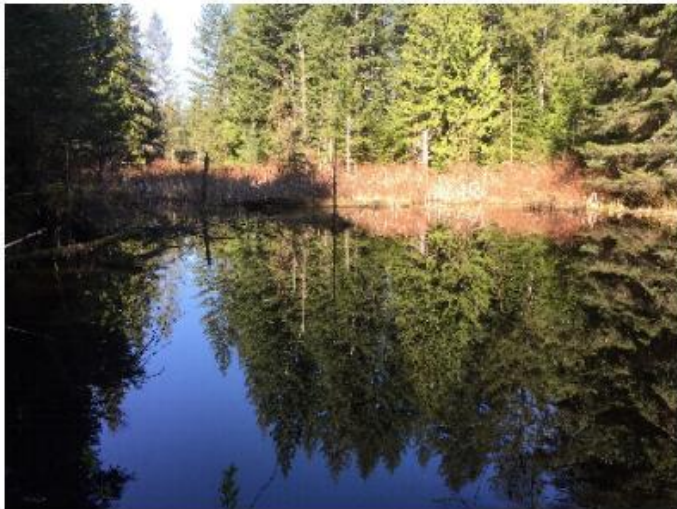
2.) Beaver Pond area - 400m long

The largest naturalized catchment of Debbie Creek in the survey area. This area has several beaver dams along its approximate 400m length and ranges in width from 5.0 to 50m. The series of dams along its length have flooded the adjacent riparian area and killed some trees through flooding. The airport side is lower relief and there is some water leaking from the pond edges over and across the Airport perimeter road and into the Ditch 4 circuit. The beaver appear to be attempting to plug this leak so they can maintain the pond depth. The beavers have flooded a band of Red Alder along this pond and are actively falling the trees for food and dam material. The riparian area of the Beaver Pond is surrounded with a 5-10m wide band of Red Alder, a few second growth Douglas Fir and a thick Salmonberry/Willow shrub line as well.

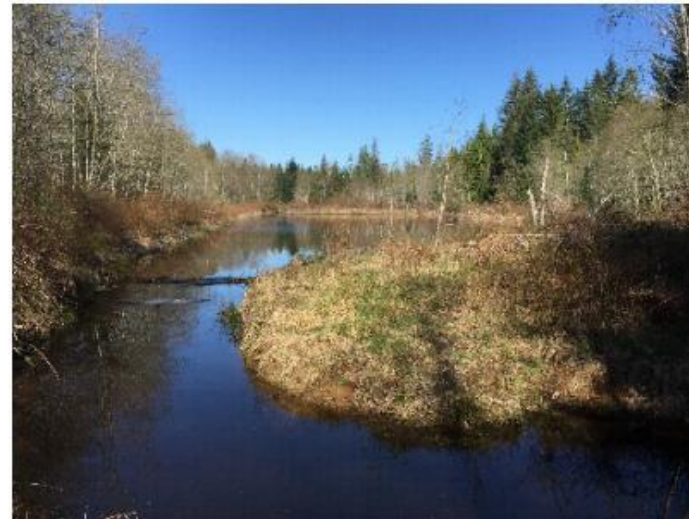
4.) Settling Pond 2 - machine dug perennial water.

The Beaver Pond and Ditch 4 drainages join and enter this man made 125m by 45m wide pond with a 2.0m depth. This gravel bed pond is perennial wetted habitat. There is a small grove of second growth Fir on the airport side as well as a ring of Alder and a dense surround of shrubbery. The Fir trees on the airport side are destined for falling, these trees offer south shade to the pond with 25-30 m height. The understory Alder are 10-15m height. The drainage leaves the Pond 2 and passes across a logging road and then joins the South Debbie Creek drainages at the property exit.

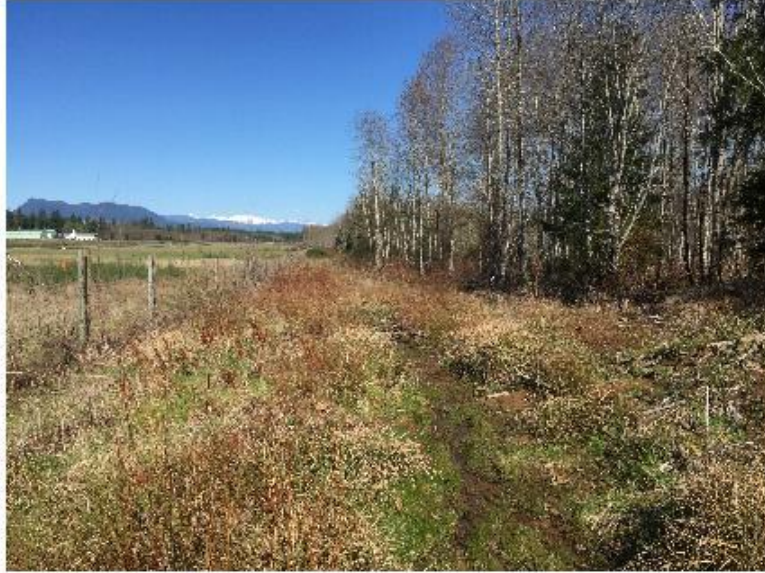
5.) Ditch 1 from Runway - no fish access.

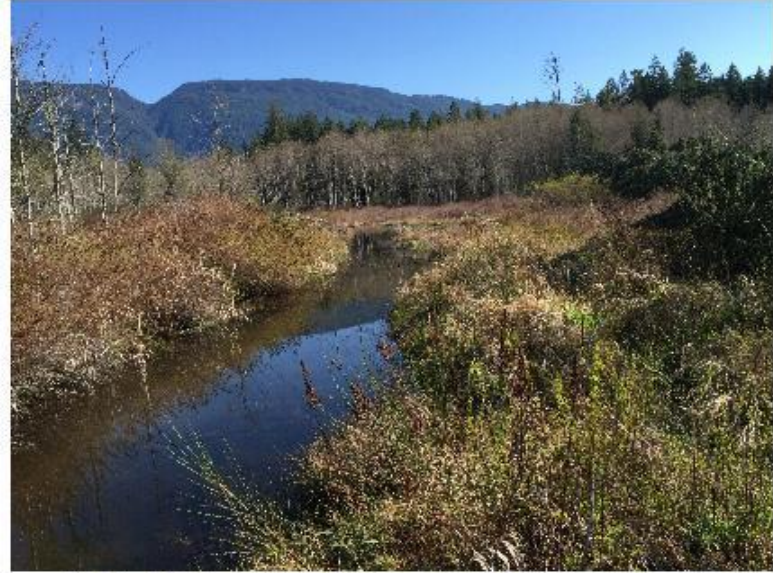
7.) Ditch 2 - leading to Settling Pond 1

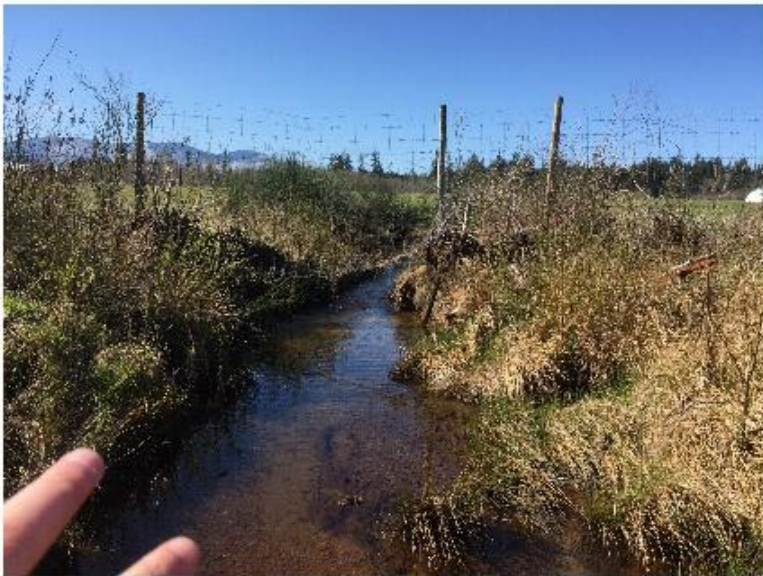
6.) Ditch 2 - from Runway - with fish access.

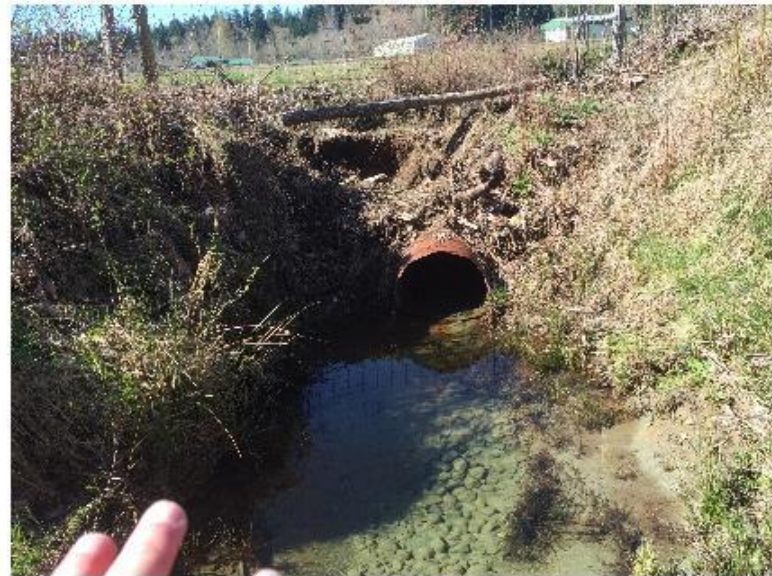
8.) Ditch 3 at runway culvert and end fish access.

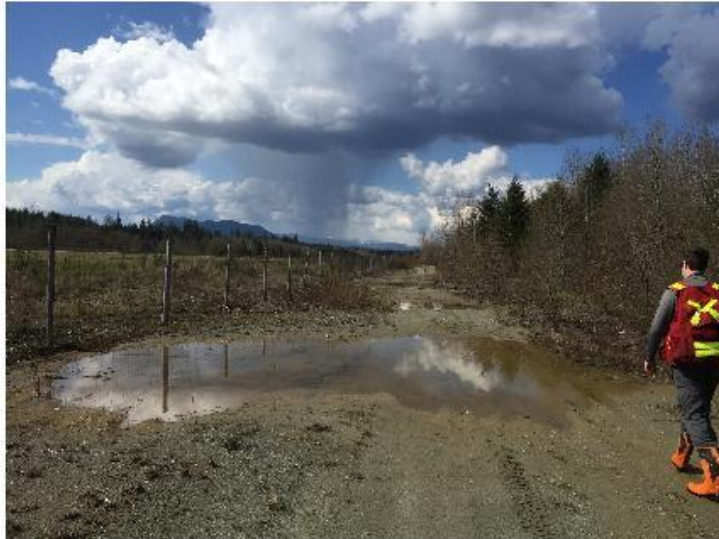
9.) Ditch 4/Beaver Pond overflow on road.

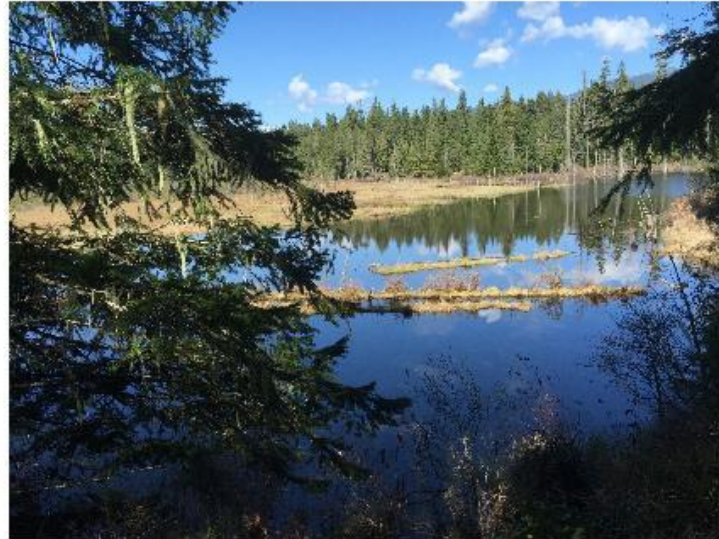
11.) Turtle Lake wetland - trees in flight line

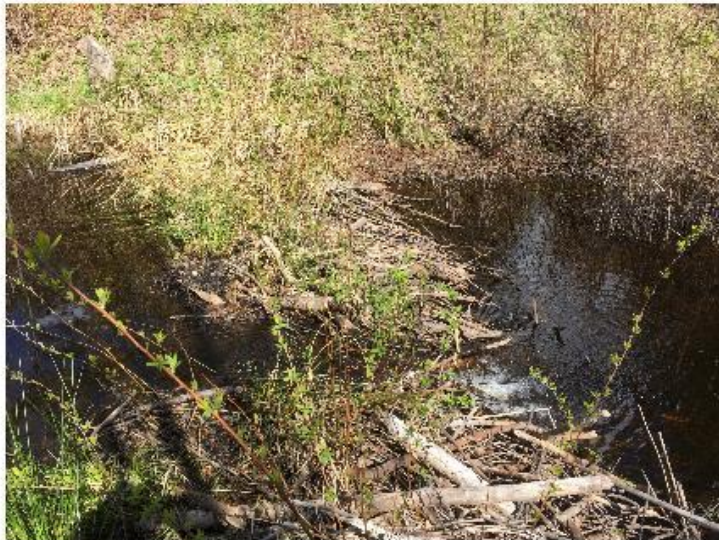
10.) Beaver dam - one of five along north east.

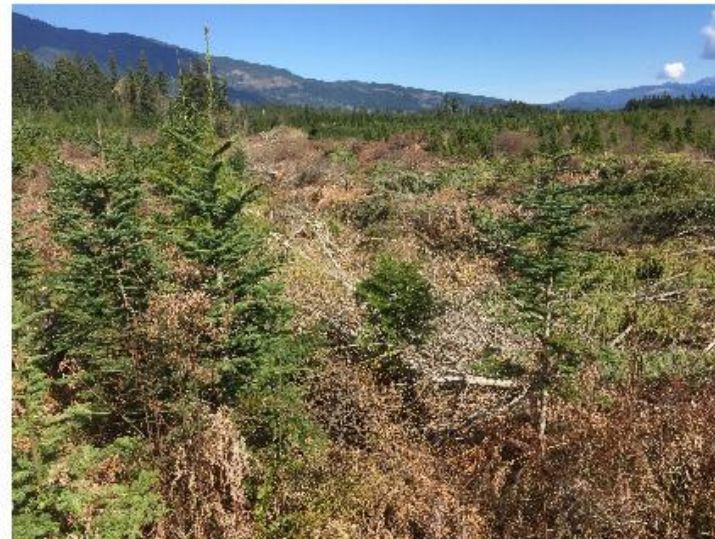
12.) McFlynn Creek - recently felled trees in creek

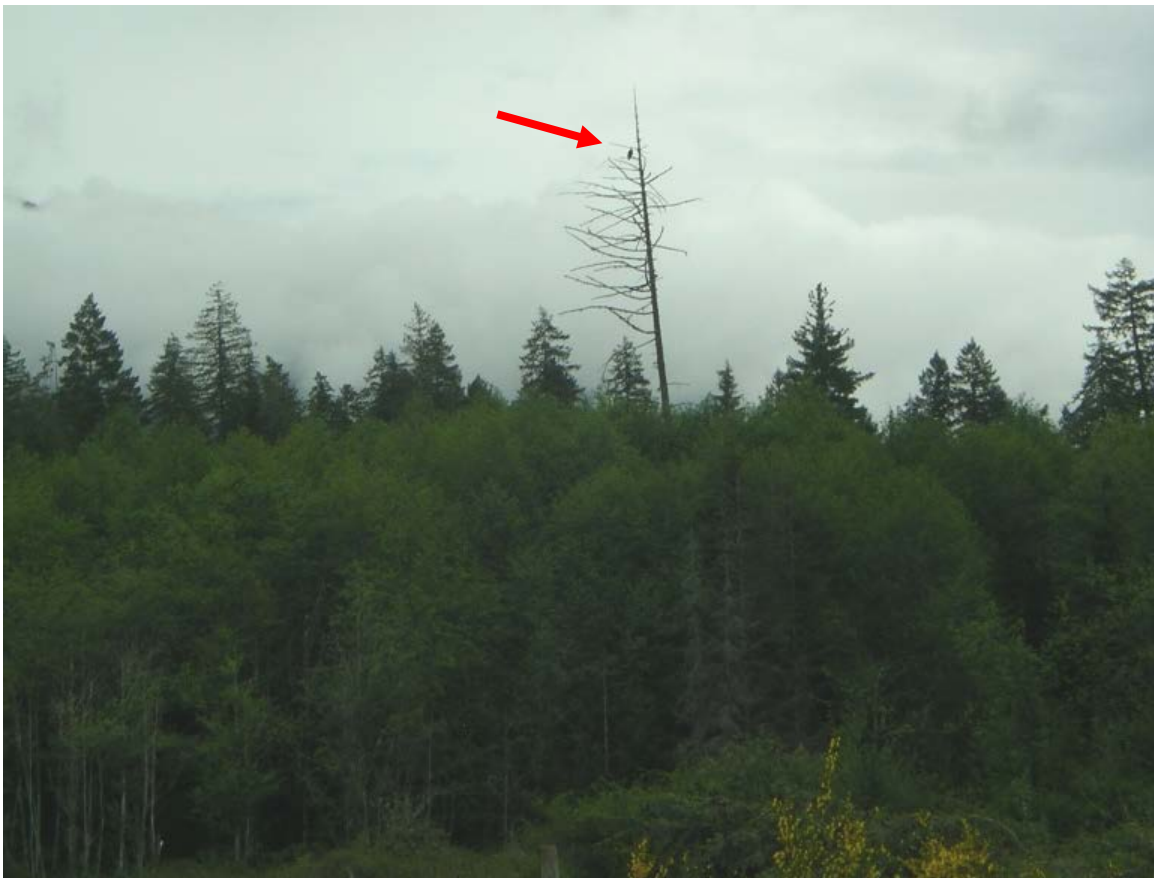
Figure 2. A perched adult Bald Eagle was recorded in the southeastern part of the work zone (red arrow), but no evidence of nesting by this species was found during the fieldwork.

While the proposed work area is fairly extensive, there are relatively few trees with characteristics suitable for the large and heavy nests typically constructed by Bald Eagles. Mature Douglas-fir trees with some potential for this species were identified near the southeastern end of the runway, and at the opposite end of the work zone, adjacent to Turtle Lake. However, no eagle nests were found at either location. A lone adult eagle was observed briefly on a tall snag just outside the southeastern part of work zone (Figure 2), and likely hunts around the AVRA grounds on occasion. This was the only raptor activity detected within or near the work zone.
