ALBERNI CLAYOQUOT REGIONAL DISTRICT

REGIONAL WATER SYSTEMS 2006 ANNUAL REPORT

**BAMFIELD
MILLSTREAM
TOFINO UCLUELET AIRPORT**

**PREPARED BY
ENVIRONMENTAL SERVICES DEPARTMENT**

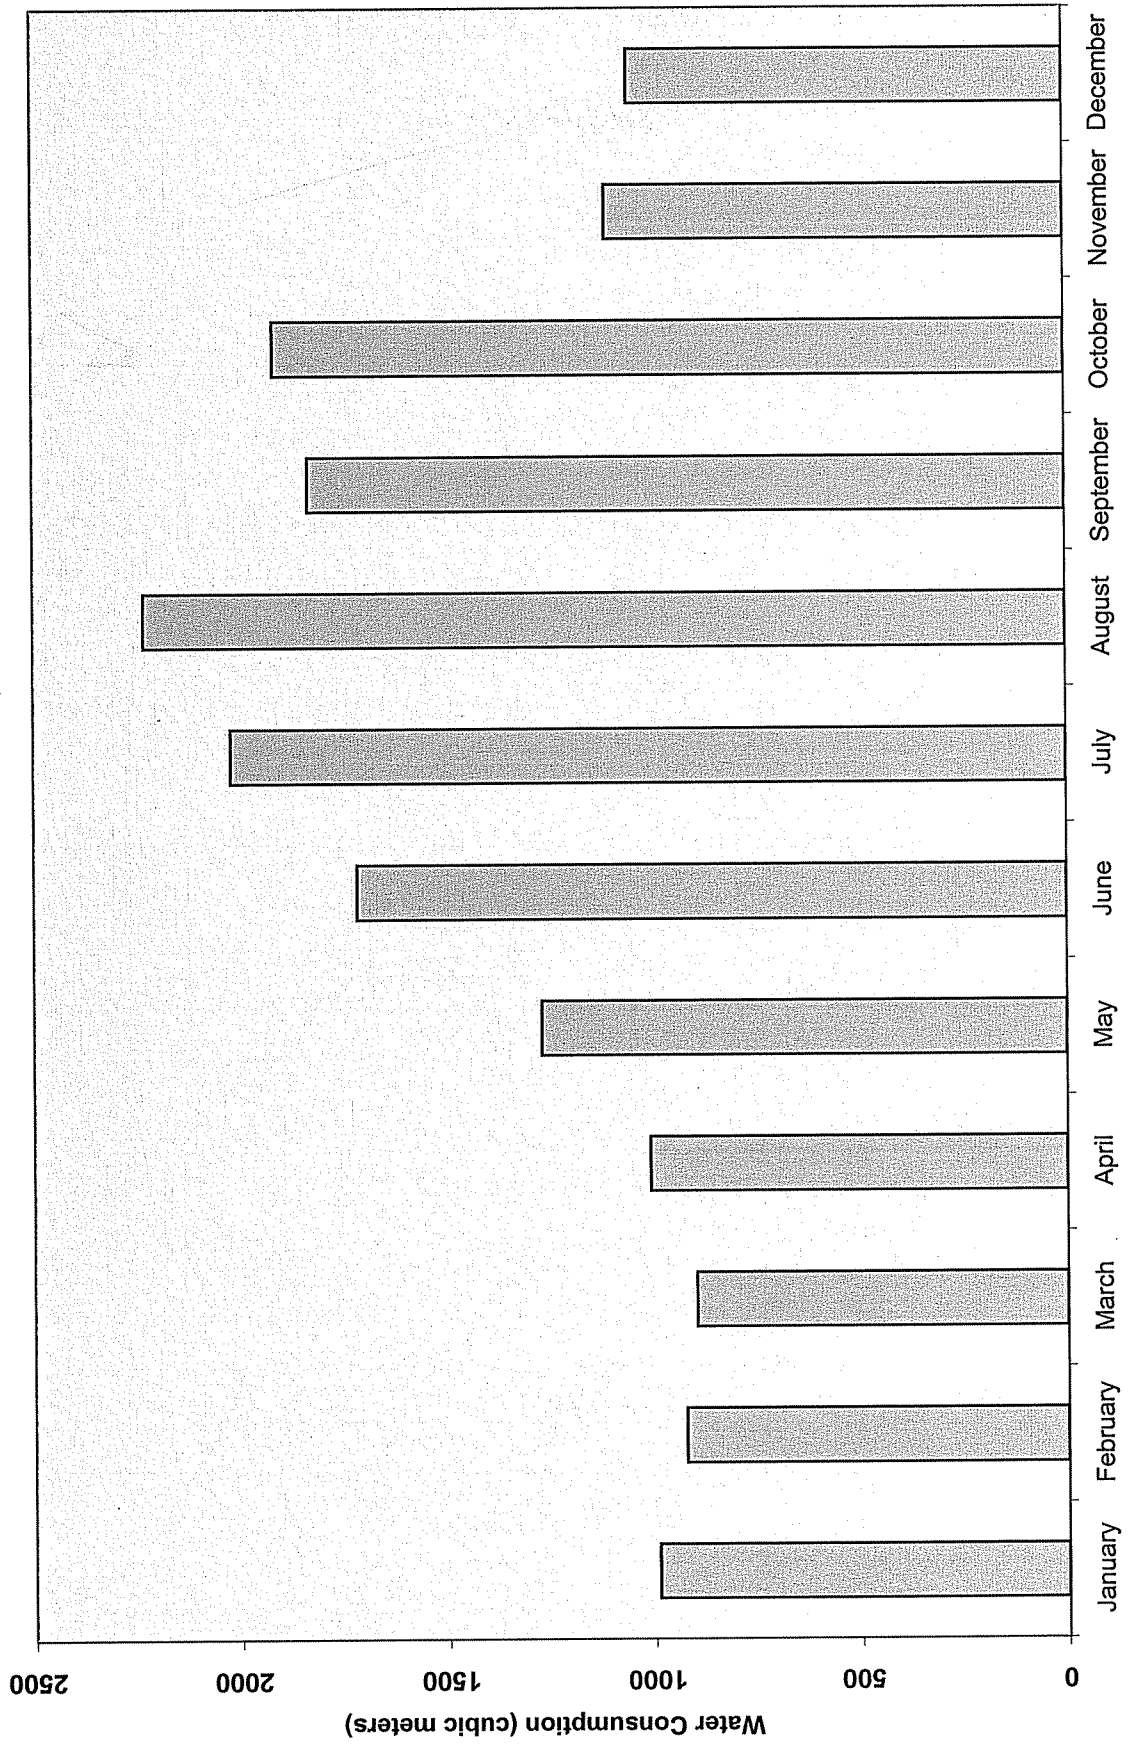
Millstream Monthly Water Consumption 2006

In the beginning of October a large leak occurred in the A.C. water main causing the reservoir level to drop. The pumps ran until the well levels dropped and only could be used when the wells recharged. This event showed the limiting factors of the water

system to be the aquifer being unable to keep up to demand and the aging infrastructure. Average daily flows were 100 cubic meters during this event. This was a significant leak that can be seen on the Monthly Consumption Graph. A Level 1 water restrictions sign was put up at the entrance to Millstream at that time.
