ALBERNI CLAYOQUOT REGIONAL DISTRICT

WATER SYSTEMS ANNUAL REPORT 2014

Alberni Clayoquot Regional District Water Systems:

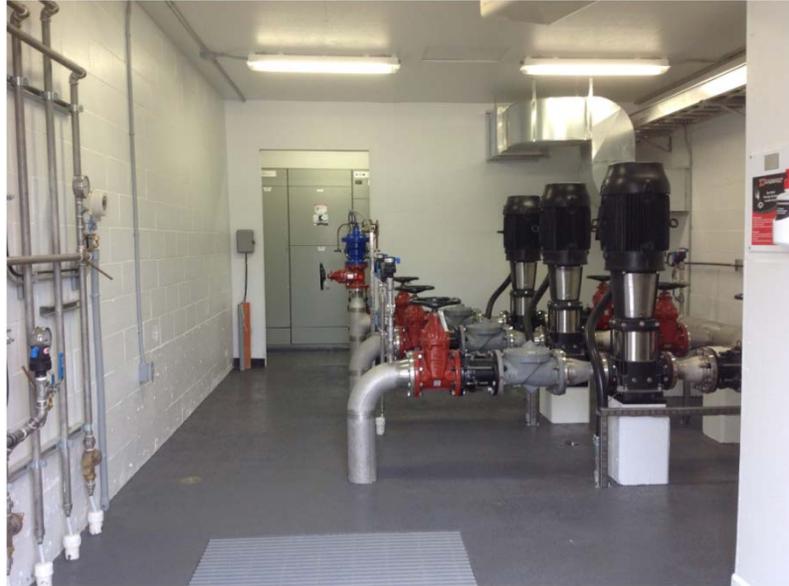
Strick Road Pump Station

- The primary projects for 2014 were the construction of the Strick Road Pump Station and the water main upgrade on Strick Road.
- All fire hydrants had annual servicing in 2014

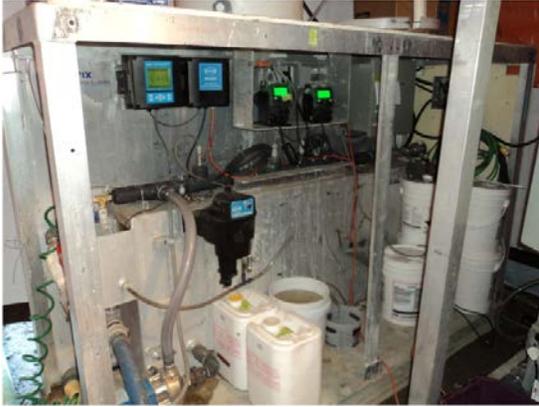
Raw Water Entering with Treatment Additives

A "pilot" water treatment plant was installed in Bamfield in the fall of 2014 in order to determine if a Dissolved Air Flootation (DAF) plant would remove the organics and colour from the lake water. This plant operated for two weeks with raw water (un-chlorinated) from the water main. Water samples and subsequent laboratory analysis was taken of the raw water entering the plant, from the clarified water coming off the DAF plant and from the final filters (see Appendix A). The DAF system worked by the reduction in pH (level of acidity) and an additive of a flocculent (to join particles together) to create a larger surface area particle. The DAF tank would then introduce dissolved air to create air bubbles that would stick to the particles and float to the top of the tank for removal. The last step is that the water would then travel through a filter bed to remove any remaining particles. The chemical testing found that the system worked well in the removal of organics and colour thereby reducing the level of disinfection byproducts.

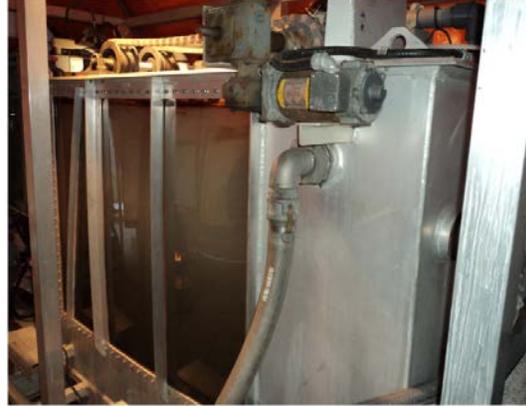
Dissolved Air Floatation Tank (DAF)

- Monthly trihalomethanes sampling is taking place at the reservoirs
- A “*Pilot*” DAF water treatment plant was successfully operated in the fall that removed the disinfection byproduct precursors. A DAF plant uses “dissolved air floatation” to float out impurities in the raw (lake) water.

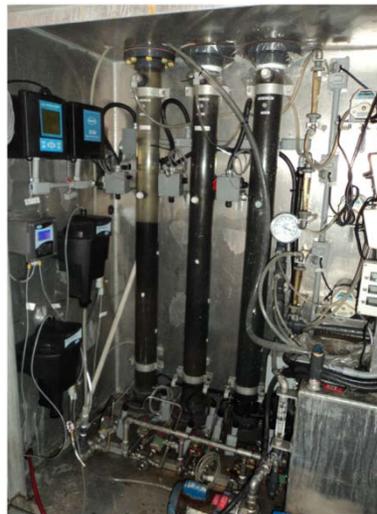
Final Filters
