West Coast Committee Meeting Wednesday, November 17, 2021

Alberni-Clayoquot Regional District

The Alberni Clayoquot Regional District (ACRD) retained PGL Environmental Consultants (PGL) to complete a Stage 1 Preliminary Site Investigation (PSI) report for Long Beach Airport (YAZ). The objective of this Stage 1 PSI is assess the likelihood that contamination is onsite and to delineate areas of potential environmental concern (APECs). and recommend further investigation if necessary.

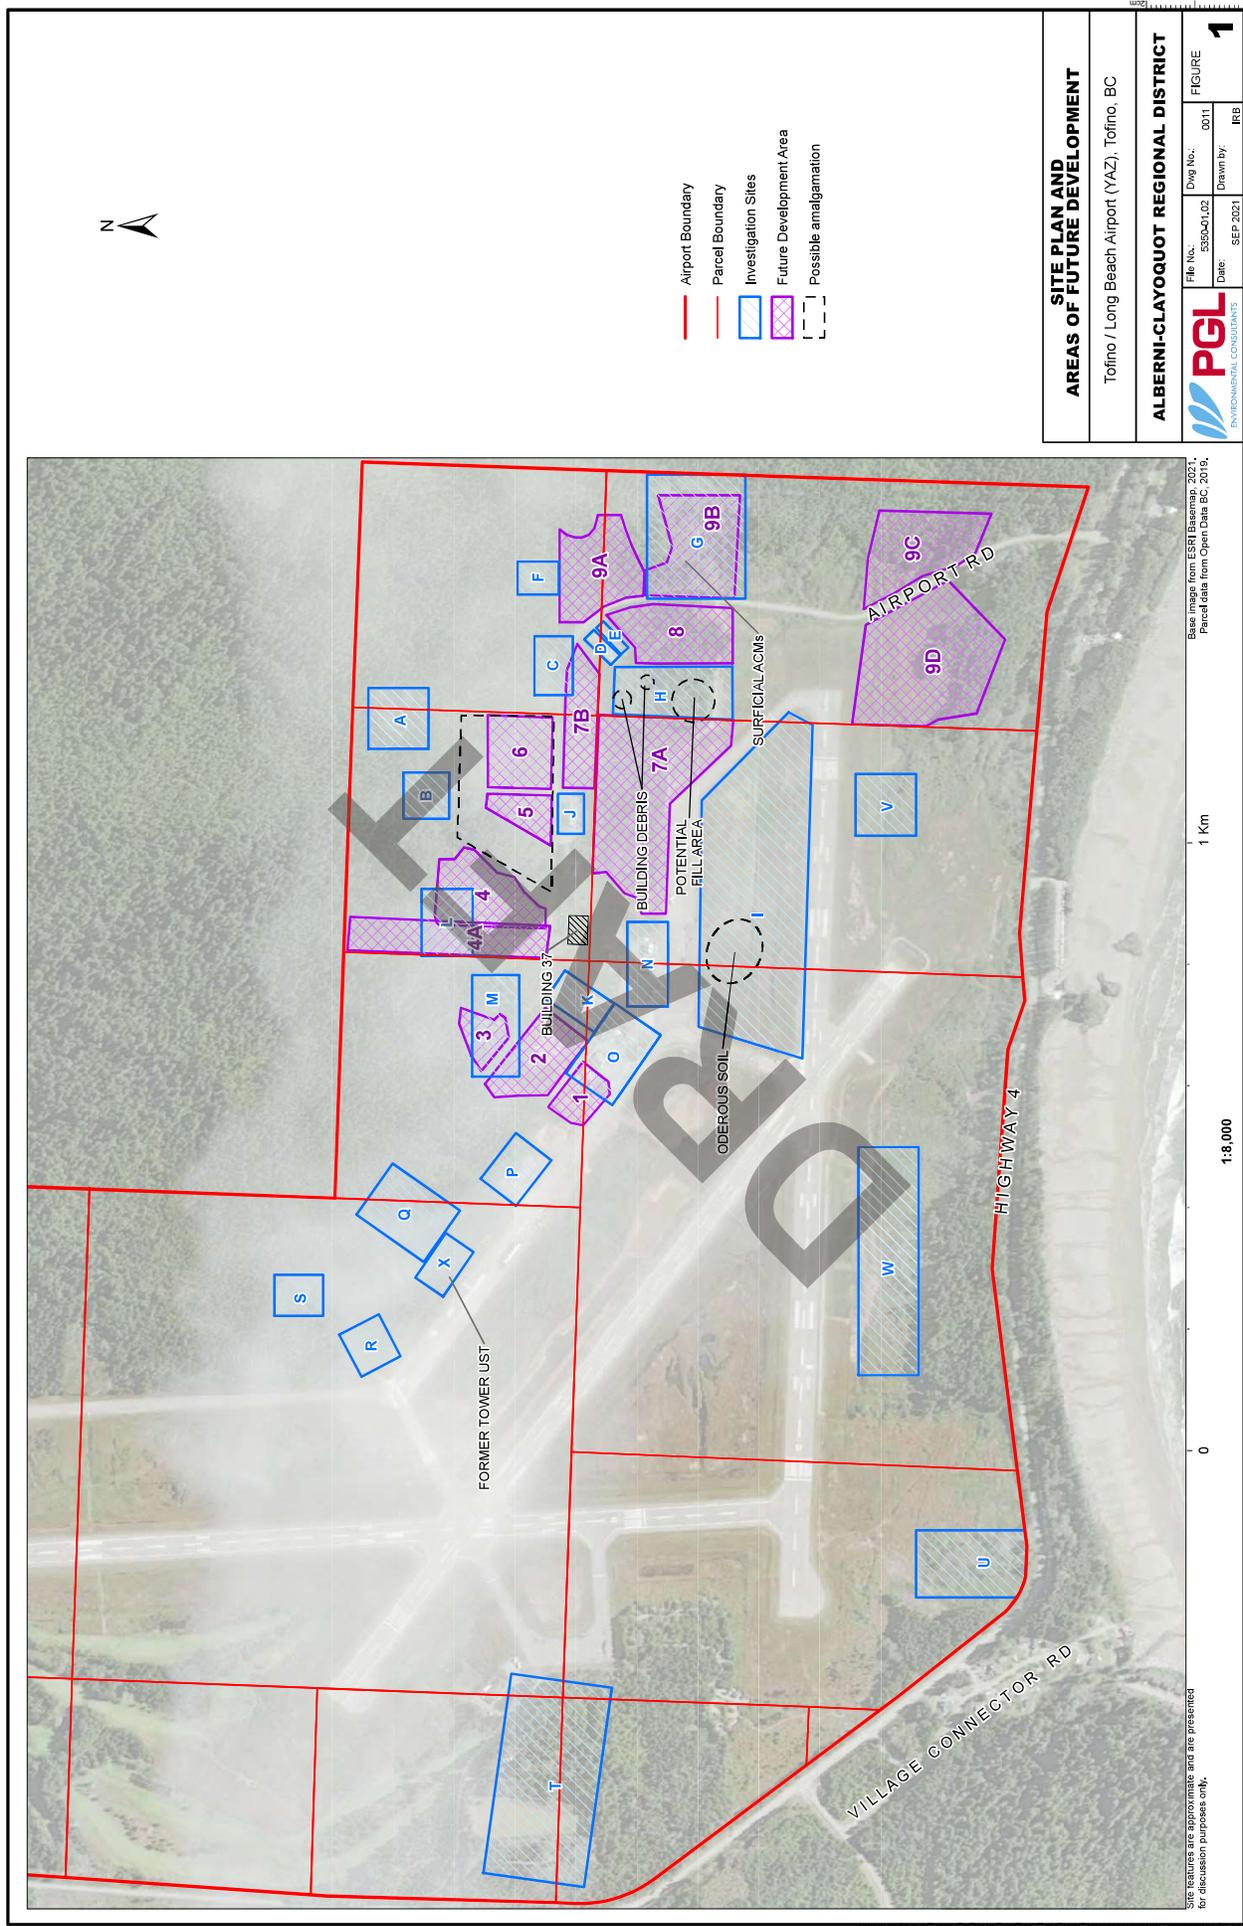
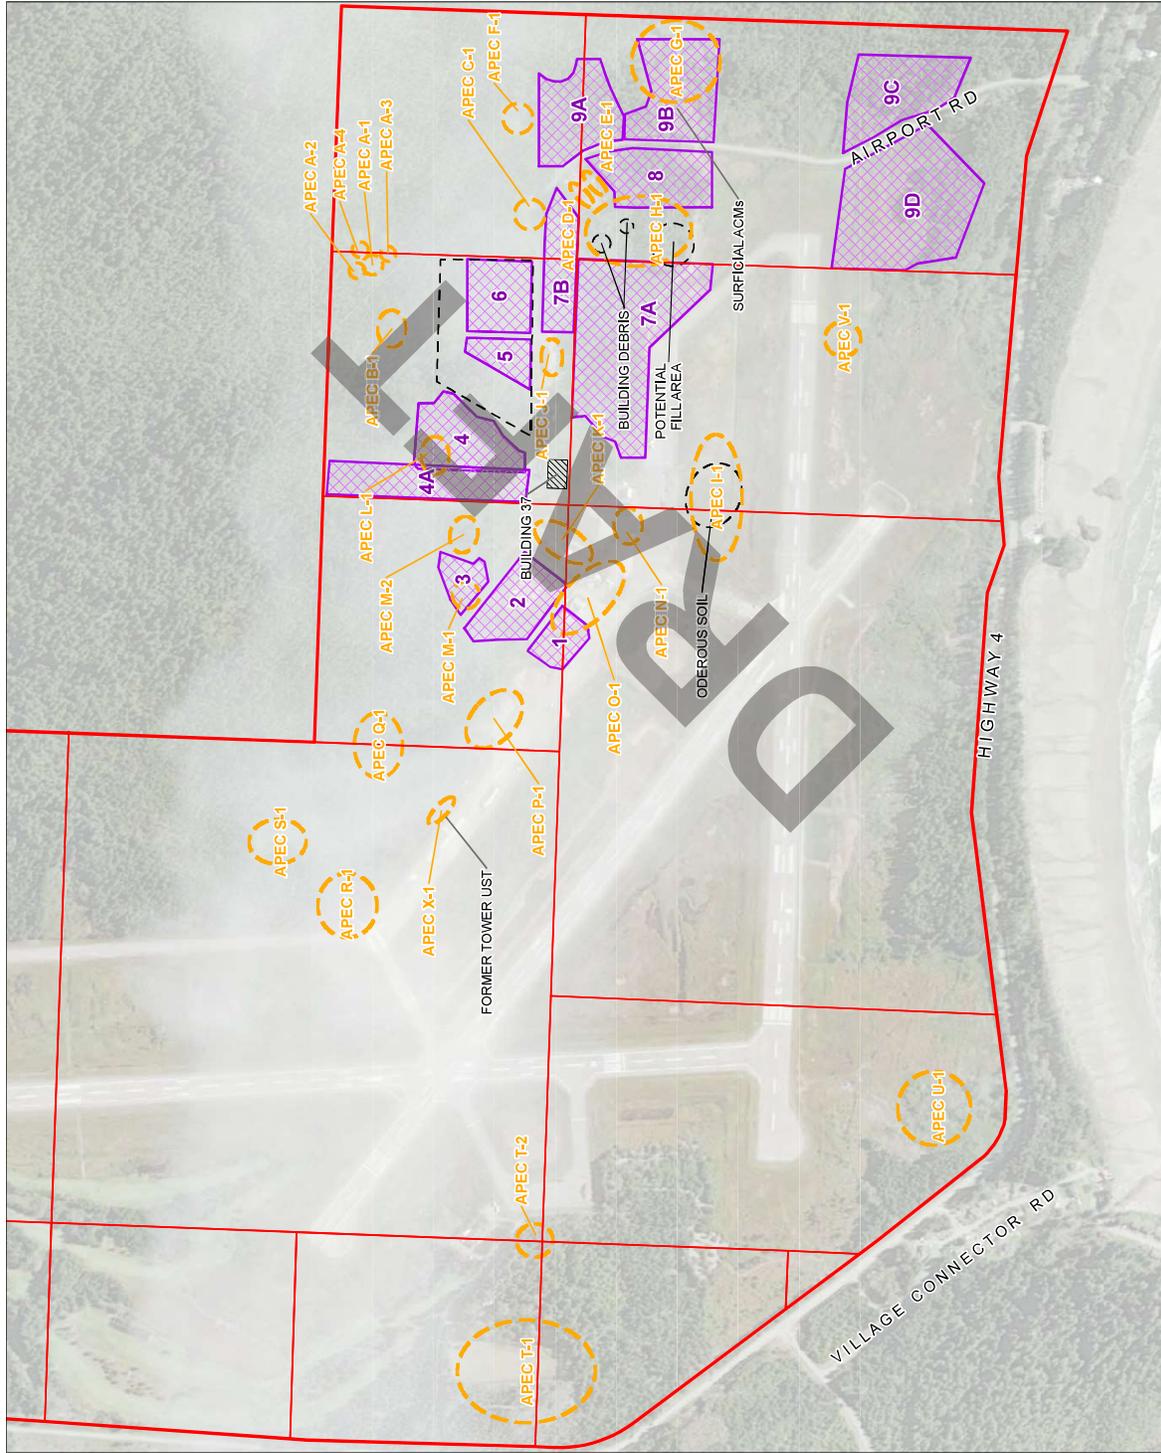
- Airport Boundary
- Parcel Boundary
- Future Development Area
- Possible amalgamation
- Area of Potential Environmental Concern
