REGIONAL DISTRICT OF ALBERNI-CLAYOQUOT
**NOTICE OF APPLICATION FOR
DEVELOPMENT VARIANCE PERMIT**
ELECTORAL AREA 'A' – BAMFIELD

DVA20006 – JULIU & ILDIKO DOMBI-SAHI, PROPERTY OWNERS

GEOTECHNICAL HAZARD ASSESSMENT

**New Residence, 422 Burlo Island,
Bamfield, BC
Lot 1, Section 19, Township 1,
Barclay District, Plan VIP68113
District, PID NO. 024-330--485**

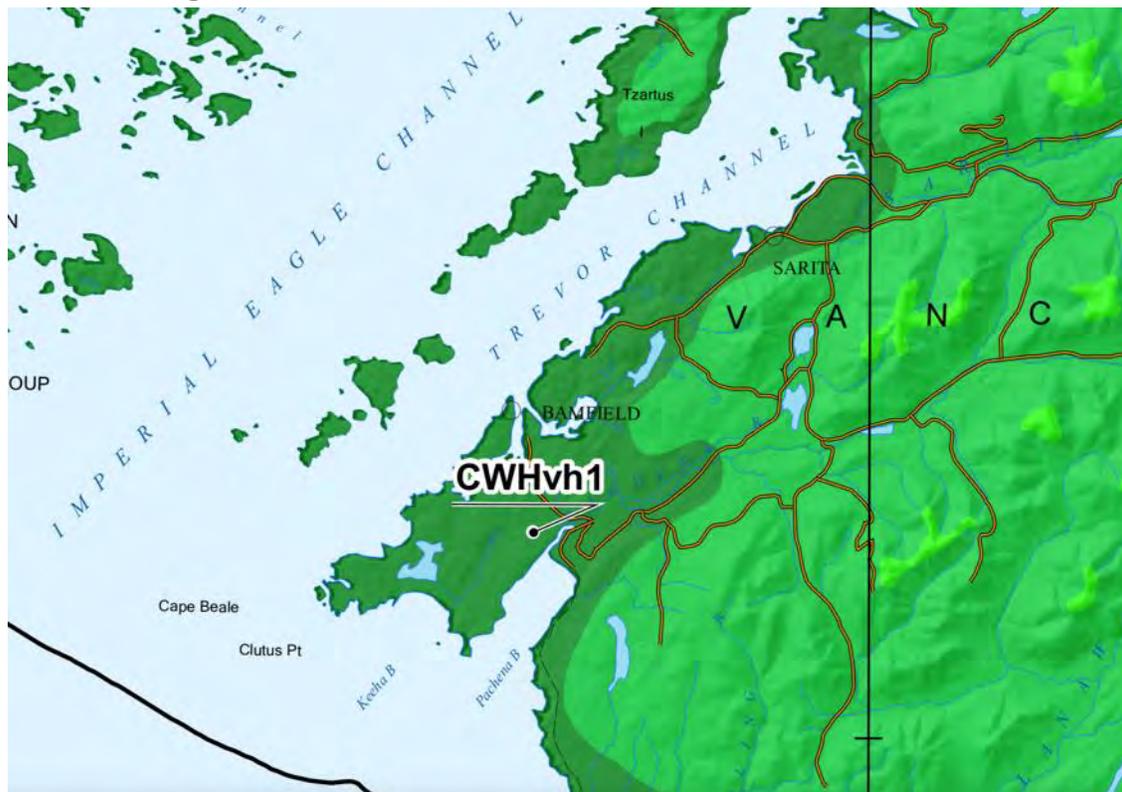
Figure 3: Ecological Area; Coastal Western Hemlock, CWH vh1.

The Burlo Island ecological setting is representative of the Coastal Western Hemlock (CWH) biogeoclimatic zone¹. The CWH zone occurs at low to middle elevations along the west coast of Vancouver Island. The CWH is the dominant biogeoclimatic zone on western Vancouver Island. The Bamfield area is in the CWHvh1 variant of “very wet hypermaritime, southern”.

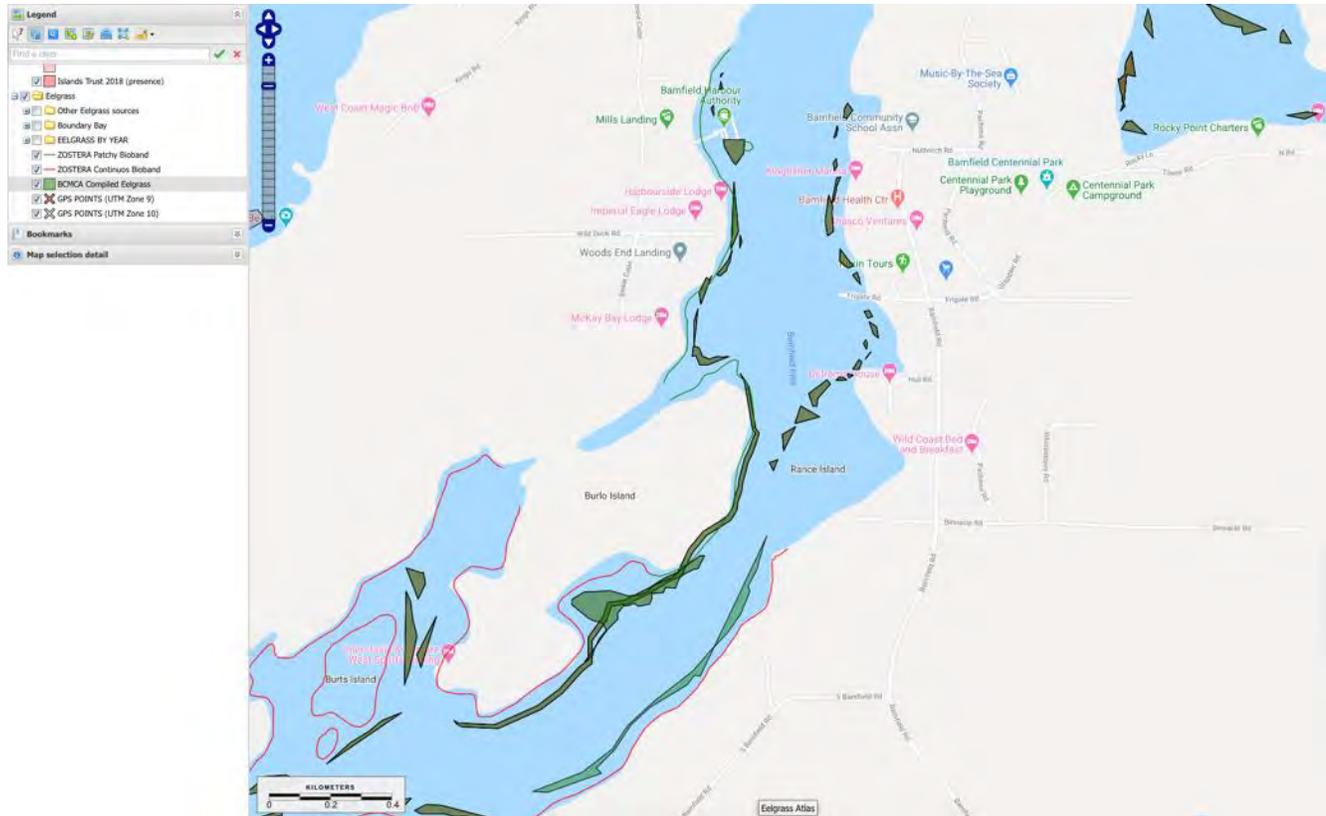
Figure 4: Eel grass map of Burlo Island and surrounding area

was observed, there was no vegetation in the small bay. There was some Rockweed (*Fucus distichus*) and Acorn Barnacles (*Balanus glandula*) on the bedrock points on either side of the bay. The bedrock and rockweed continues along the northwest side of the island past the existing dock. There was eel grass observed during the survey and mapped just out from the shore of the northern end of Burlo island (See Fig 4).

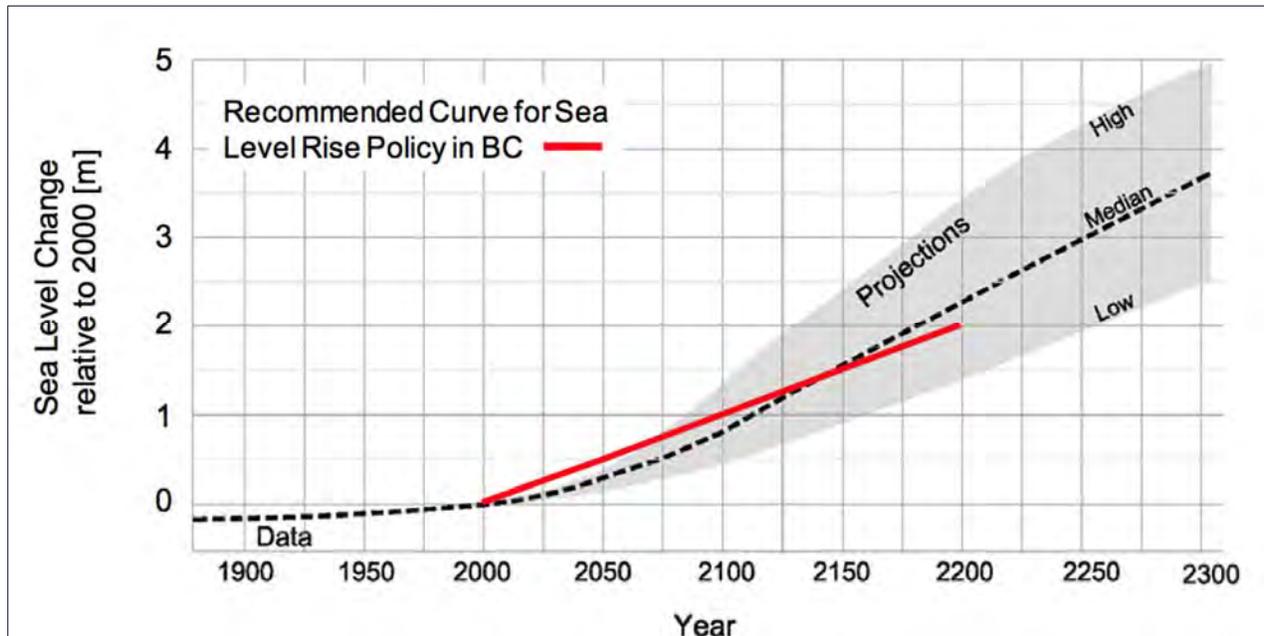
- a. Information prepared by the provincial government in 2011 regarding policy for coastal floodplain mapping assumes a 1.0m rise in sea level over a 100 year span from the year 2000 to 2100. See figure 4.3 below.

Figure 4.3 – Recommended Global SLR Curve for Planning and Design in BC

- b. The assumed amount of SLR is based on current information and will be evaluated in the future as more information becomes available. It should be noted that a 1.0m SLR estimate by the year 2100 is a conservative projection and has been used in the preparation of this report. Whereas the 2.0m SLR estimate by the year 2200 would be considered a mid to low range projection.
- c. Forecasting this far into the future carries significant uncertainties. Monitoring changes of SLR is beyond the scope of this report. We expect local authorities to remain informed in order to adjust their flood management plans/guidelines accordingly.
