Site investigation For Proposed Subdivision

Legal Description: Lot 4, District Lot 21, Alberni District, Plan VIP 927
PID 008 168 334

Street Address: 5605 Mersey Road, Port Alberni.

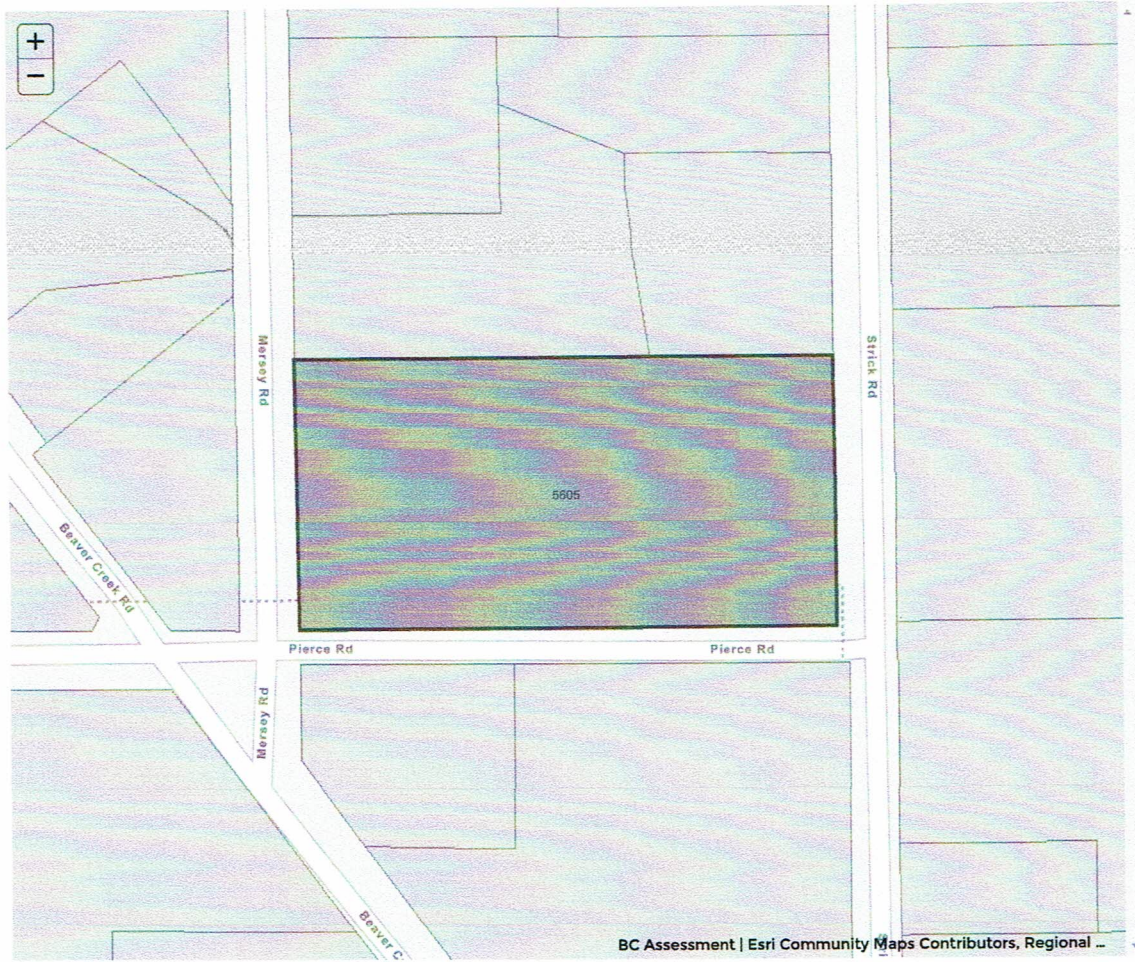
As Built Site Plan for Onsite Wastewater System

North

Test Pits - □

Percolation Pits - ○

Mersey Road

Pierce Road

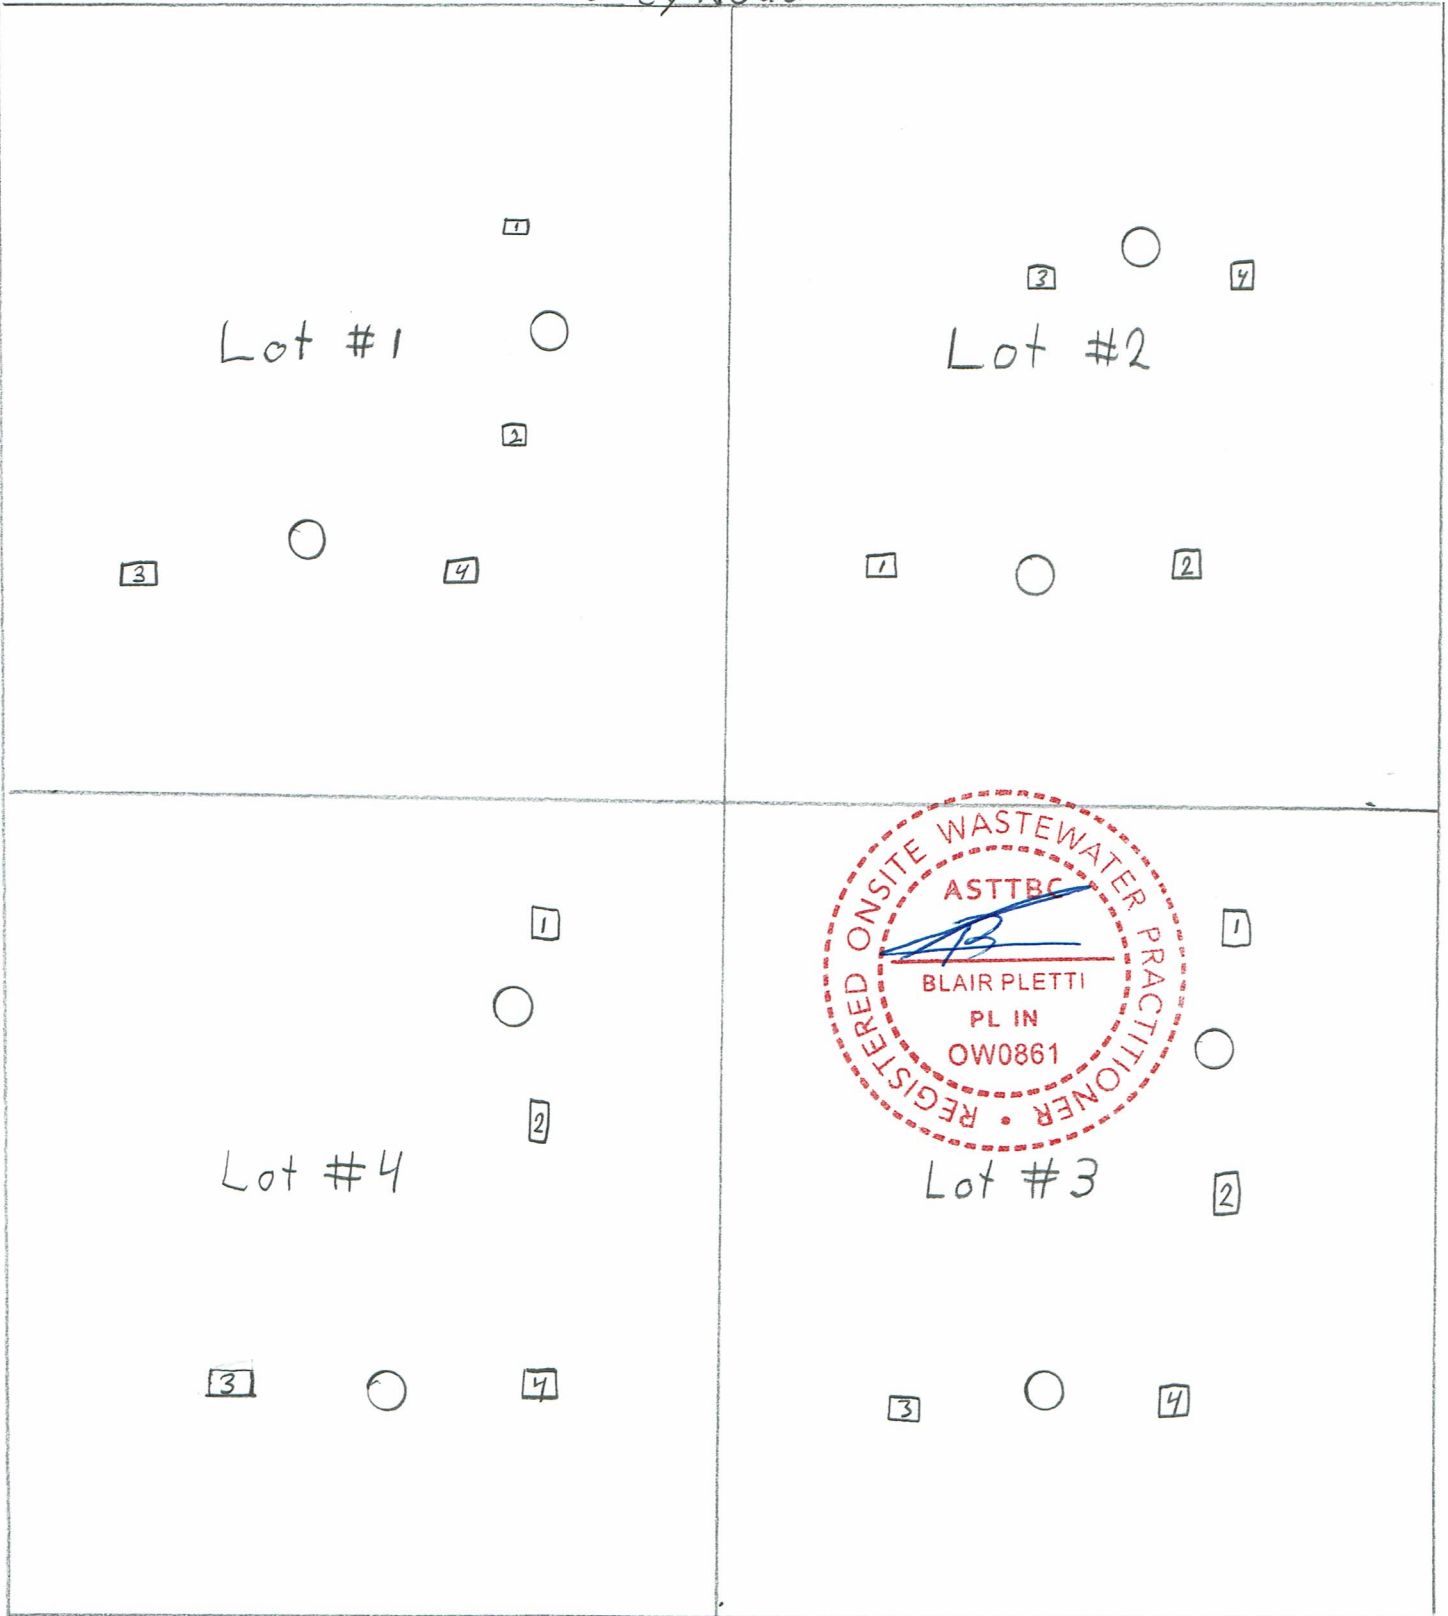
Proposed Lot #1

Test pit #1, #2:

0 – 40 cm	Dark Brown color, Loamy Sand. Moist, moderate grade Granular structure type with soft consistence. Many large to small roots. < 20% coarse fragment content.
40 – 80 cm	Light Greyish yellow color. Moist, soft consistence. Loose to slightly hard Common fine roots. < 15% coarse fragment content.
The Limiting condition is seasonal water table estimated at 80cm

Test Pit #3 & #4:

0 – 50 cm	Dark brown color, Granular texture. Loamy sand Moist, moderate grade granular structure type, 20% coarse fragment content, fine root growth
50– 70 cm	Reddish grey color, moderate grade, soft consistence. Moist, 15% coarse fragment content, loose to friable, fine root growth.
70 – 90 cm	Light grey color, loose to slightly hard , granular soft consistence, no root growth, water seepage at 90cm
The limiting condition is seasonal water table estimated at 90cm

Proposed lot #1 has 4-7% slope east, breakout point is a shallow seasonal drainage ditch at north east end of property downslope from proposed primary & reserve dispersal location. Minimum 7.5m horizontal setback distances can be exceeded. Percolation rate of 7 minutes per inch.
