2010 Water Systems Report

June 30, 2011

Environmental Services Department
Alberni-Clayoquot Regional District
3008 Fifth Avenue
Port Alberni, BC

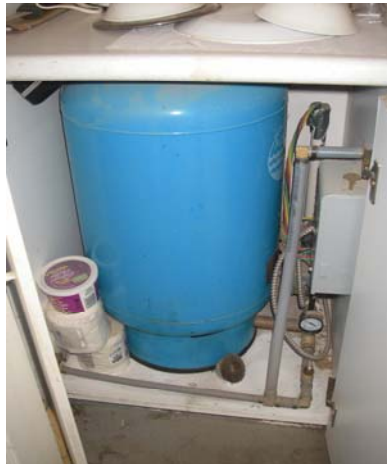
Photo 6. West Coast Landfill Small Water System

The source water for the West Coast Landfill is from a shallow dug well located near the scale house (Photo 5). The geology of the area has significant amounts of marine clay allowing the well to be heavily influenced by surface water. The water system is comprised of one well with one submerged pump. The water is pumped into a pressure tank located inside the scale house. The pressure tank has a pressure switch which controls the operation of the pump. From the pressure tank the water is distributed to the user demand (Photo 6).

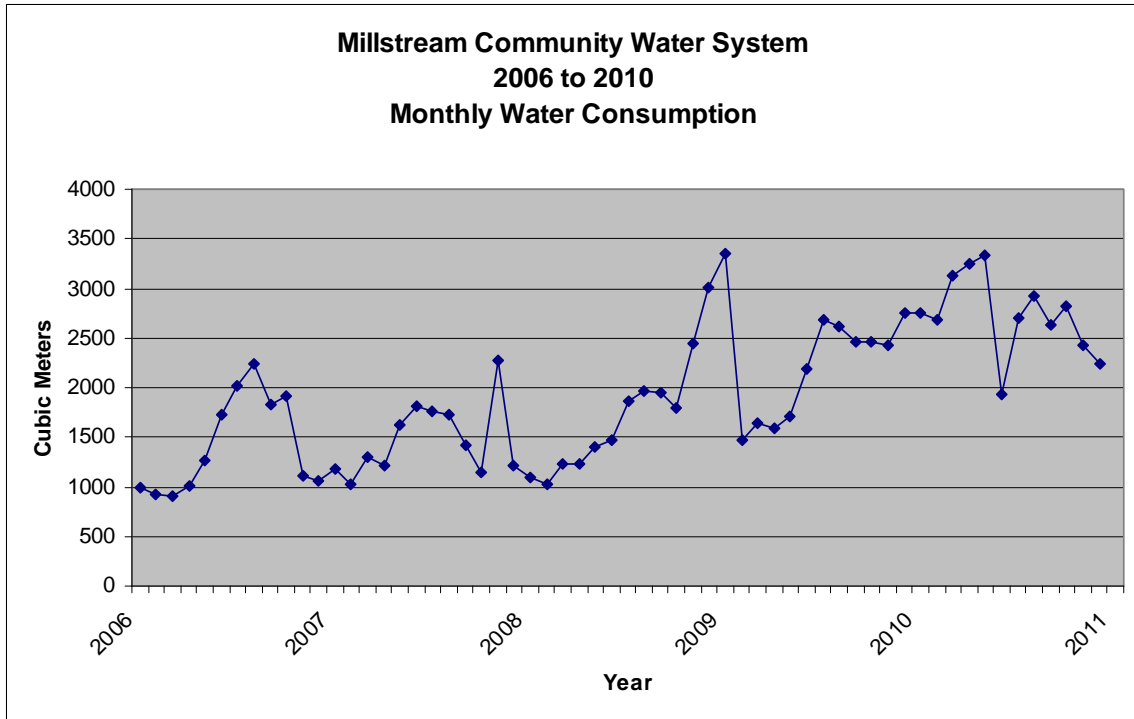
Figure 10. Millstream Community Water System monthly water consumption

The system has approximately fifty connections and serves a population of approximately 150 people. As can be seen in the monthly consumption graph there is an increasing trend in consumption since 2006 (Figure 10).

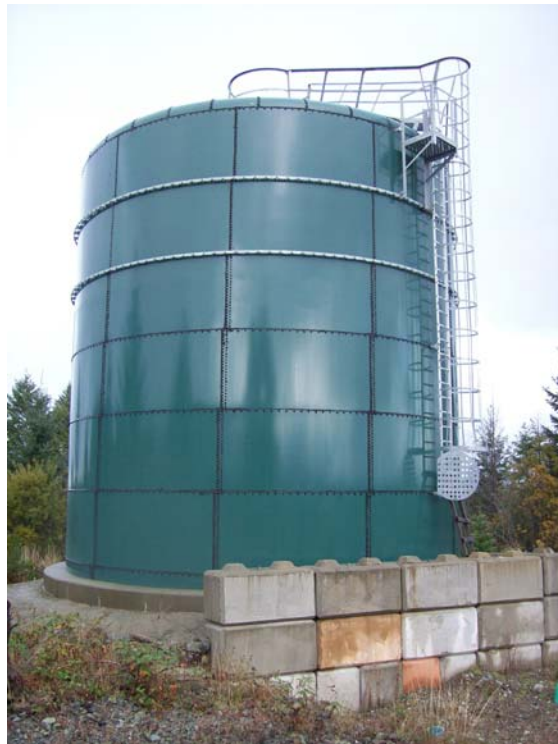
Photo 9. Alberni Valley Landfill Small Water System reservoir

The Port Alberni Division of Catalyst Paper has a water license for Sproat Lake. The mill is located at the head of the Alberni Inlet and requires water for its operations. The water comes from Sproat Lake through a 1350 mm diameter HDPE water main going to the mill. The water main is located near the main entrance to the Alberni Valley Landfill off of McCoy Lake Road. A service line comes off the water main and into a pump house near McCoy Lake Road. When water is required to fill the reservoir at the landfill the pumps turn on and pump water from the Catalyst water main.

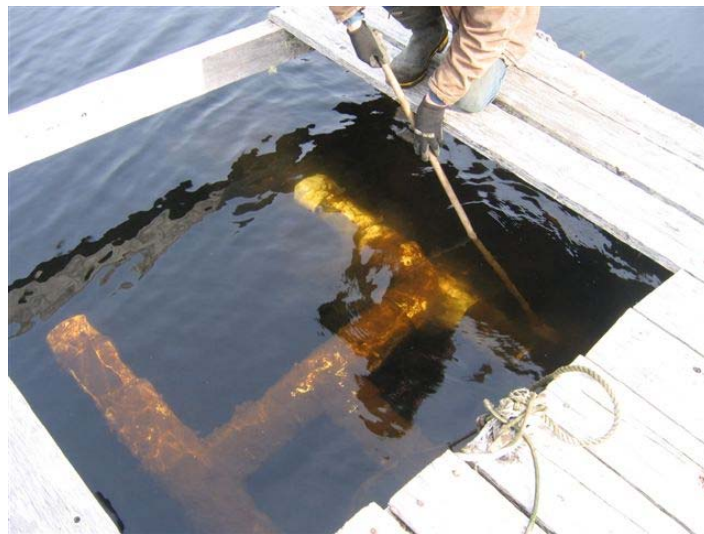
Photo 11. Bamfield Community Water System, cleaning the intake screens

The water supply system is comprised of a water source and intake structure at the south east end of Sugsaw Lake, approximately four kilometers northeast of Bamfield. The intake structure is a floating walkway with the water main and intake screens suspended underneath (Photo 10 & 11). The structure is anchored in many places to hold it in the correct position. The ACRD has a water licence from the Ministry of Environment for 91,250,000 gallons per year from Sugsaw Lake. The 2010 annual water use was 56,939 cubic meters.
