Track and Bridge Condition Assessment

ACRD Rail Corridor

Port Alberni Subdivision

Alberni-Clayoquot Regional District

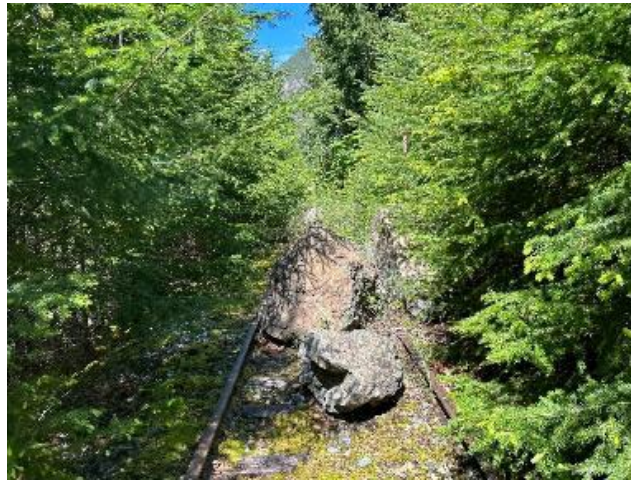
Figure 2-7: Segment 2 – Rockslide Mile 14.8

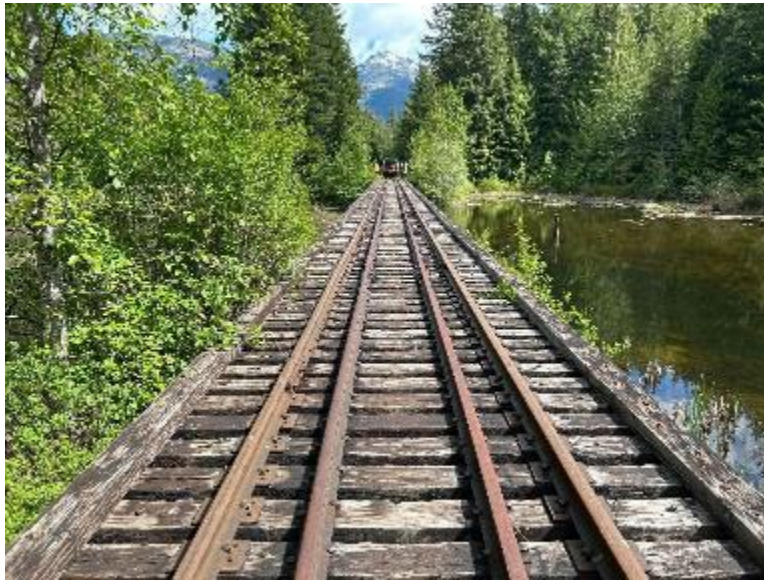
Figure 3-36: Bridge at Mile 21.4 – Deck View Looking East

- Entire bridge deck is in fair condition.
- Running and Jordan rails are in fair condition.

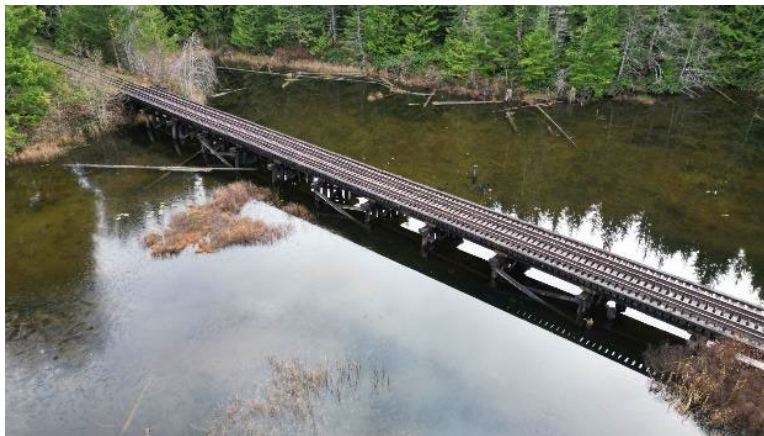
Figure 3-37: Bridge at Mile 21.4 – Aerial View Looking North

- Bent caps, bracing, and posts are in fair condition.
- The overall condition of the substructure is fair.

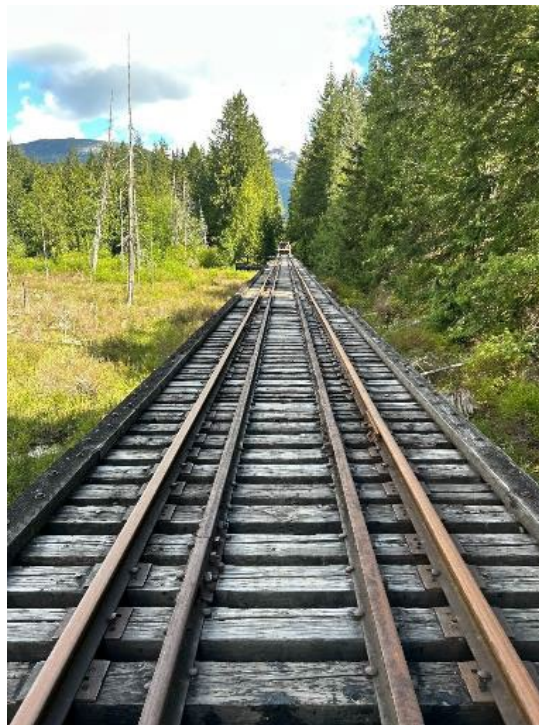
Figure 3-39: Bridge at Mile 21.8 – Deck View Looking East

- 25% of the deck ties are in poor condition.
- A section of guard timber is missing on the north side near bent 1.
- Running and Jordan rails are in fair condition.
- Refuge bays are observed to be missing handrails.
- The bridge deck is in fair condition, with the exception of the ties that need to be replaced.

Recommendations	Description	Cost
Replacement of 25% of Deck Ties	About 25% of the deck ties were noted to be in poor condition and need to be replaced.	\$78,325
Replace Section of Guard Timber	There is a section of guard rail that is missing and needs to be replaced.	Included in tie replacement cost.
Post Pile 5, Bent 32	WSP noted that pile 5 at bent 32 is split, has failed, and should be posted.	\$7,000
Brush Clearing Around Bridges	General vegetation clearing and removal at debris in the waterway around the bridge ends is recommended where feasible.	\$4,000
Visual Bridge Inspection	It is recommended that annual inspections be conducted on the bridge once the required upgrades are completed for 10-ton hi-rail access. This will ensure the bridge remains in operating condition ahead of any emergency access needs.	N/A
Total (without contingency)		\$89,325

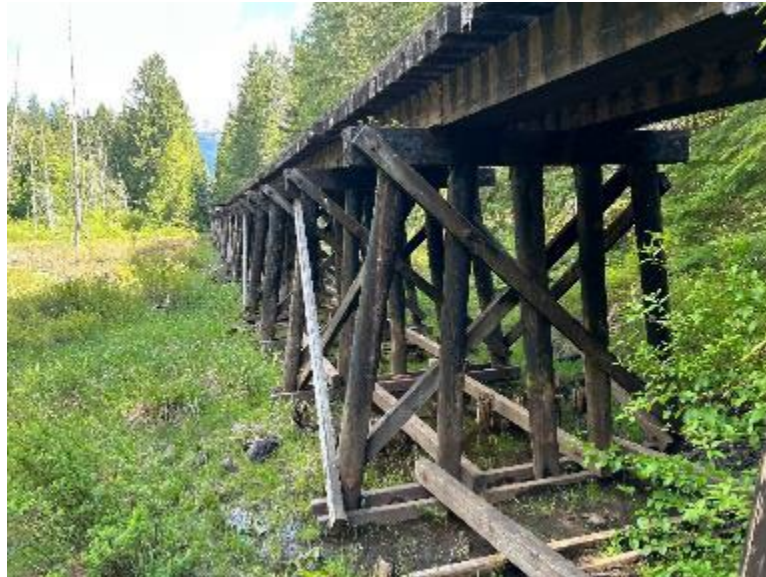
Figure 3-40: Bridge at Mile 21.8 – Under Side View Looking East

- The bridge has 3 chord stringers. Stringer 1 shows signs of decay and is noted to be in poor condition.
- Overall, the superstructure is in fair condition.

- The bent caps are showing signs of decay and are in fair to poor condition. 15% of caps are in poor condition.
- Bracing and posts are in fair condition.
- The overall condition of the substructure is fair.

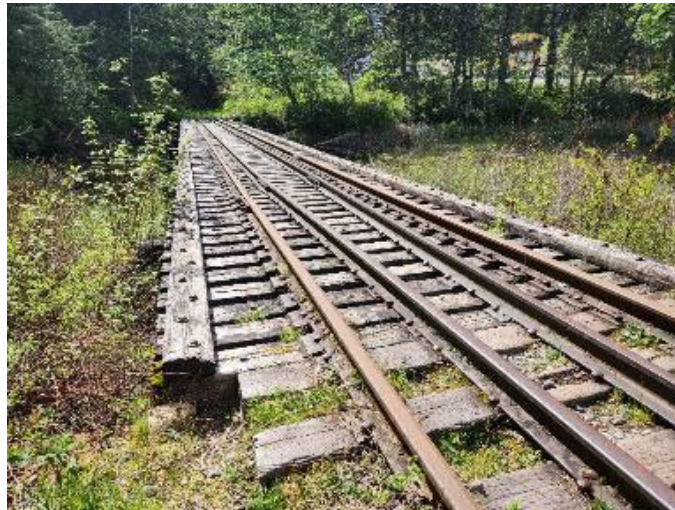
Figure 3-42: Bridge at Mile 22.1 – Deck View Looking West

- The north section of the deck -has fire damage to the ties and guard timber.
- The ties are showing signs of deterioration due to the water level.
- Running and Jordan rails are in fair condition.
- The bridge deck is in fair condition.

Recommendations	Description	Cost
Replacement of Burnt Deck Ties and Guard Timber	The deck ties with fire damage should be replaced.	\$1,950
Debris Cleaning	There is debris build-up on the north side of the bridge that should be removed to allow flow of water under the bridge.	\$3,000
Visual Bridge Inspection	It is recommended that annual inspections be conducted on the bridge once the required upgrades are completed for 10-ton hi-rail access. This will ensure the bridge remains in operating condition ahead of any emergency access needs.	N/A
Total (without contingency)		\$4,950

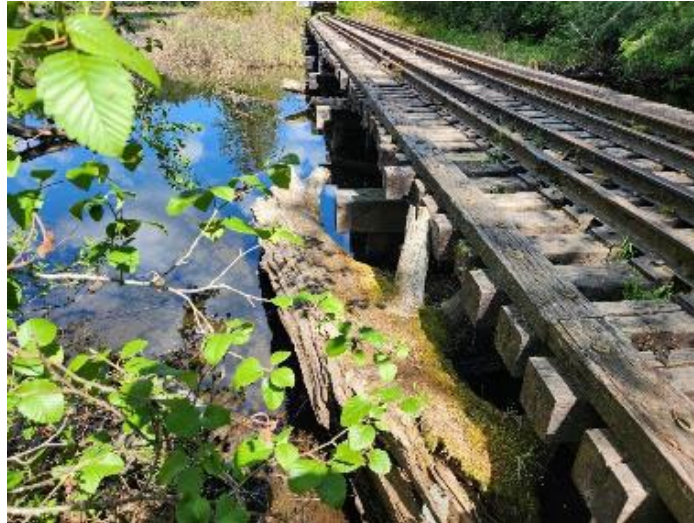
Figure 3-44: Bridge at Mile 22.1 – Debris Build up in North Side

- There is debris build-up on the north end of the bridge.
- Bracing and posts are in fair condition.
- The overall condition of the substructure is fair.

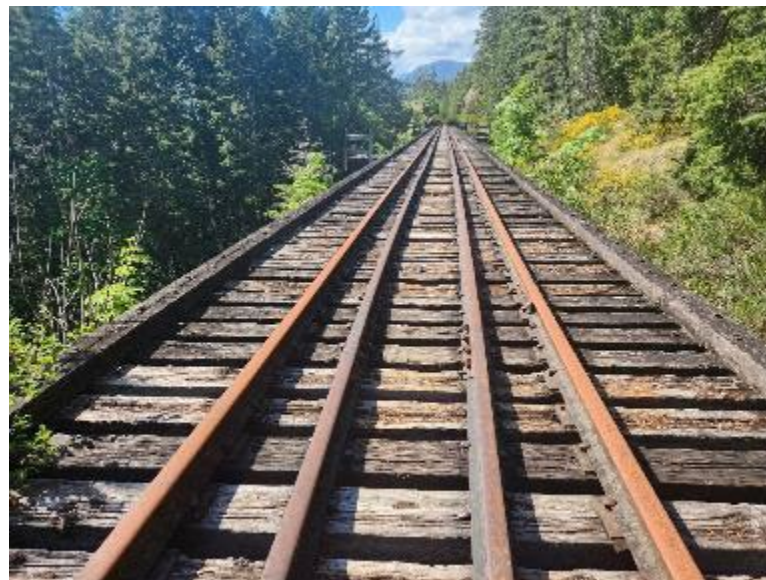
Figure 3-46: Bridge at Mile 25.0 – Deck View Looking West

- Track alignment is observed to have lateral deviations throughout the bridge.
- Most deck ties are in poor condition and 90% need to be replaced.
- Running and Jordan rails are in fair condition.
- The bridge deck is in poor condition.

Recommendations	Description	Cost
Replace Deck Ties	The majority of deck ties are in poor condition and are recommended to be replaced.	\$224,900
Replace Mud Sills	The mud sills seen are deteriorating or completely crushed which could be the cause to the wavy track alignment. The condition of all mud sills could not be determined due to vegetation growth but it has been assumed that 50% of the mud sills are required.	\$106,000
Brush Clearing Around Bridges	General vegetation clearing around the bridge is recommended where feasible to reduce the risk of timber decay and fire hazard.	\$10,000
Visual Bridge Inspection	It is recommended that annual inspections be conducted on the bridge once the required upgrades are completed for 10-ton hi-rail access. This will ensure the bridge is in operating condition ahead of any emergency access needs.	N/A
Total (without contingency)		\$340,900

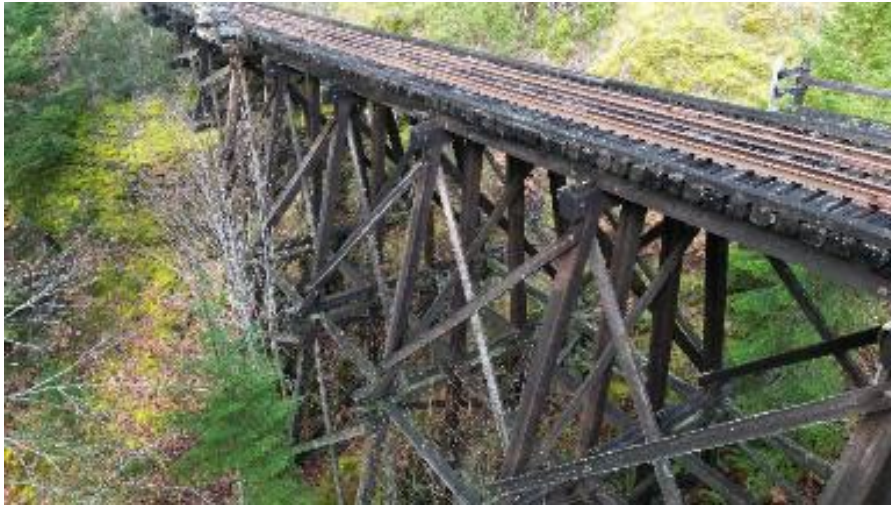
Figure 3-47: Bridge at Mile 25 – South Elevation

- Bent caps are in fair condition.
- Posts are in fair condition.
- Various braces are broken or split.
- There is a large amount of vegetation growth at the base of the bents.
- The sills are rated as fair to poor, with poor sills showing severe deterioration, some completely crushed.
- The overall condition of the substructure is poor to fair.

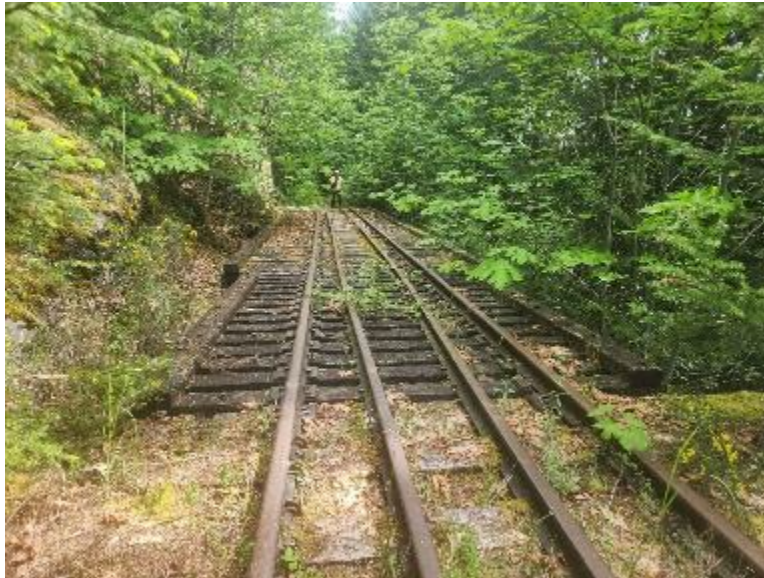
Figure 3-51: Bridge at Mile 28.9 – Deck View Looking East

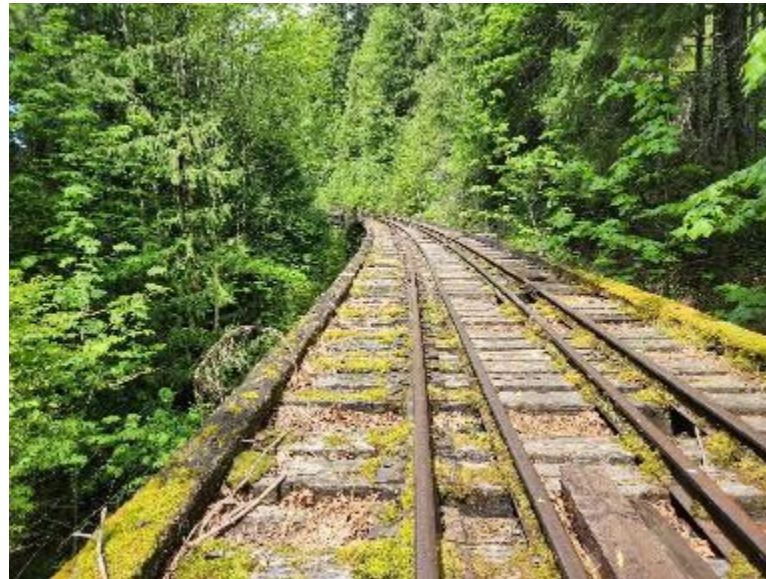
Figure 3-53: Bridge at Mile 29.9 – Deck View Looking West

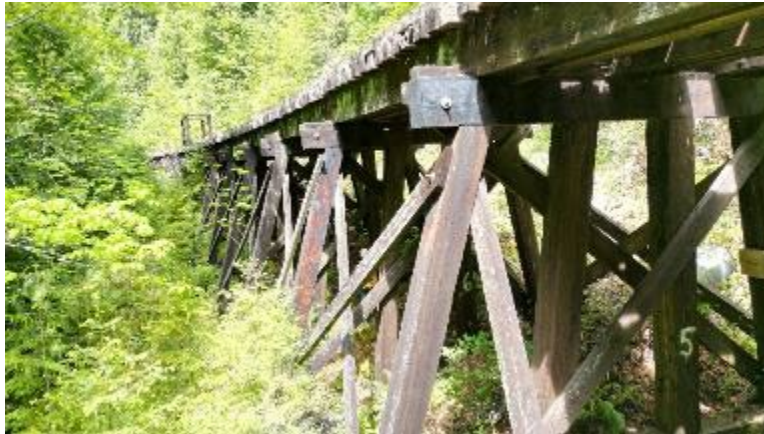
Figure 3-54: Bridge at Mile 29.9 – Side View Looking West

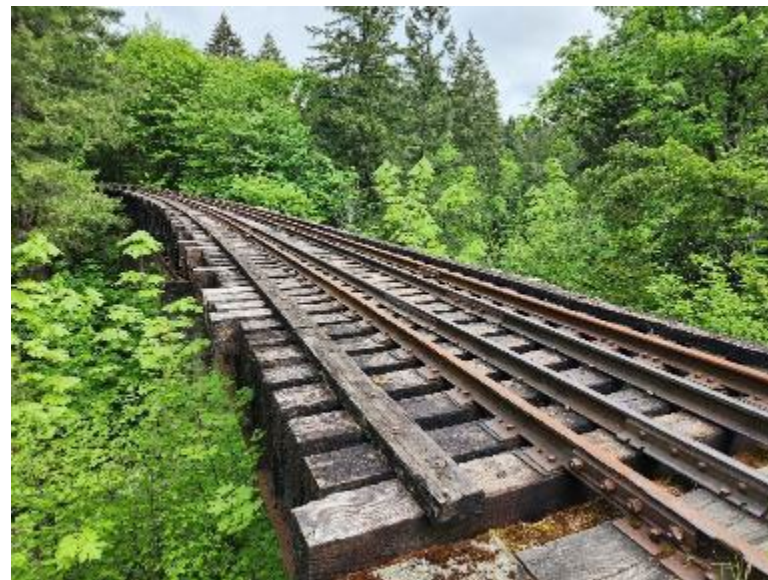
Figure 3-57: Bridge at Mile 36.5 – Deck View Looking East

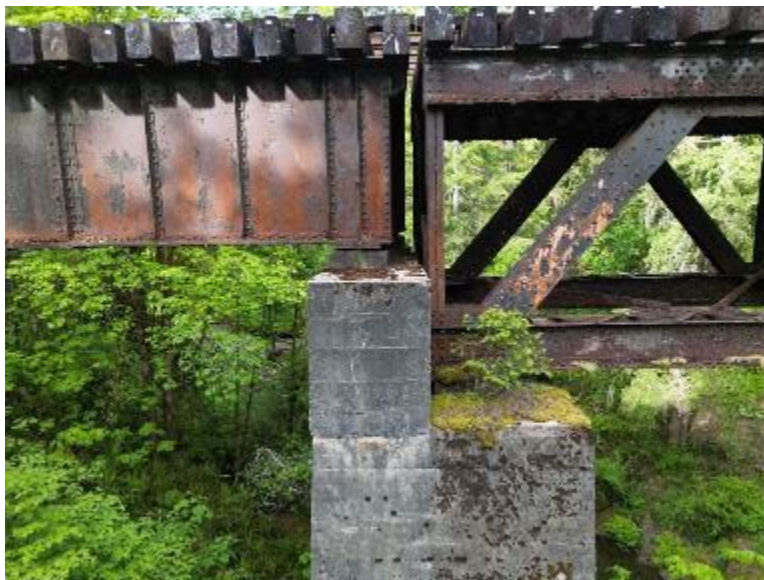
Figure 3-59: Bridge at Mile 36.5 – West Pier

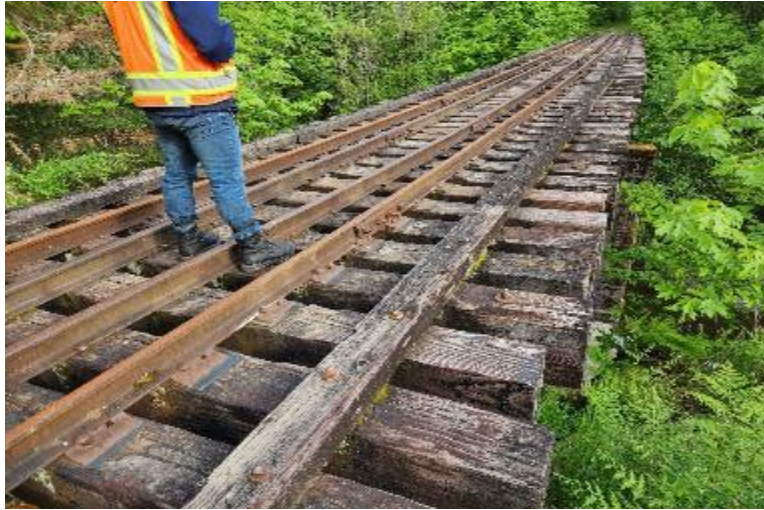
Figure 3-61: Bridge at Mile 37.1 – Deck View Looking West

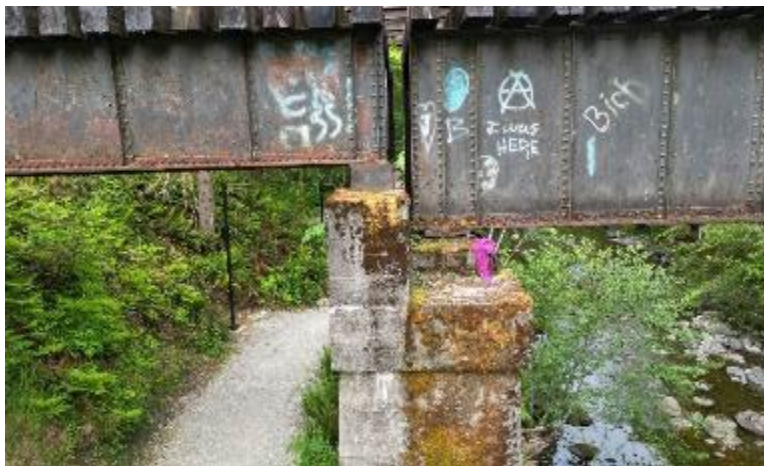
Figure 3-62: Bridge at Mile 37.1 – Pier View
