ALBERNI CLAYOQUOT REGIONAL DISTRICT

BAMFIELD WATER SYSTEM

ANNUAL REPORT
2018

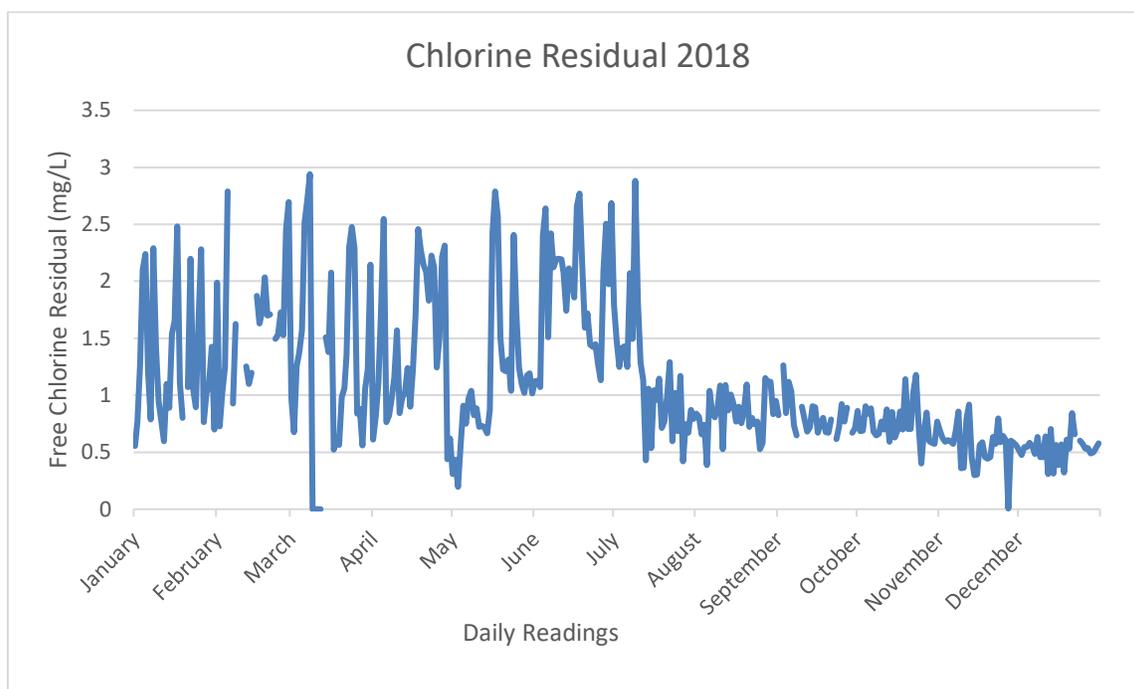
To ensure good water quality throughout the distribution system, water mains are regularly flushed to remove any accumulated silt by creating an increase in velocity to scour the pipes. As water flows within a distribution system, the chlorine is slowly eaten up by organics in the water or any material built up in the pipes. Residual chlorine is an immediate test to measure if the water is safe to drink; although water without a chlorine residual is not necessarily unsafe. Other tests to ensure safety (such as bacterial testing) require 3 to 4 days for results. Low to no chlorine residual in the water system can indicate poor circulation of water and a need for increased flushing.

As can be seen on the Chlorine Residual graph above, there was a significant change in the variation of results half way through the year. The first half of the year shows that the water quality changes frequently and that chlorine addition requires frequent changes. The last half of the year shows how the new DAF water treatment plant (startup July 14th) produces a consistent water quality that requires small changes to the chlorine addition.

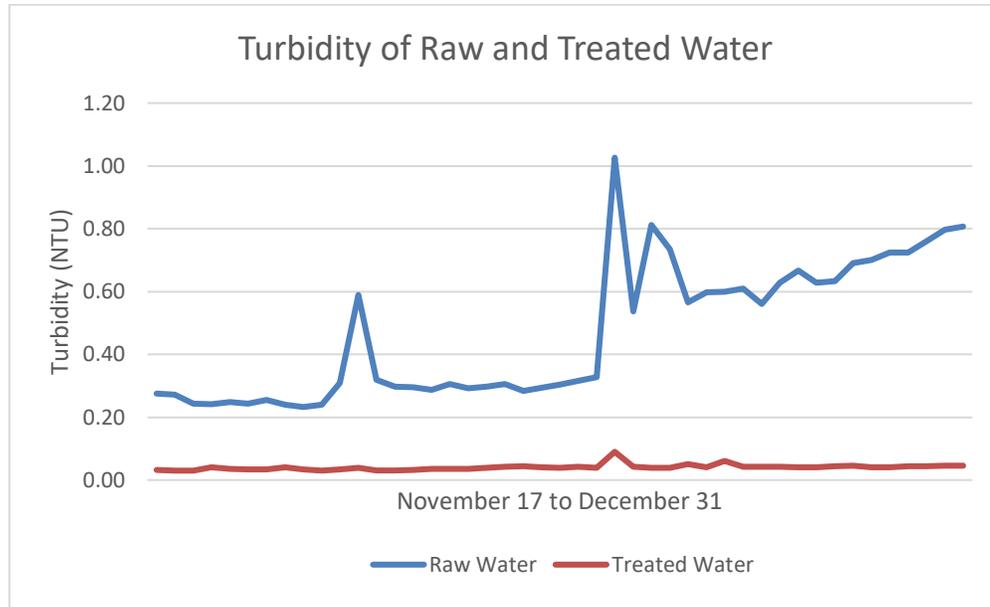
Turbidity is the cloudiness or haziness of a fluid caused by the suspension of individual particles. This parameter is continually monitored as it effects the ability of chlorine to disinfect. The following graph only shows the turbidity starting in late November and December due to the start of automatic monitoring of the new water treatment plant. The incoming raw water turbidity can be quite high (up to 1 NTU) but the treated water's turbidity is consistently between 0.03 and 0.04 NTU. This demonstrates that the new treatment plant is very effective.

Typical raw water from Sugsaw Lake has turbidity below 0.4 NTU but during winter rain events turbidity can double or triple. High rain fall events tend to wash in soil particles from the water shed which increases the turbidity.

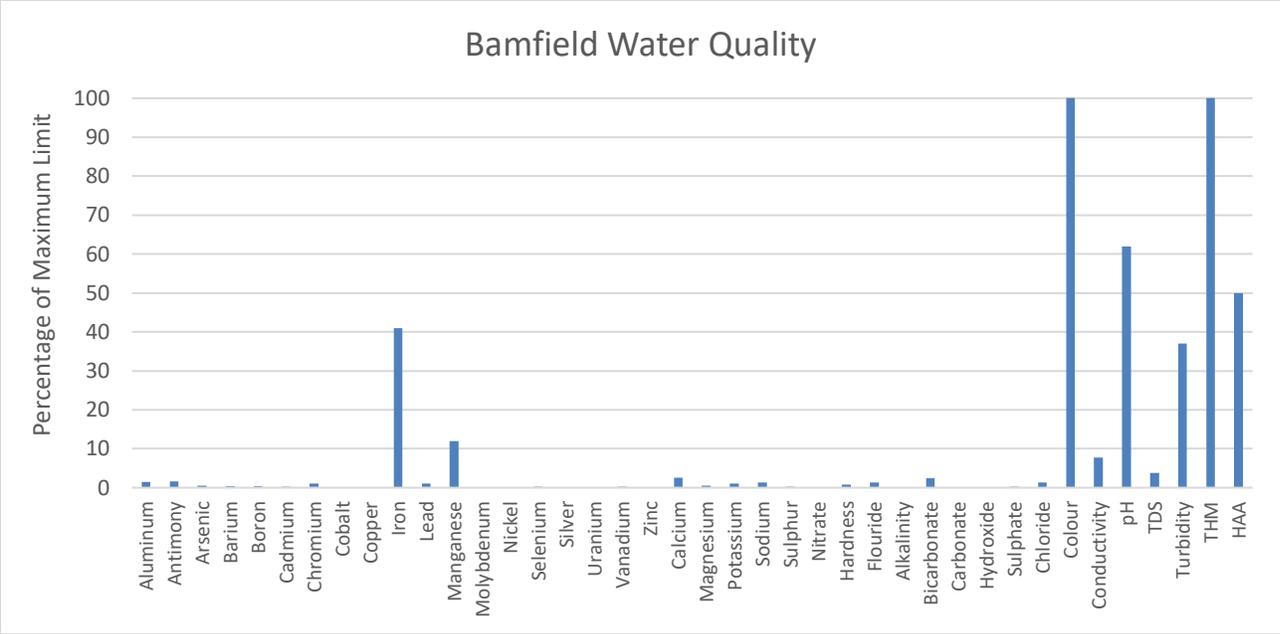
The ACRD regularly performs tests to ensure that the water is meeting all standards. The water system's latest complete potability sample is shown in the following Water Quality Parameters graph. As this testing was completed before the Water Treatment Plant was installed there were DBP and colour values above the standards.

The above graph shows the results in meeting the Canadian Drinking Water Standards. Colour and disinfection byproducts (THM) exceeded the standards. Although colour alone isn't harmful, the associated organics in water often causes disinfection byproducts. The high THM values obtained at this sampling event are not indicative of the entire year but only for this sampling event. The plant was operational in July and has since then been successful in removing the precursors of DBP (colour and organics). All DBP's values and colour values are now well below the guidelines.

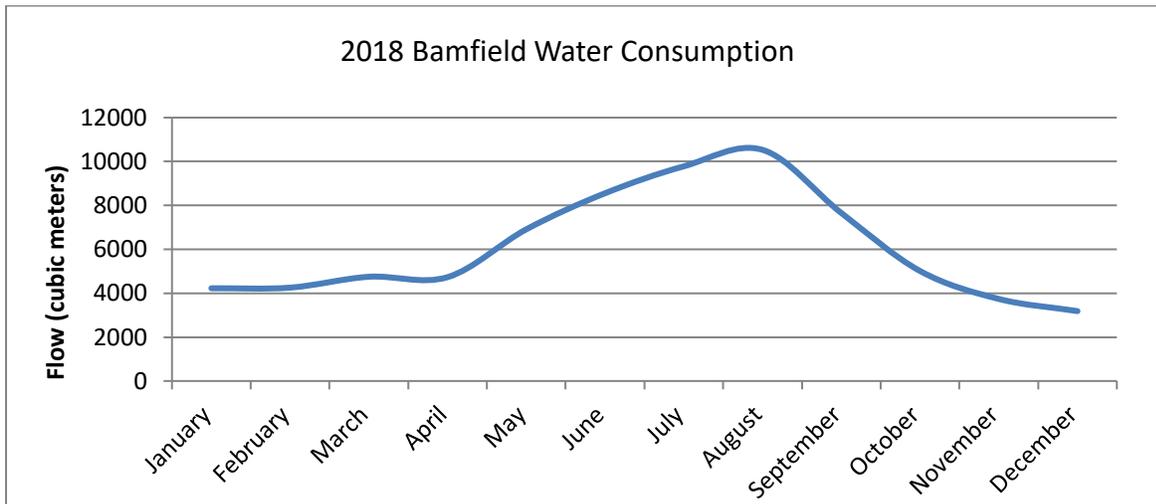
A water system must be designed to provide the peak demand and fire flow. If peak demands are excessively high, then the water pipes are required to be oversized which is expensive and causes operational challenges in keeping water fresh in the lower flow time periods. Our target it to have the peak day demand (PDD) less than twice as much as the average day demand(ADD). Peak summer day demand is approximately 299 m3/day compared to average daily demand of approximately 201 m3/day. This is approximately 1.5:1 ratio of PDD to ADD.
