# **ALBERNI CLAYOQUOT REGIONAL DISTRICT**

## **BAMFIELD WATER SYSTEM**

### ANNUAL REPORT 2020

Prepared by the  
Environmental Services Department  
3008 Fifth Avenue, Port Alberni, BC, Canada, V9Y 2E3, Phone 250-720-2700

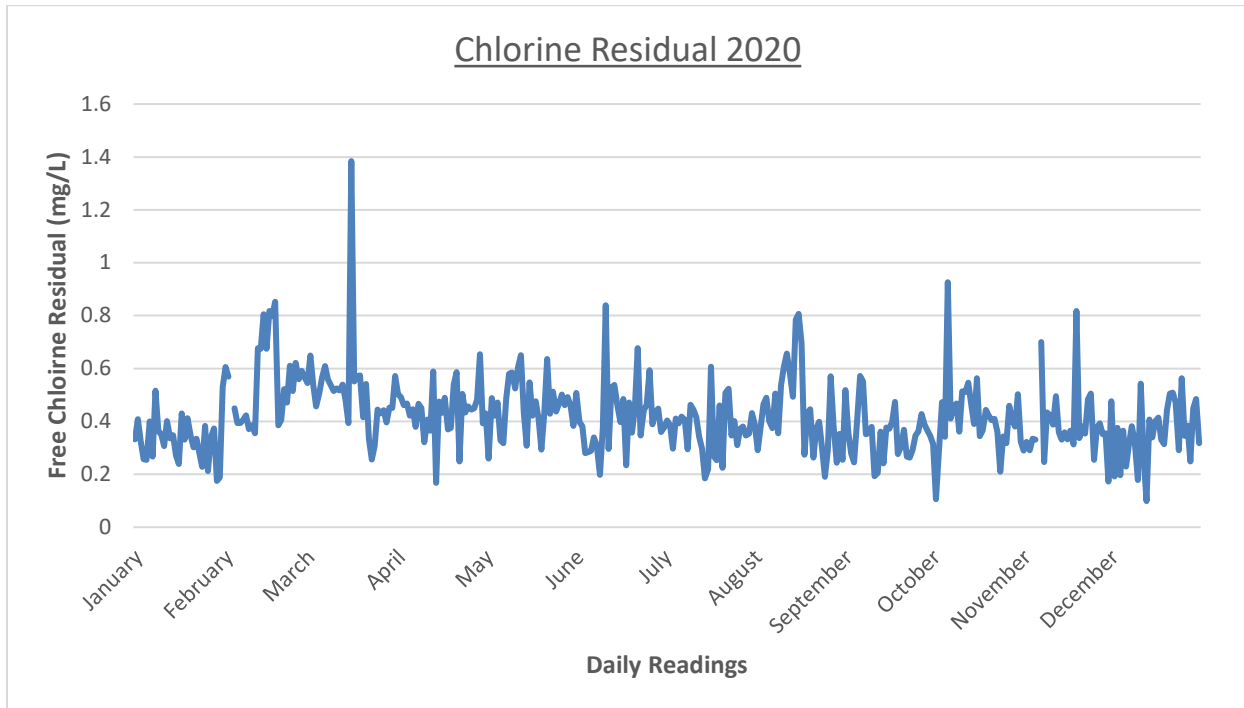
The graph above shows that the free chlorine levels leaving the water treatment plant is usually between 0.2 and 0.8 ppm with some fluctuations above or below. This variation has significantly reduced since the operation of the treatment plant, prior to which levels would range between 0.2 and 3.0 ppm. These values can easily change due to changing water chemistry and chemical pump speed fluctuations. The water system has additional chlorine injection at the reservoirs to ensure the entire water system has adequate disinfection. The water operator conducts daily chlorine checks throughout the system and adjusts the pump speeds if necessary to maintain the minimum 0.20 mg/L chlorine residual throughout the distribution system.

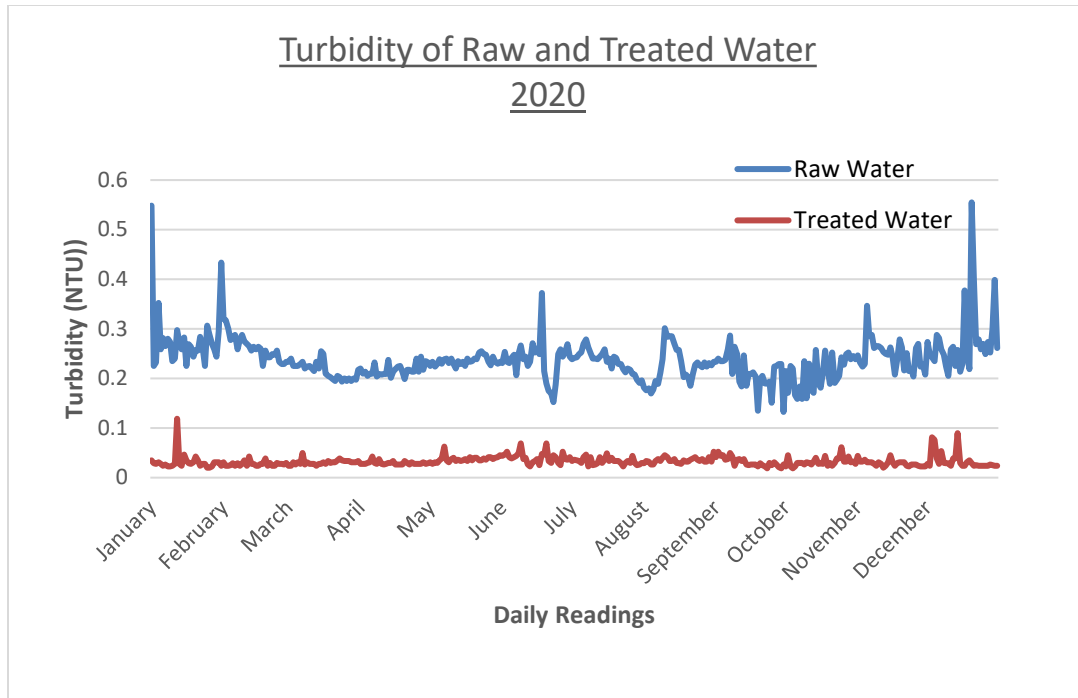
Typical raw water from Sugsaw Lake has turbidity below 0.3 NTU but during winter rain events turbidity can double or triple. High rainfall events tend to wash in soil particles from the watershed which increases the turbidity. The graph above shows January and December's high turbidity in the raw water and the effectiveness of the plant to remove the turbidity.

Turbidity is the cloudiness or haziness of a fluid caused by the suspension of individual particles. This parameter is continually monitored as it affects the ability of chlorine to disinfect. The following graph shows that there was high turbidity in the raw water source in January and December due to heavy rains. However, the treated water's turbidity is consistently between 0.03 and 0.04 NTU. This demonstrates that the new treatment plant is very effective.

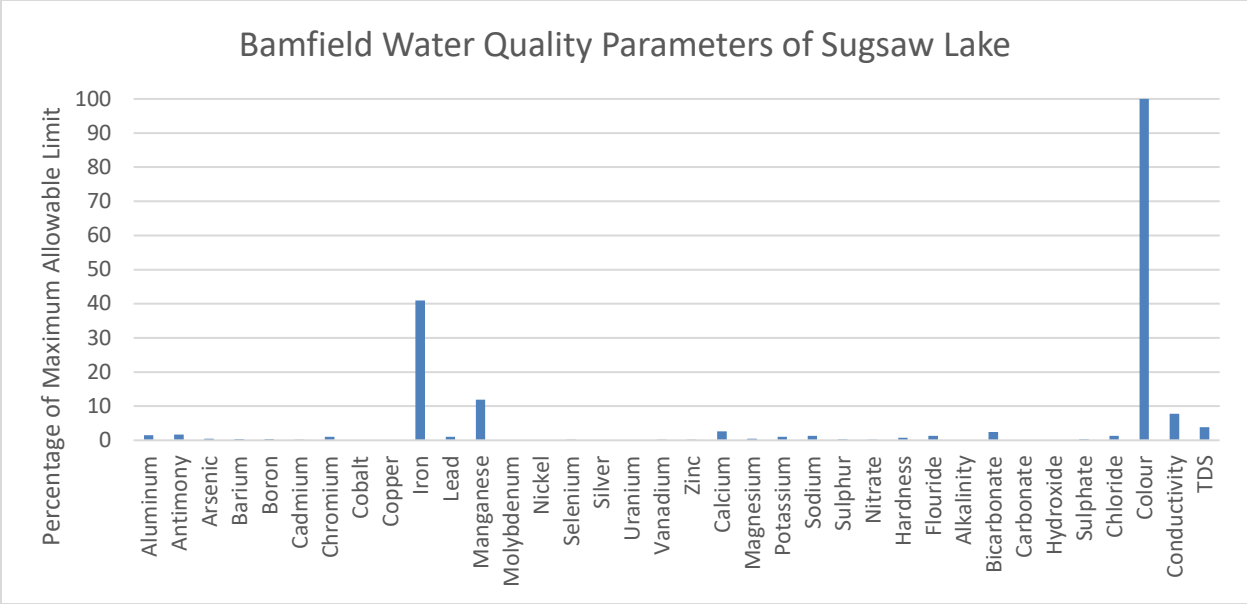
The above graph shows the untreated water’s results in meeting the Canadian Drinking Water Standards. The colour is above the acceptable limit in the raw water but after the water treatment plant the water exceeds the standards. Although colour alone is not harmful, the associated organics in water often causes disinfection byproducts. The plant has been successful in removing the precursors of DBP (colour and organics). The treated water has all DBP’s values and colour values well below the guidelines. The graph below illustrates the effectiveness of the treatment plant in the reduction in DBP’s.

The ACRD regularly performs tests to ensure that the water is meeting all standards. The water system's latest complete potability sample is shown in the following Water Quality Parameters graph. Prior to the construction and commissioning of the new treatment plant, water in the system did not meet the drinking water quality guidelines due to the DBP's.

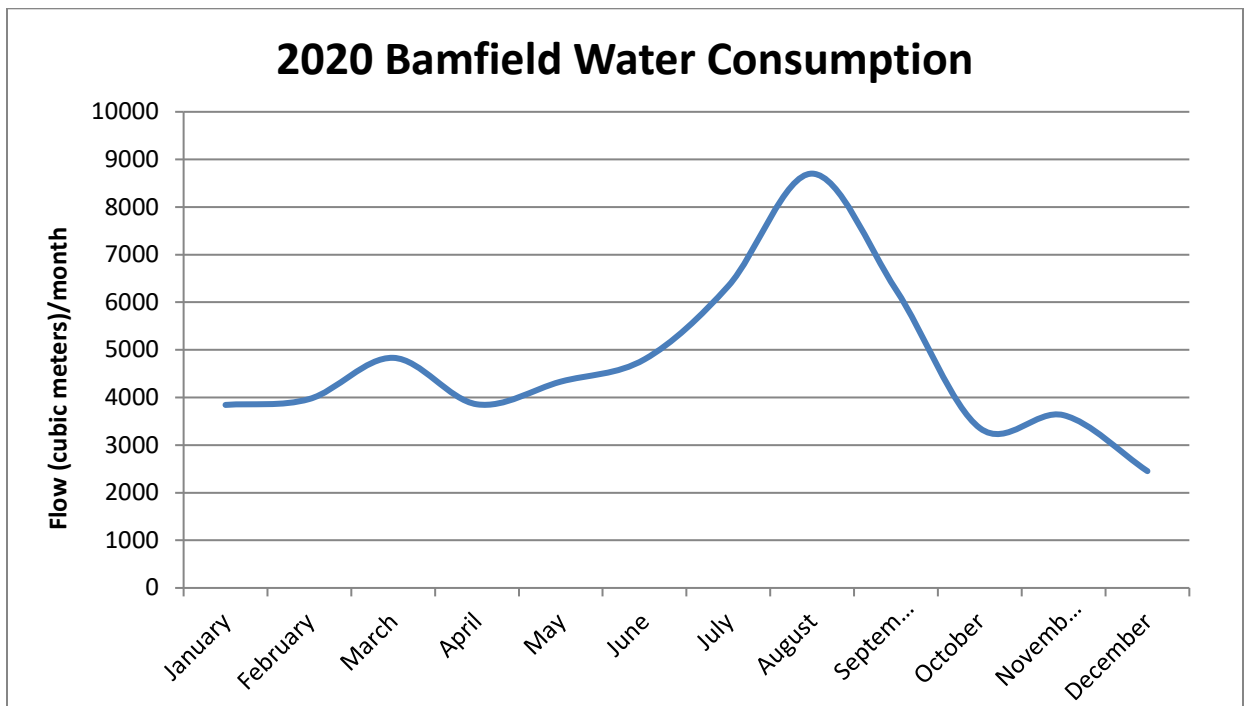
A water system must be designed to provide the peak demand and fire flow. If peak demands are excessively high, then the water pipes are required to be oversized which is expensive and causes operational challenges in keeping water fresh in the lower flow time periods. The target is to have the peak day demand (PDD) less than twice as much as the average day demand (ADD). Peak summer day demand is approximately 216 m<sup>3</sup>/day compared to average daily demand of approximately 154 m<sup>3</sup>/day. This is approximately 1.40:1 ratio of PDD to ADD. The 2020 water consumption graph below shows higher values in the fall due to large leak events.
