ALBERNI CLAYOQUOT REGIONAL DISTRICT

BAMFIELD WATER SYSTEM

ANNUAL REPORT
2021

Prepared by the
Community Services Department
3008 Fifth Avenue, Port Alberni, BC, Canada, V9Y 2E3, Phone 250-720-2700

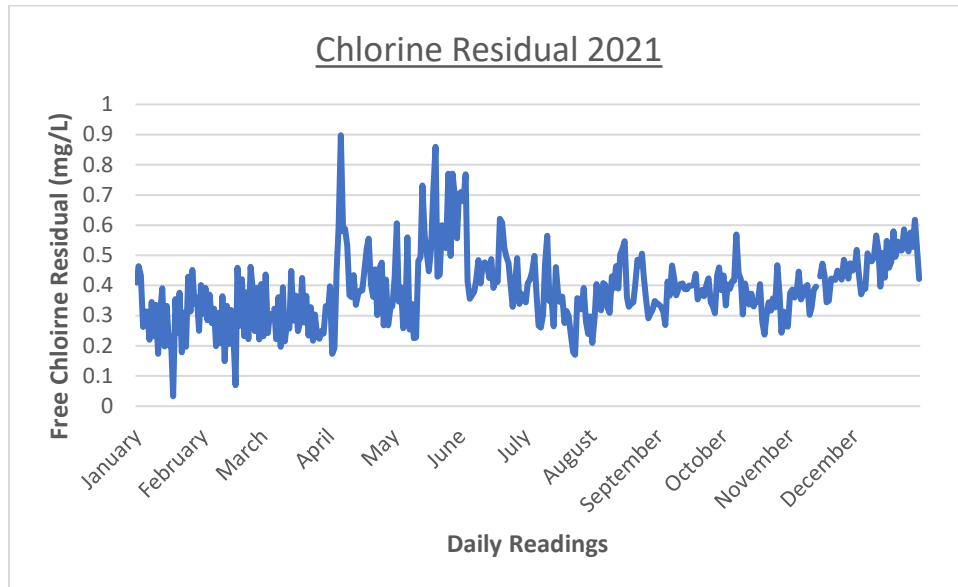
The graph above shows that the free chlorine level leaving the water treatment plant is usually between 0.2 and 0.8 ppm with some fluctuations above or below. This variation has significantly reduced since the operation of the treatment plant, prior to which levels would range between 0.2 and 3.0 ppm. These values can easily change due to changing water chemistry and chemical pump speed fluctuations. The water system has additional chlorine injection at the reservoirs to ensure the entire water system has adequate disinfection. The water operator conducts daily chlorine checks throughout the system and adjusts the pump speeds if necessary to maintain the minimum 0.20 mg/L chlorine residual throughout the distribution system.

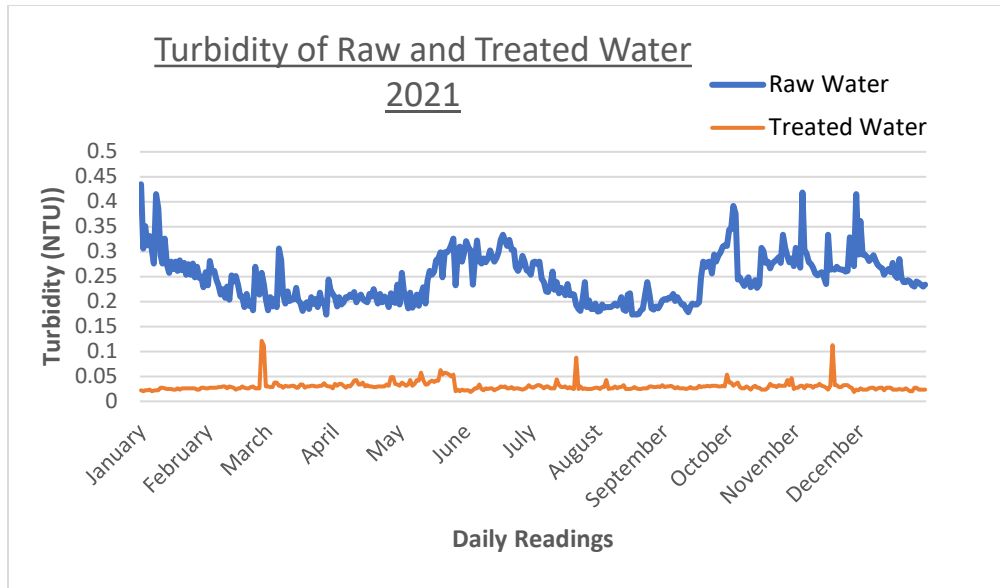
Typical raw water from Sugsaw Lake has turbidity below 0.3 NTU but during winter rain events turbidity can double or triple. High rainfall events tend to wash in soil particles from the watershed which increases the turbidity. The graph above shows January and December’s high turbidity in the raw water and the effectiveness of the plant to remove the turbidity.

Turbidity is the cloudiness or haziness of a fluid caused by the suspension of individual particles. This parameter is continually monitored as it affects the ability of chlorine to disinfect. The following graph shows that there was high turbidity in the raw water source in January and December due to heavy rains. However, the treated water's turbidity is consistently between 0.03 and 0.04 NTU. This demonstrates that the new treatment plant is very effective.

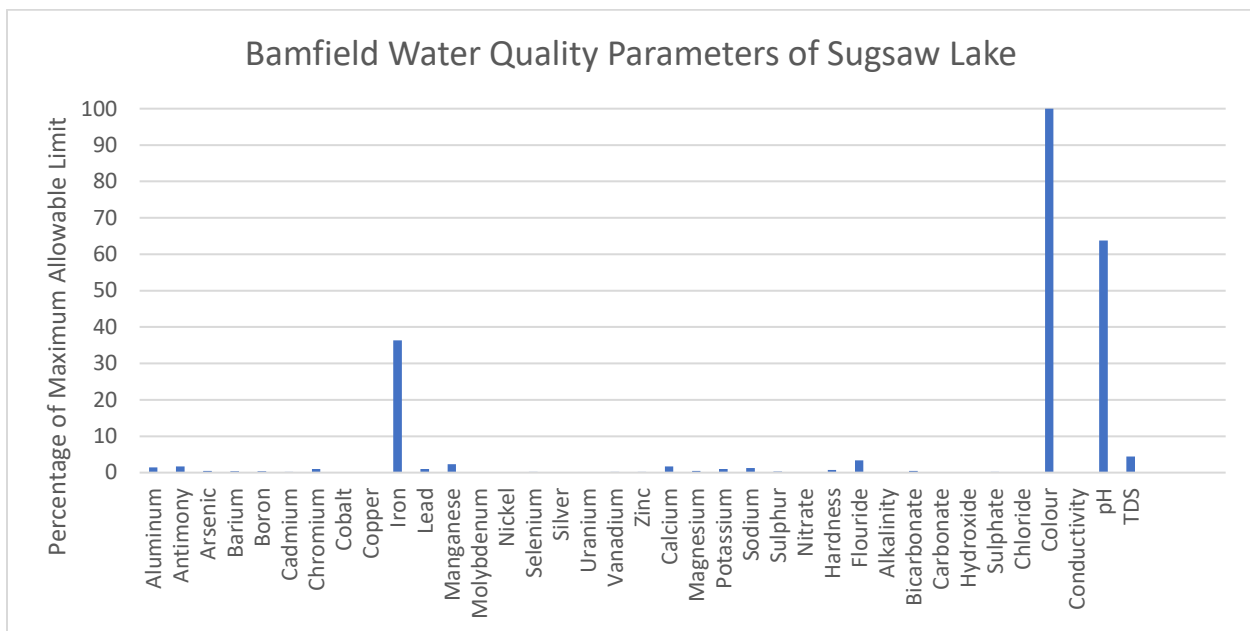
The above graph shows the untreated water’s results in meeting the Canadian Drinking Water

Standards. The colour is above the acceptable limit in the raw water but after the water treatment plant, the water exceeds the standards. Although colour alone is not harmful, the associated organics in water often causes disinfection byproducts. The plant has been successful in removing the precursors of DBP (colour and organics). The treated water has all DBP's values and colour values well below the guidelines. The graph below illustrates the effectiveness of the treatment plant in the reduction in DBP's.

The ACRD regularly performs tests to ensure that the water is meeting all standards. The water system’s latest complete potability sample is shown in the following Water Quality Parameters graph. Prior to the construction and commissioning of the new treatment plant, water in the system did not meet the drinking water quality guidelines due to the DBP’s.

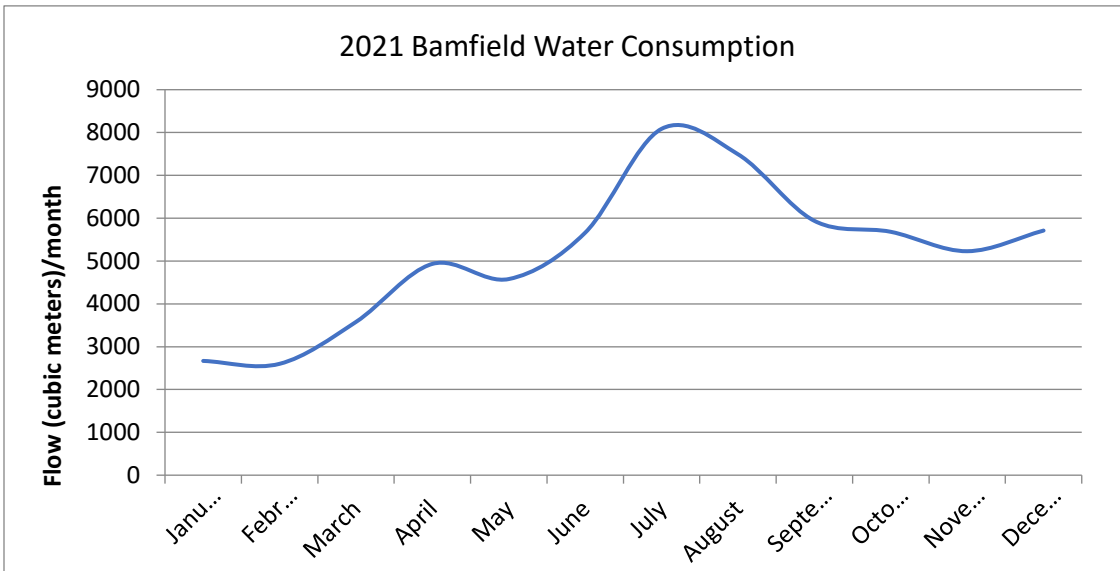
m³/day. This is approximately 1.36:1 ratio of PDD to ADD. The 2021 water consumption graph below shows higher values in April due to leaks and repairs to a submerged main with subsequent flushing.
